Customer: **Planar Monolithics Industries, Inc.**

Specification **Customer's PO & MIL-STD-202G**

Part Type: **Microcircuit**

## CERTIFICATE OF COMPLIANCE

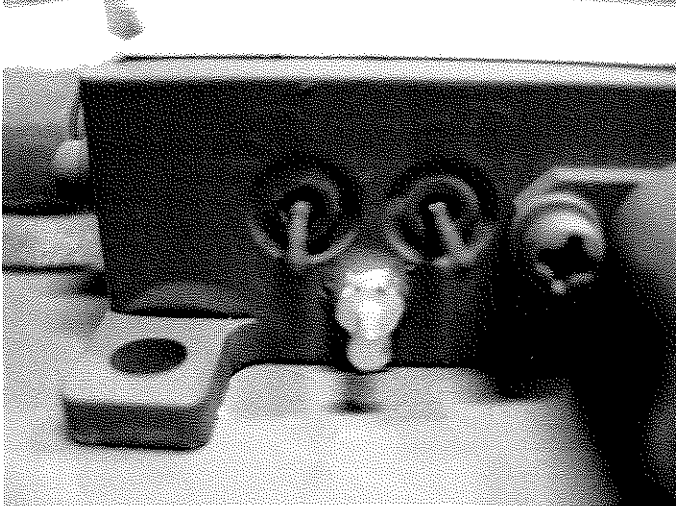
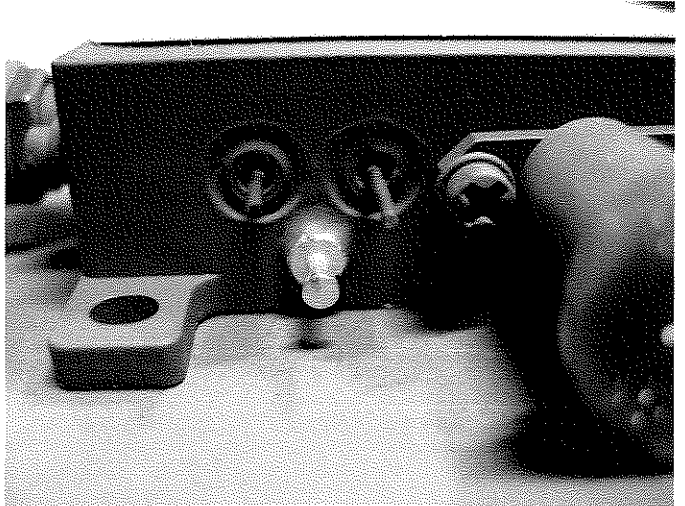
After

Note: Sypris performed no PASS/FAIL inspection on Moisture Resistance Units. Final results must be evaluated by Planar Monolithics Industries, Inc.

**PHOTOS OF HUMIDITY TESTING**

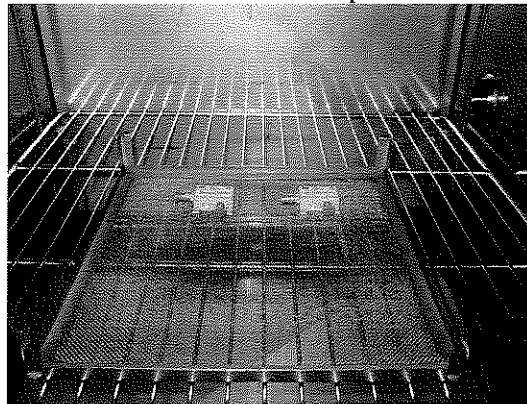
Chamber Setup

MOISTURE RESISTANCE	<p><b>Documentation:</b> MIL-STD-202G, Method 106g Customer P.O.</p> <p><b>Conditions:</b> Perform Initial Conditioning: No Perform Initial Measurements: No Step 7 applicable: No Number of Cycles: 10 Cycle Duration: 24 hours each (Per Figure 106-1)</p> <p><b>RETURN PARTS IN MOISTURE BARRIER BAG! DEVICES MUST BE ELECTRICALLY TESTED AT PLANAR MONOLITHICS INDUSTRIES, INC. WITHIN 48 HOURS OF REMOVAL FROM CHAMBER!</b></p> <p><b>Details:</b> Operational: NA Failure criteria: End point measurements to be performed by Planar Monolithics Industries.</p> <p><b>Operator's Notes:</b> Only Test serial numbers labeled "TEST UNIT 1 and TEST UNIT 2"</p> <p>The units under test were subjected to the above conditions for the conditional period of time. After completion of testing it was noted that a large portion of the leads on one unit had rusted as well as the tip of one of the pins on the other unit under test. Sypris Test &amp; Measurement did not perform an electrical test of the parts and final compliance is to be determined by Planar Monolithics Industries, Inc.</p>	9/28/09	STM 20-17 TECH

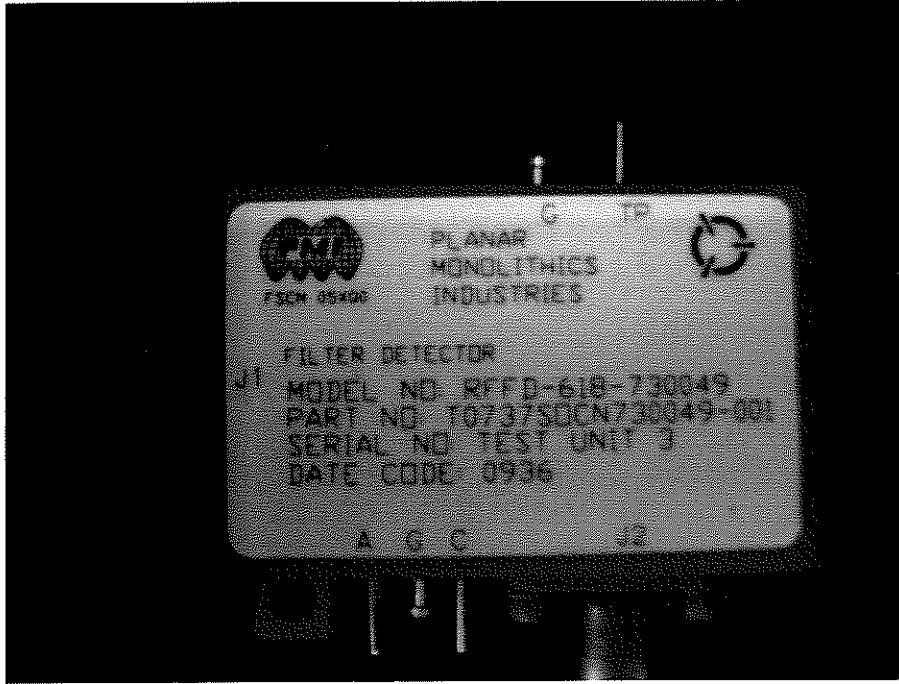
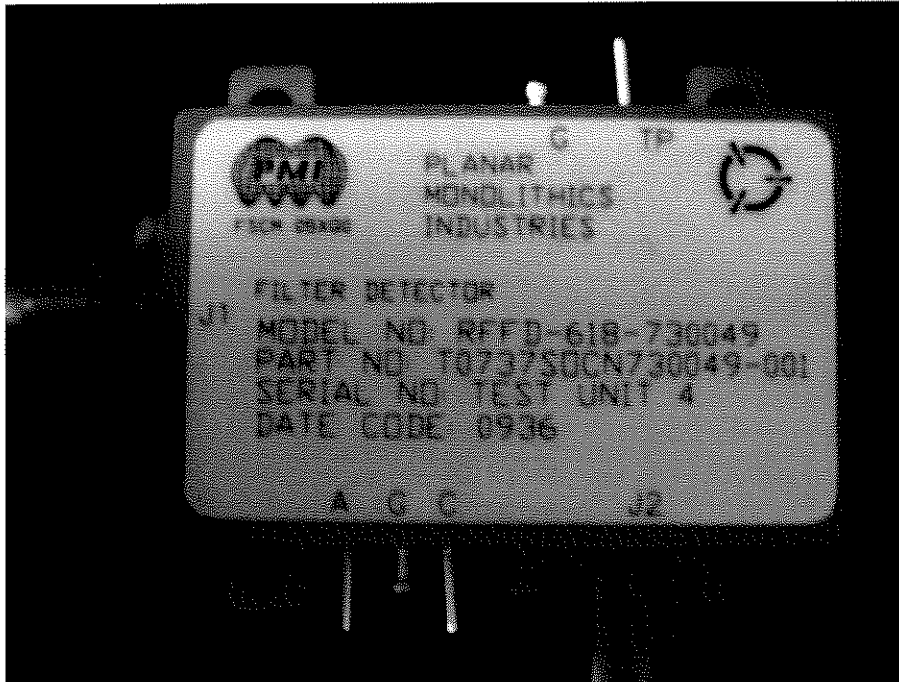
PHOTOS OF RESISTANCE TO SOLVENT TESTING

<b>RESISTANCE TO SOLVENTS</b>	<p><b>Documentation:</b> Customer P.O. &amp; MIL-STD-202G Method 215K</p> <p><b>Conditions:</b> A) 1/4 Isopropyl Alcohol 3/4 Mineral spirits at +25°C (±5°C)  C) A terpene based solvent (BIOACT EC7)  D) 42 parts by volume deionized water 1 part by volume propylene glycolmonomethyl ether 1 part by volume monoethanolamine.</p> <p>Solvents A, and C are at +25°C ± 5°C Solvent D is between +63 and +70°C.</p> <p><b>Procedure:</b></p> <ol style="list-style-type: none"> <li>1. Expose units to first chemical solution.</li> <li>2. Examine units for failures</li> <li>3. Expose units to second chemical solution.</li> <li>4. Examine units for failures</li> <li>5. Expose units to third chemical solution.</li> <li>6. Examine units for failures.</li> </ol> <p><b>Details:</b> Failure criteria: Evidence of cracking, crazing, discoloration, bleeding of foreign matter, and pitting. All markings should be legible.</p> <p><b>Operator's Notes:</b>  <b>Only Test serial numbers labeled "TEST UNIT 3 and TEST UNIT 4"</b></p> <p><b>Evaluation &amp; Results:</b>  <b>Testing was performed on one unit serial number labeled "TEST UNIT 3 and TEST UNIT 4" by following the application of the prescribed test conditions stated above.</b></p> <p><b>All units tested were found to have Passed Testing.</b></p>		<p>9/24/09</p>
