**SUMMARY TEST DATA
ON
P5T-100M1G-90-T-55-SFF**

PL22019/1802

Customer: _____	Tested By: <u>A. Lopez</u>
SO No: _____	Temperature: <u>+25°C</u>
Model No: <u>P5T-100M1G-90-T-55-SFF</u>	Date: <u>01/16/17</u>
Serial No: <u>PL22019/1802</u>	Drawing No: <u>27614302</u> Rev: <u>A1</u>

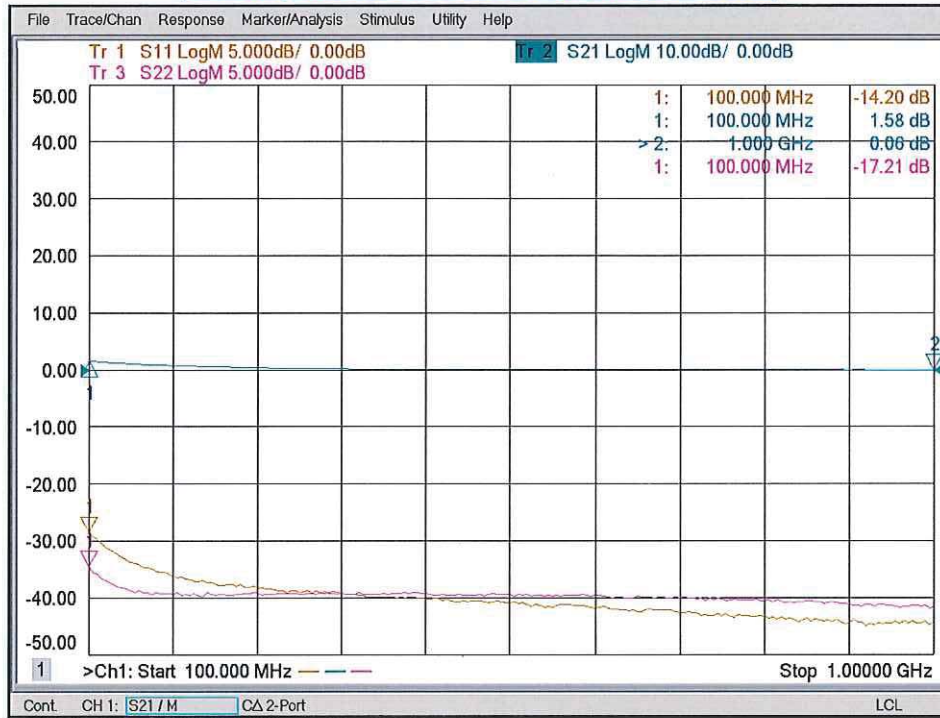
(J1-J2) Insertion Loss and Return Loss

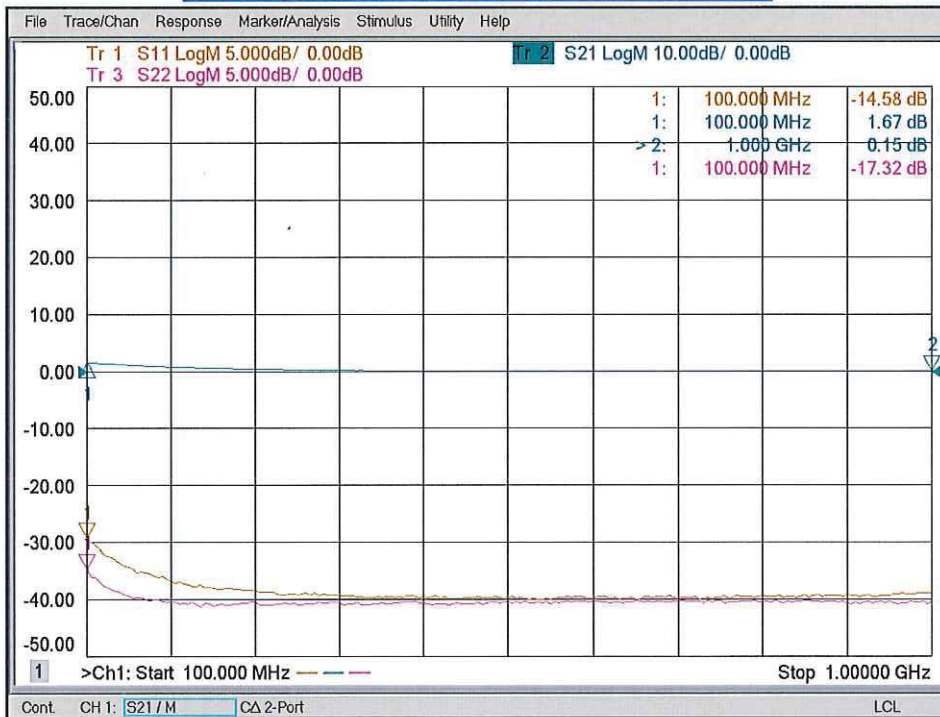
(J1-J3) Insertion Loss and Return Loss

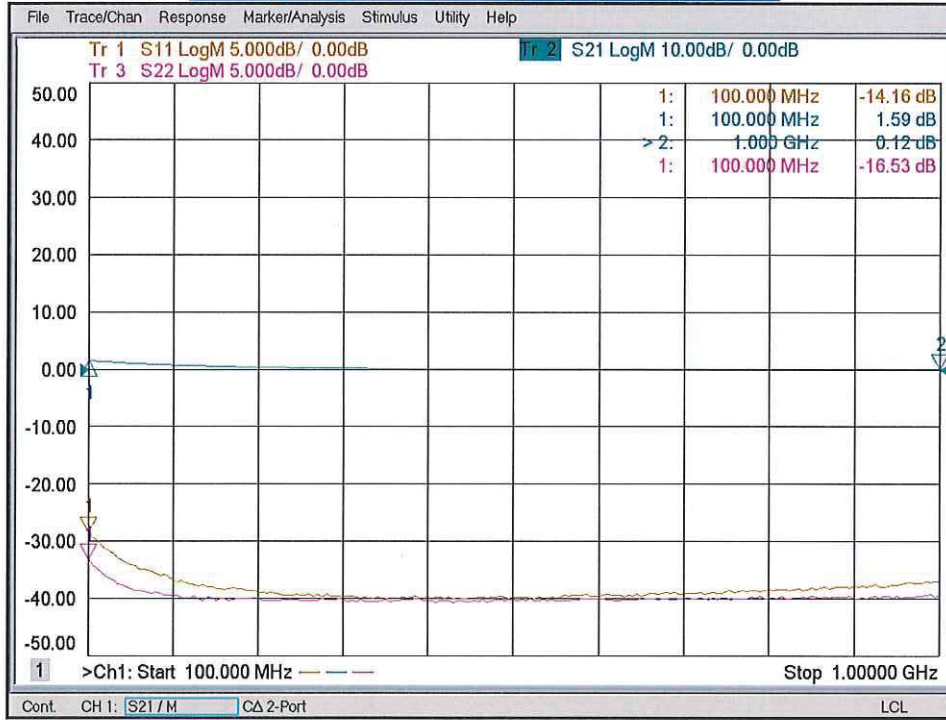
(J1-J4) Insertion Loss and Return Loss

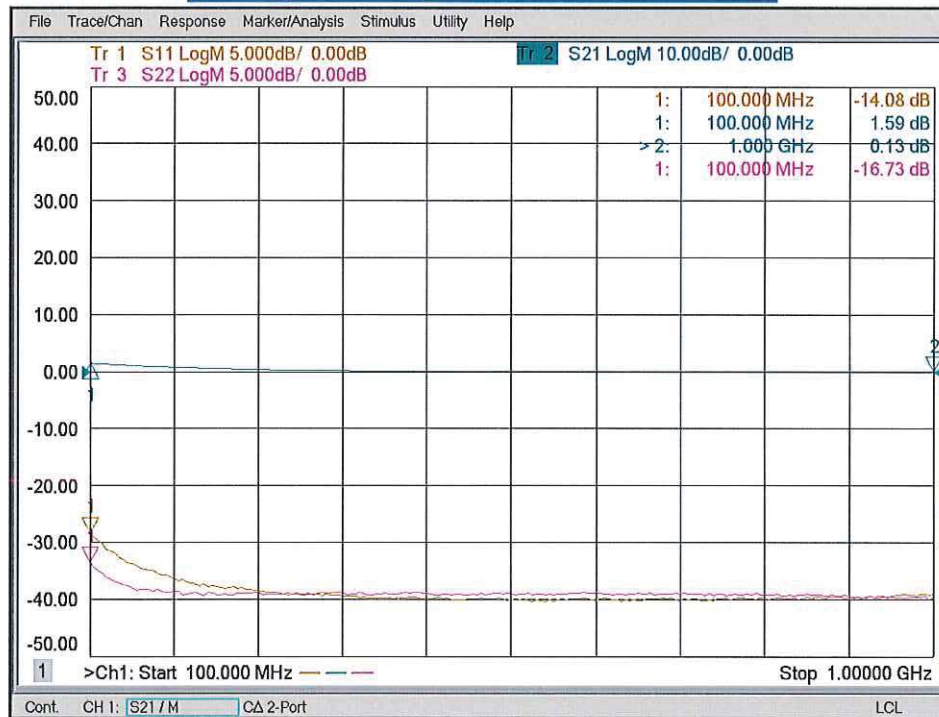
(J1-J5) Insertion Loss and Return Loss

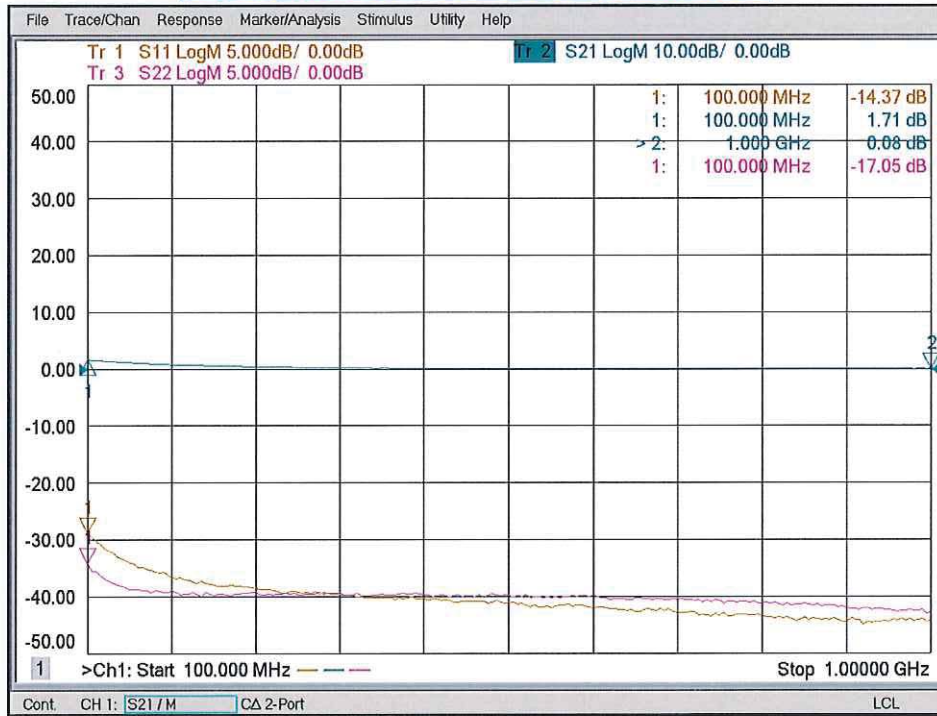
(J1-J6) Insertion Loss and Return Loss

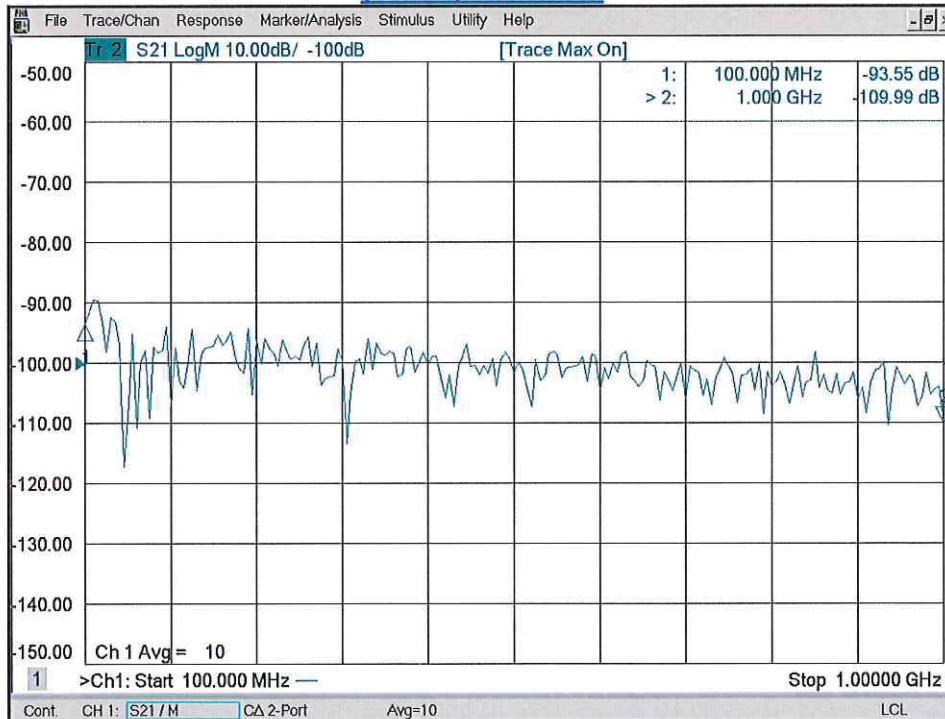
(J1-J2) Isolation

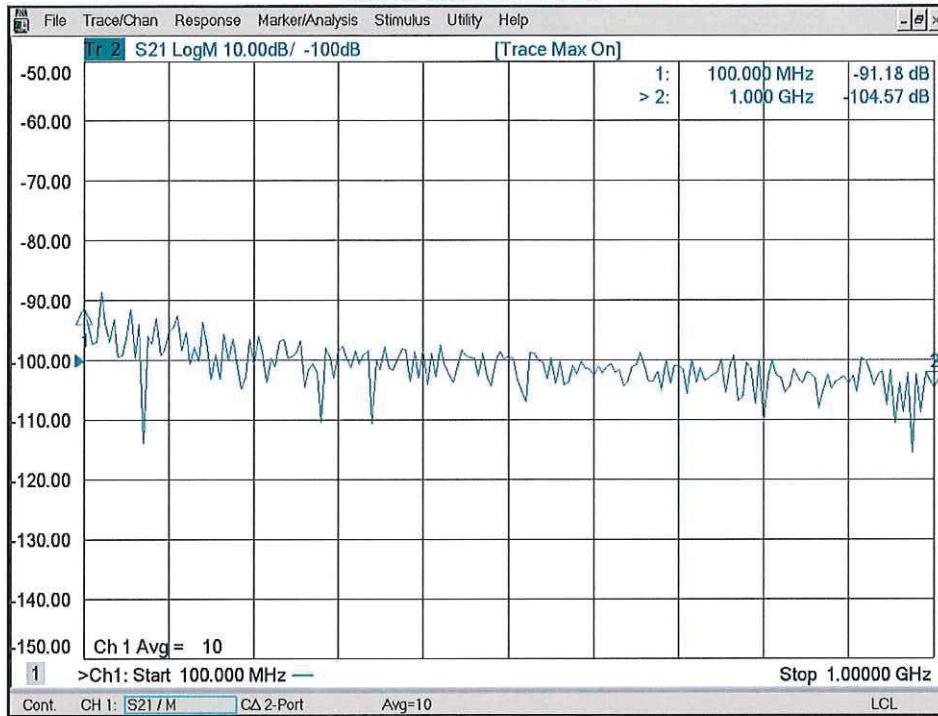
(J1-J3) Isolation

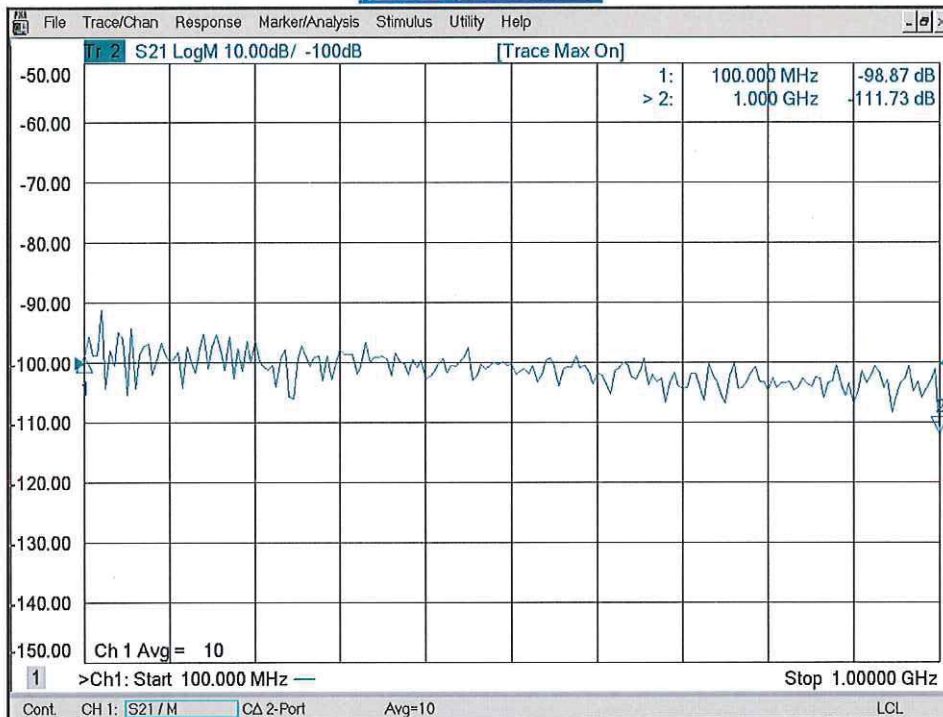
(J1-J3) Isolation

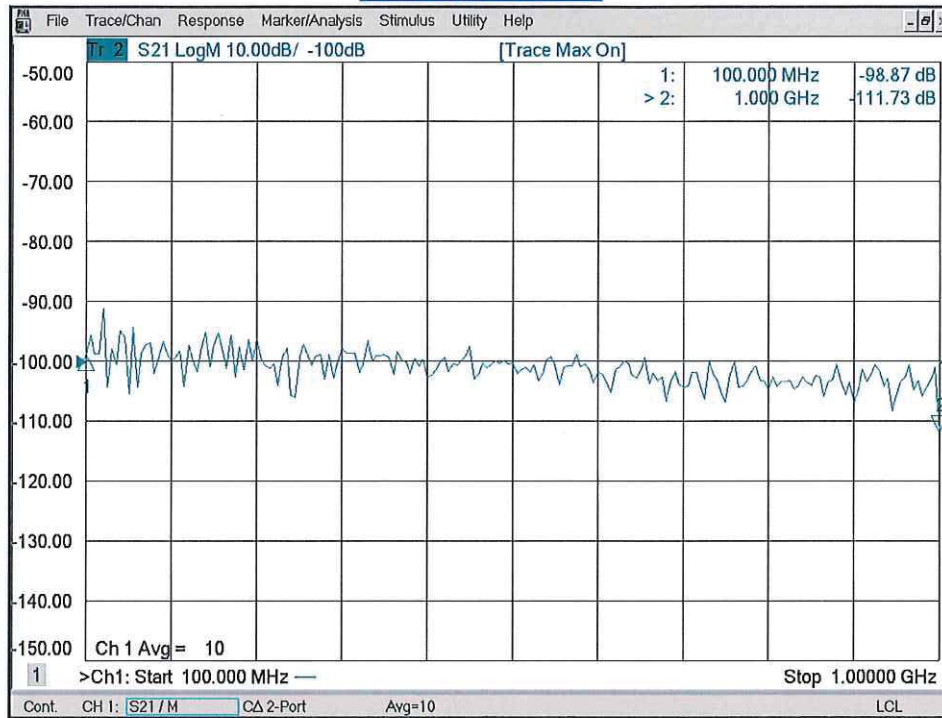
(J1-J4) Isolation

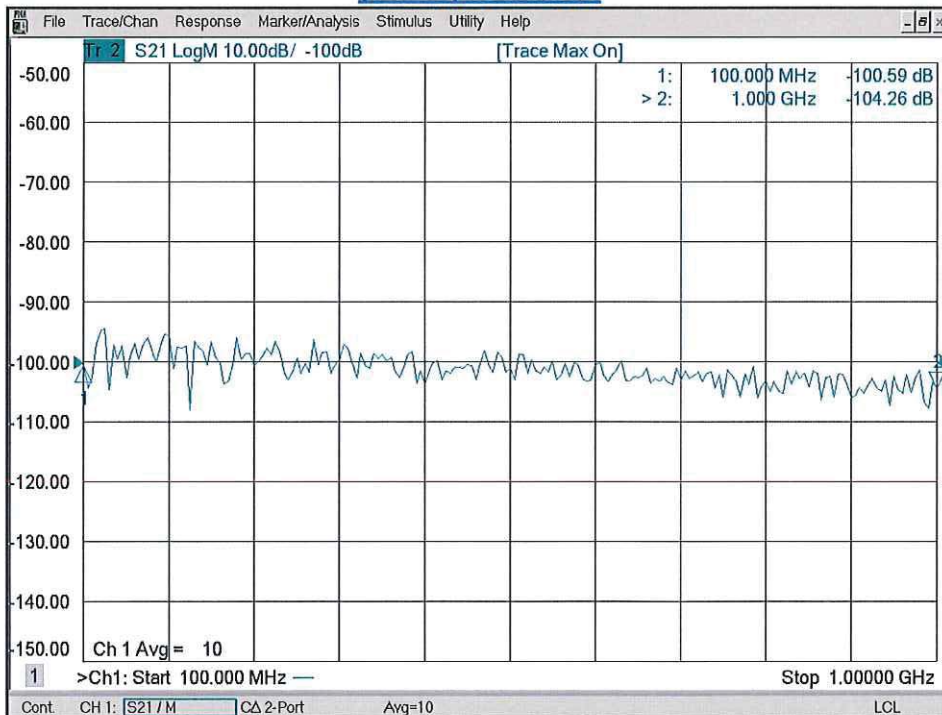
(J1-J5) Isolation

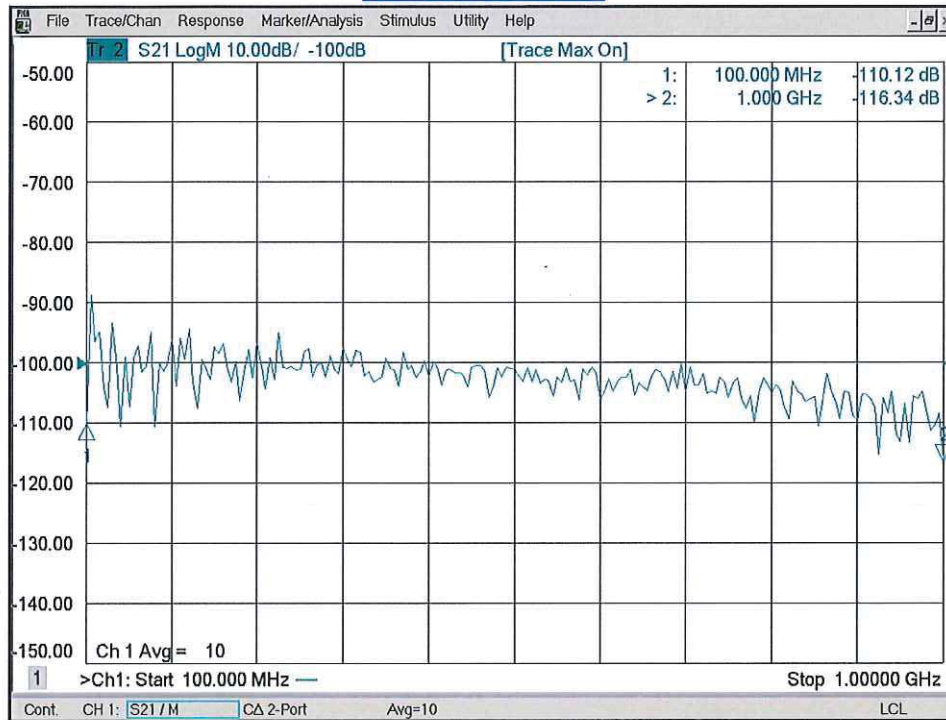
(J1-J5) Isolation
