**SUMMARY TEST DATA
ON
APD-8-3D13D5-40W-SFF**

PL19240/1623

Customer: _____ Tested By: Jerry N.
SO No: _____ Temperature: +25°C
Model No: APD-8-3D13D5-40W-SFF Date: 05/23/2016
Serial No: PL19240/1623 Drawing No: 27626081 Rev: A1

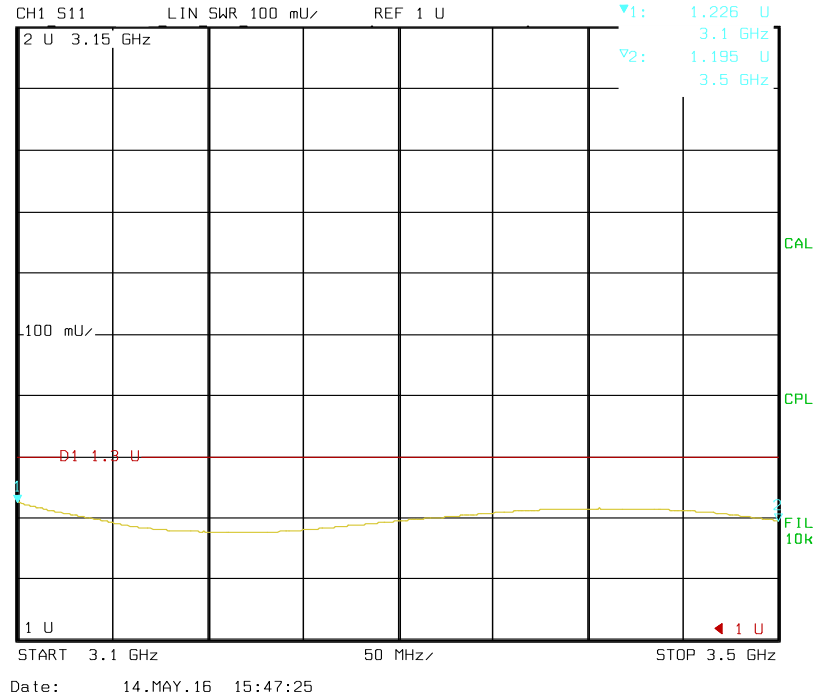
J0 Input VSWR

TEST. ITEM NO	PARAMETERS	SPECIFIED VALUE	TEST RESULTS	QA QC
1	Frequency Range	3.1 TO 3.5 GHz	3.1 TO 3.5 GHz	
2	Insertion Loss	≤0.6 dB	0.49dB (See Plot)	
3	Isolation	≥23 dB	24dB (See Plot)	
4	VSWR	INPUT ≤1.30:1 OUTPUT ≤1.20:1	INPUT 1.23 :1 OUTPUT 1.14 :1 (See Plot)	
5	Amplitude Balance	≤ ±0.2 dB	±0.09dB (See Plot)	
6	Phase Balance	≤ ±2°	1.4° (See Plot)	
7	Power Handling	Forward ≤40 W Reverse ≤1 W	40W 1W	
8	Impedance	50 Ω	50 Ω

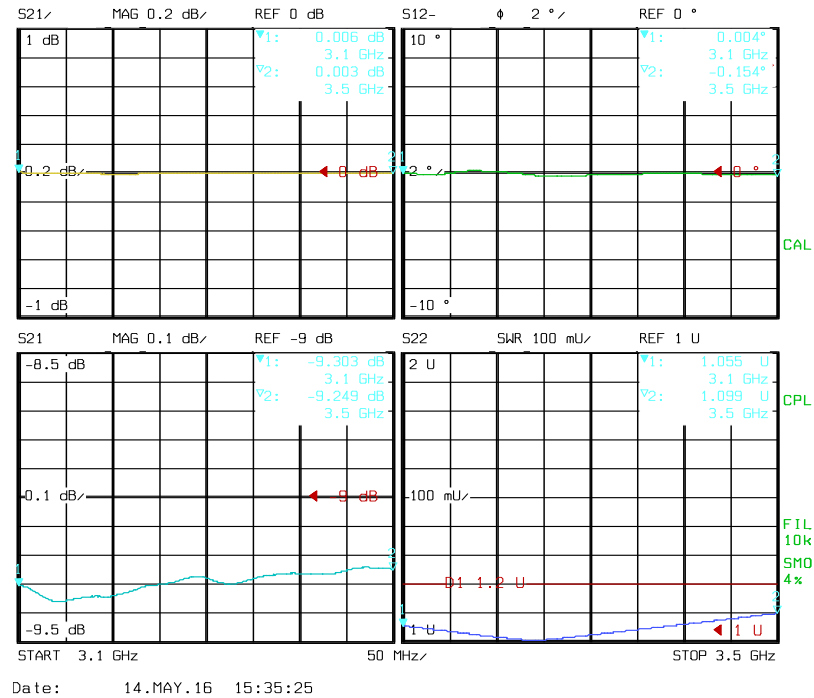
J0 to J1 Amplitude Balance, Insertion Loss, Phase balance, J1 VSWR

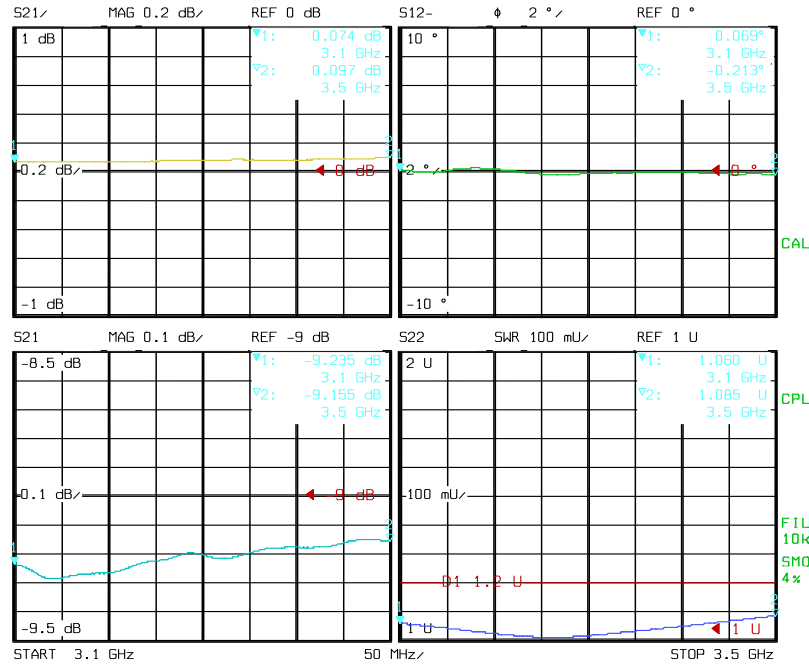
J0 to J2 Amplitude Balance, Insertion Loss, Phase balance, J2 VSWR

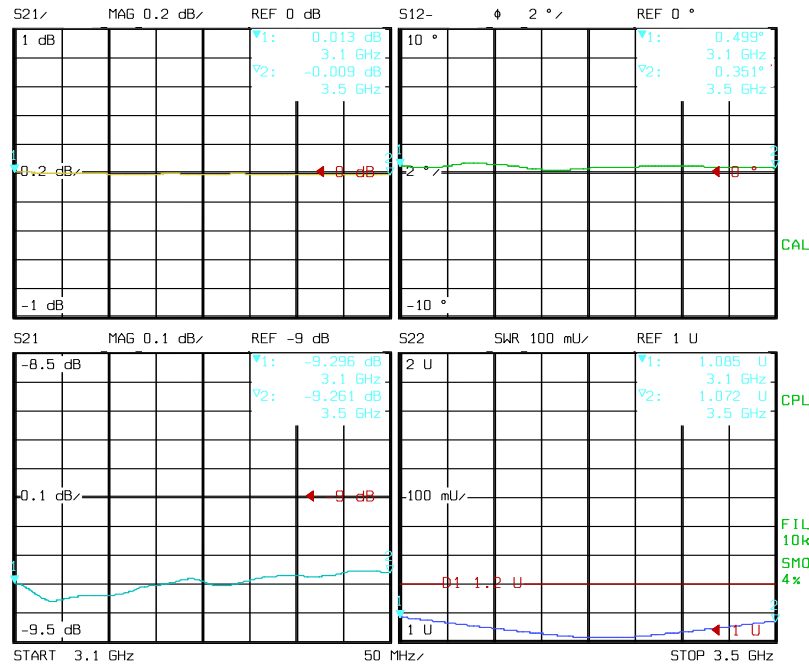
J0 to J3 Amplitude Balance, Insertion Loss, Phase balance, J3 VSWR

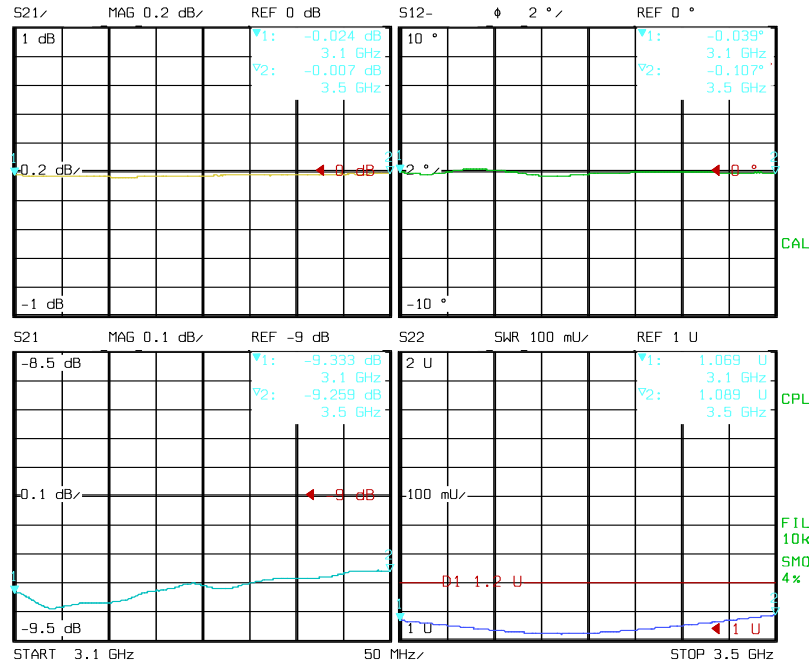
J0 to J4 Amplitude Balance, Insertion Loss, Phase balance, J4 VSWR

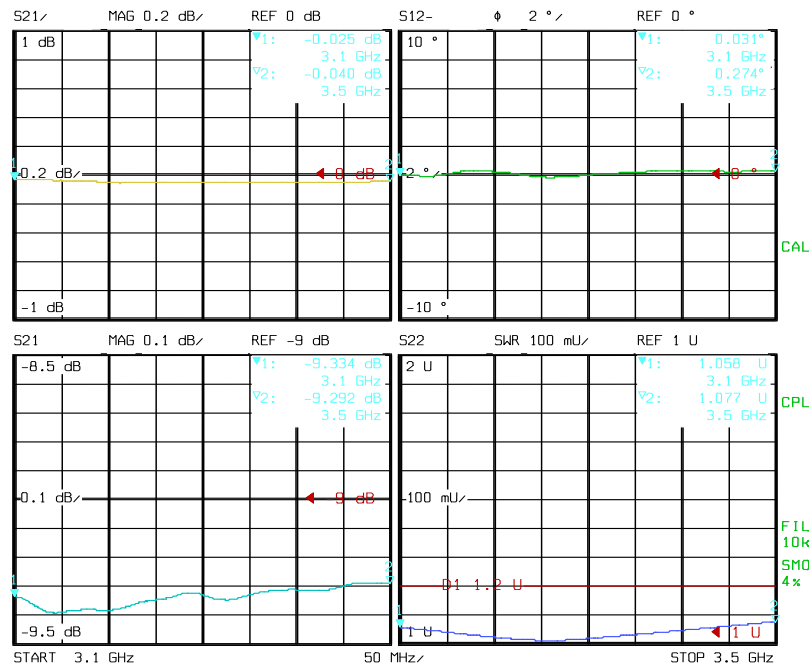
J0 to J5 Amplitude Balance, Insertion Loss, Phase balance, J5 VSWR

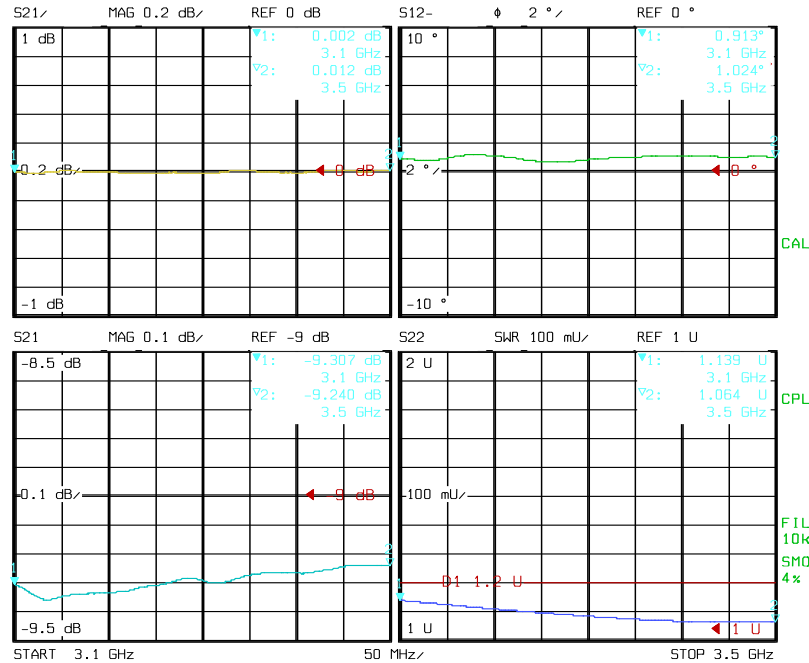
J0 to J6 Amplitude Balance, Insertion Loss, Phase balance, J6 VSWR

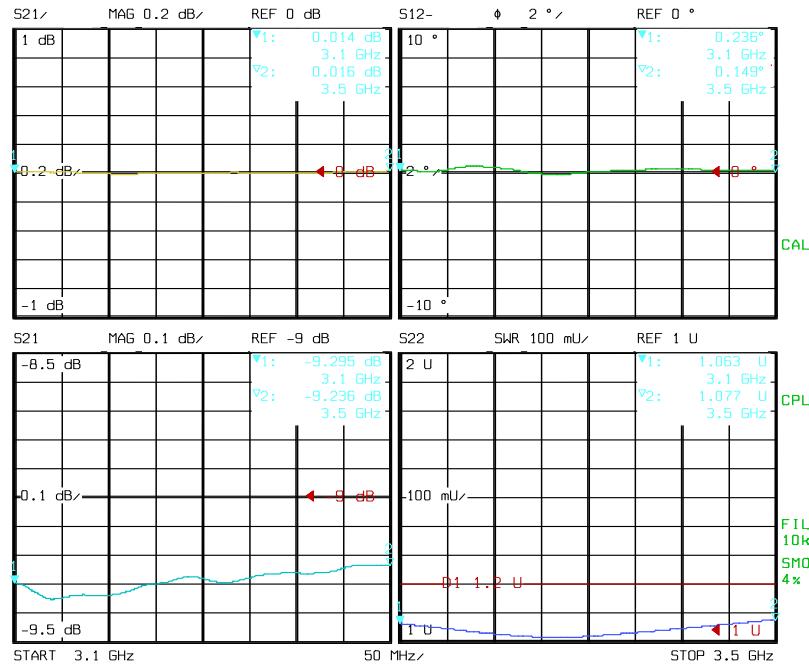
J0 to J7 Amplitude Balance, Insertion Loss, Phase balance, J7 VSWR

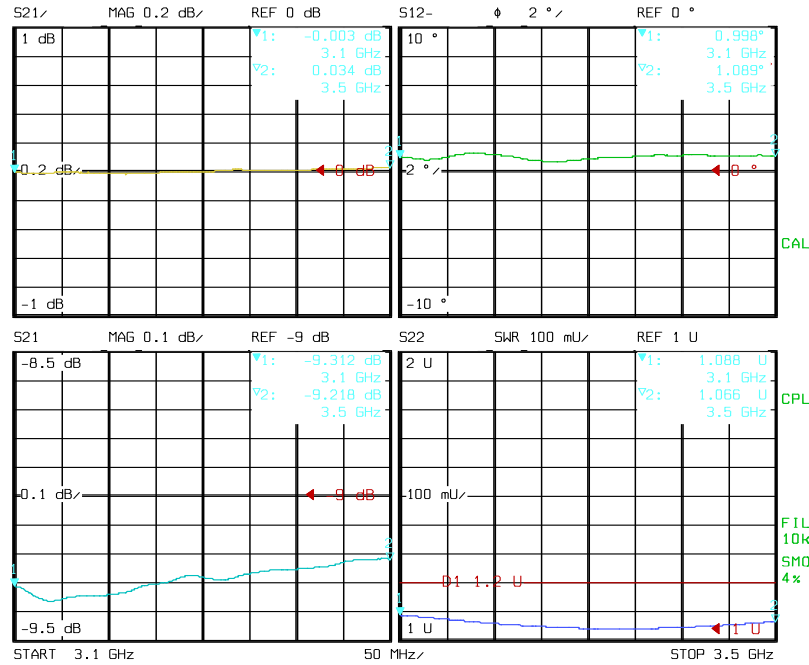
J0 to J8 Amplitude Balance, Insertion Loss, Phase balance, J8 VSWR

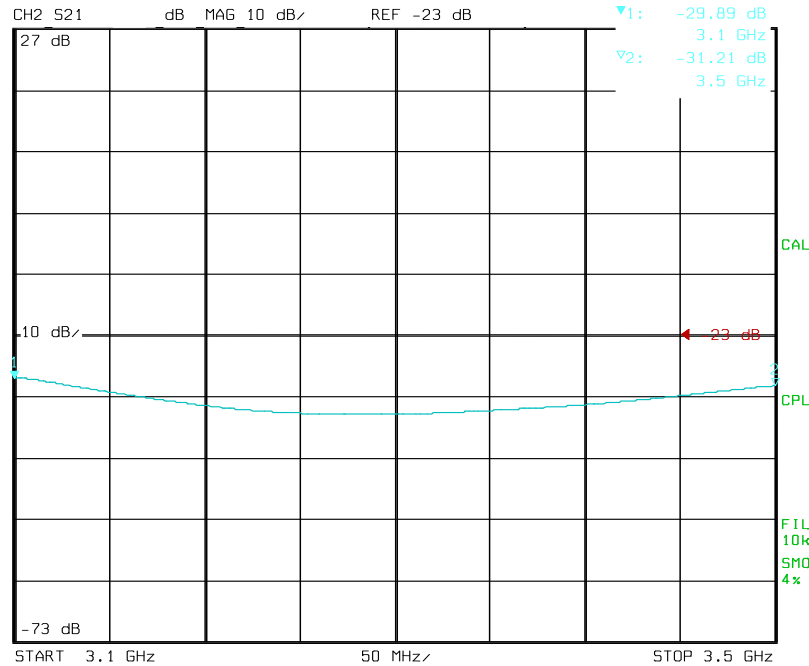
J1- J2 Isolation

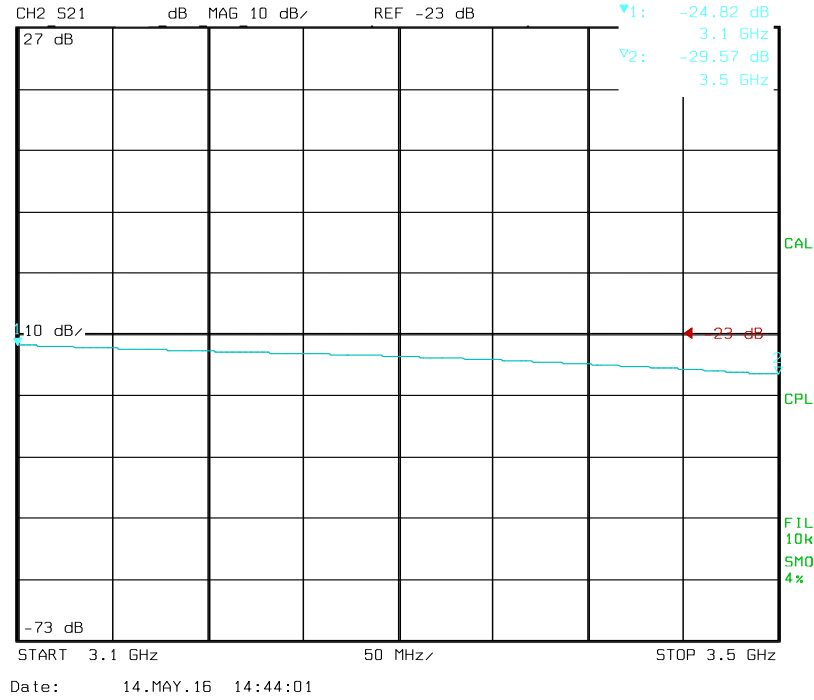
J1- J3 Isolation

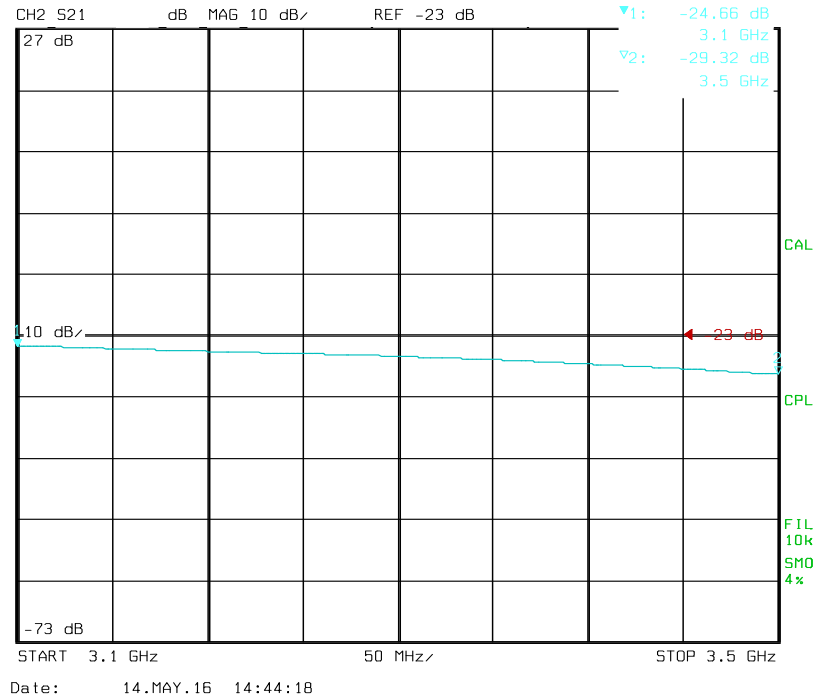
J1- J4 Isolation

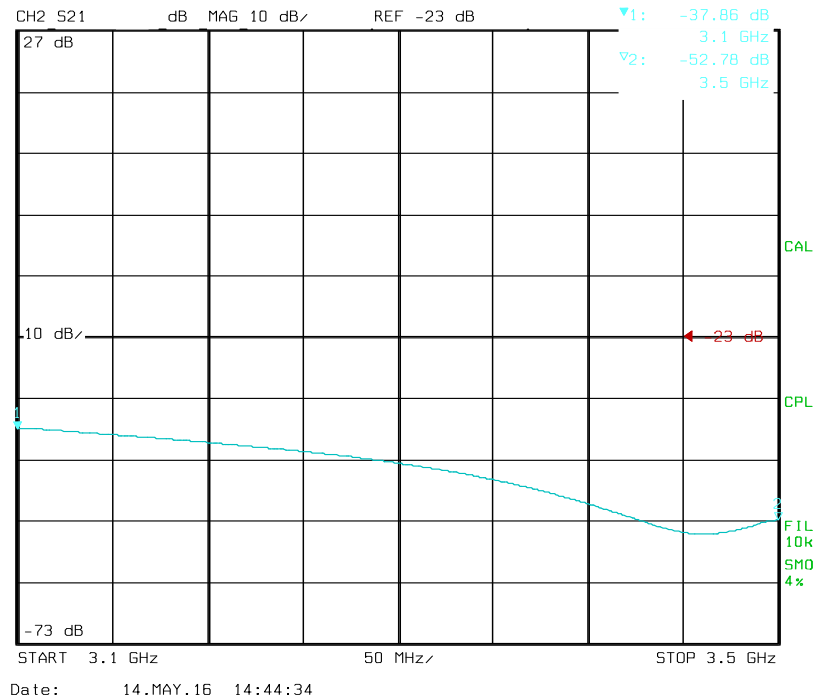
J1- J5 Isolation

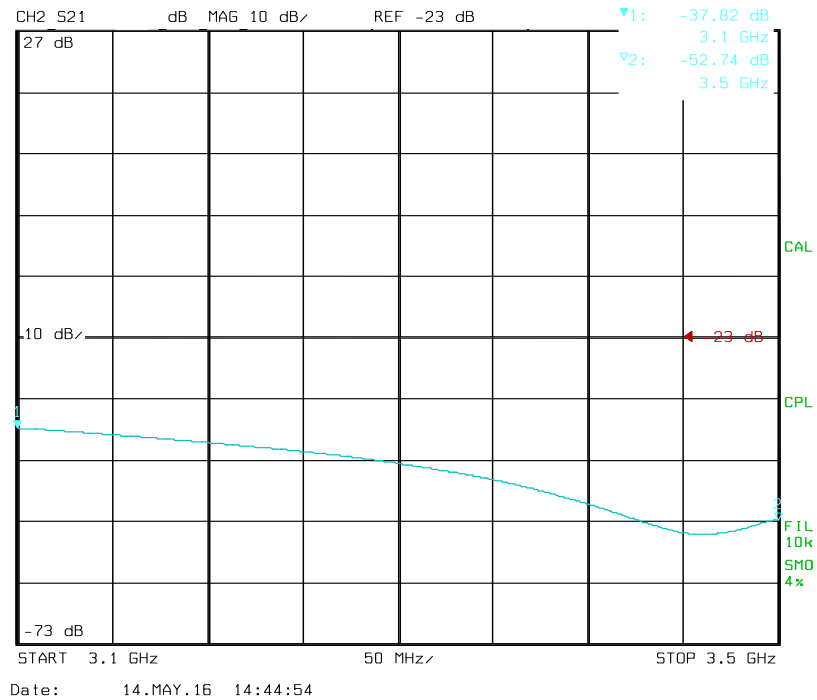
J1- J6 Isolation

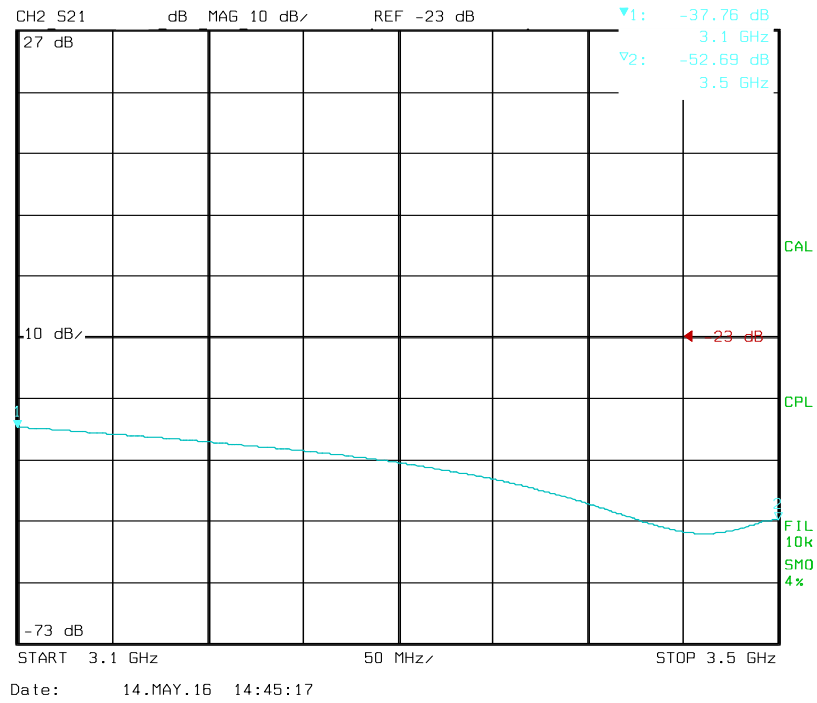
J1- J7 Isolation

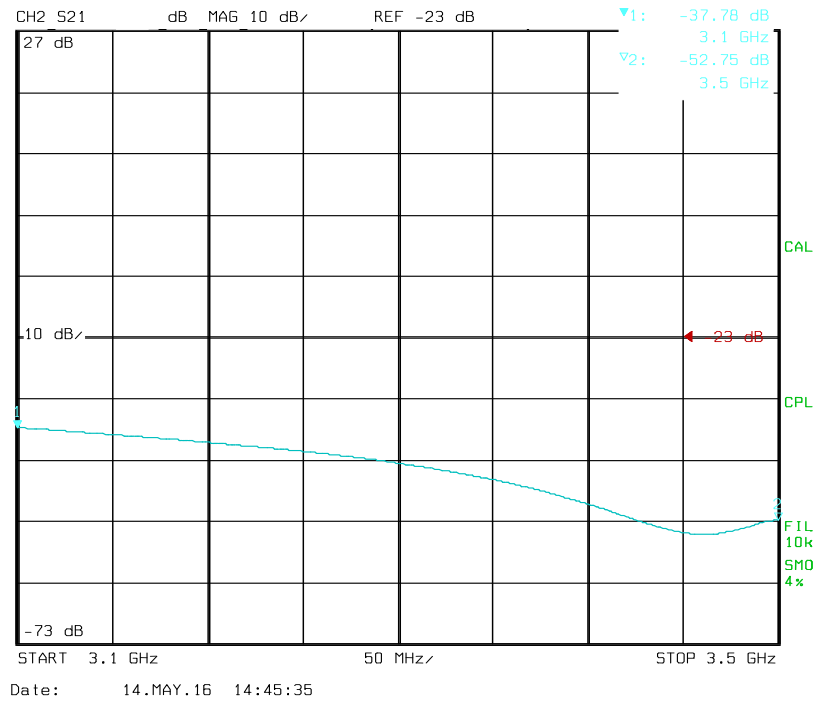
J1- J8 Isolation

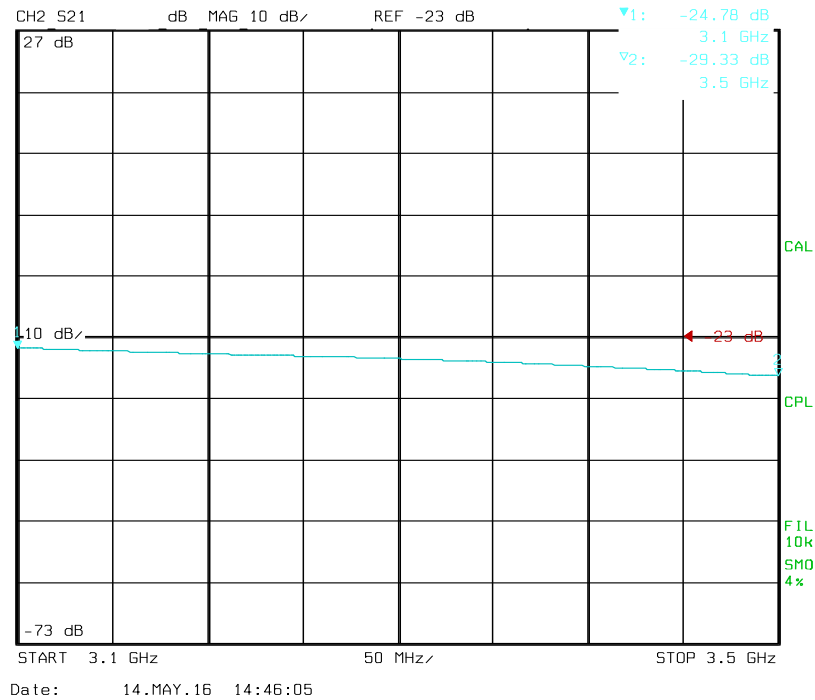
J2- J3 Isolation

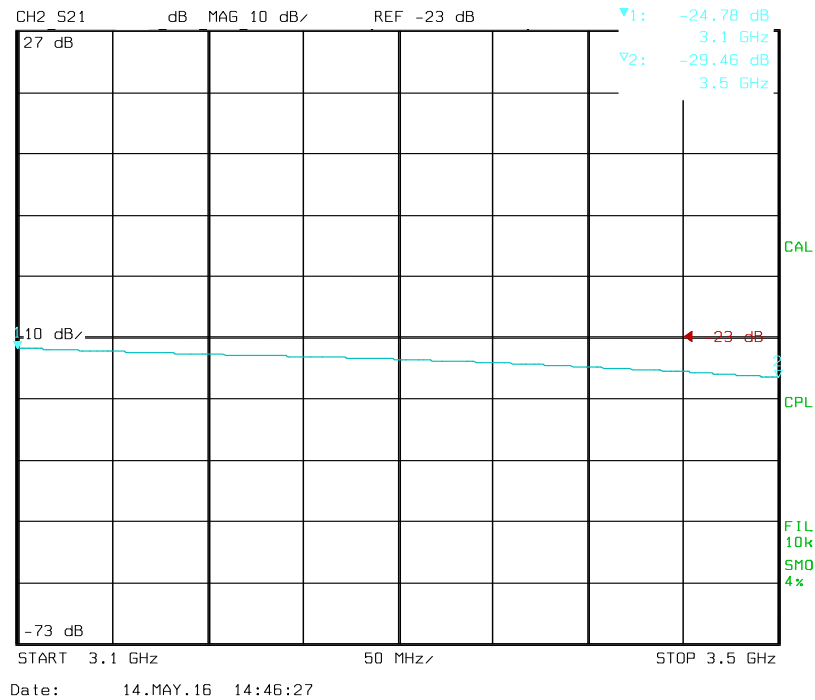
J2- J4 Isolation

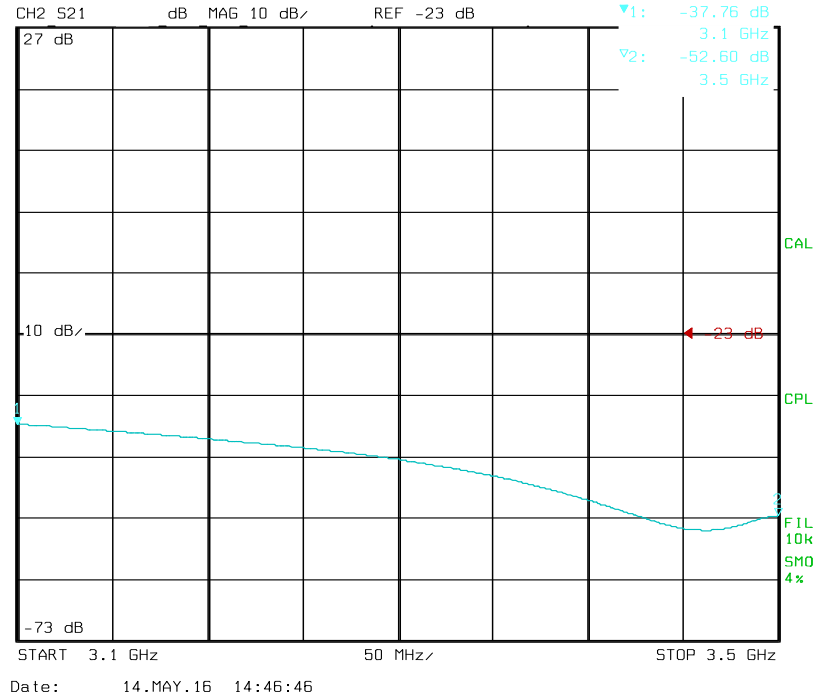
J2- J5 Isolation

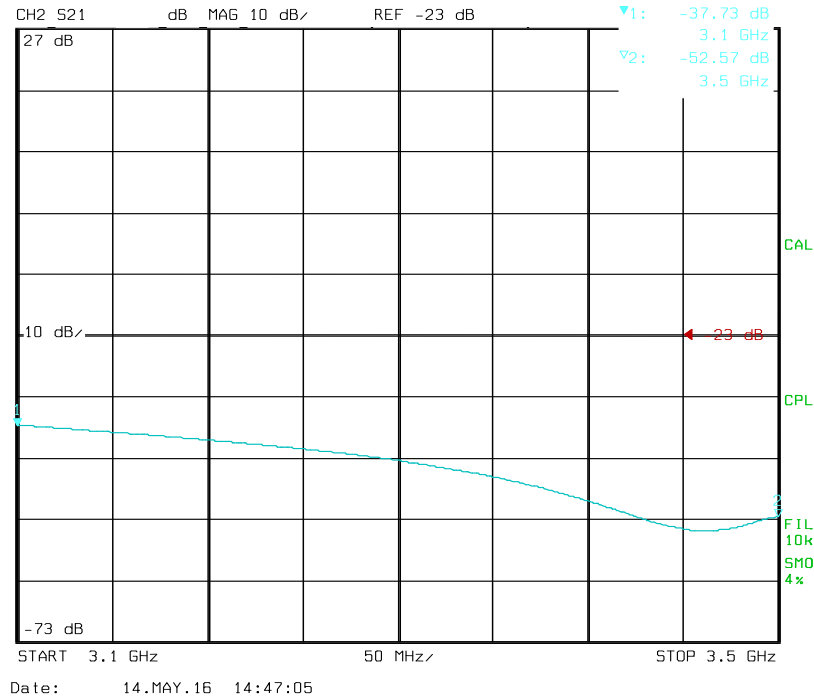
J2- J6 Isolation

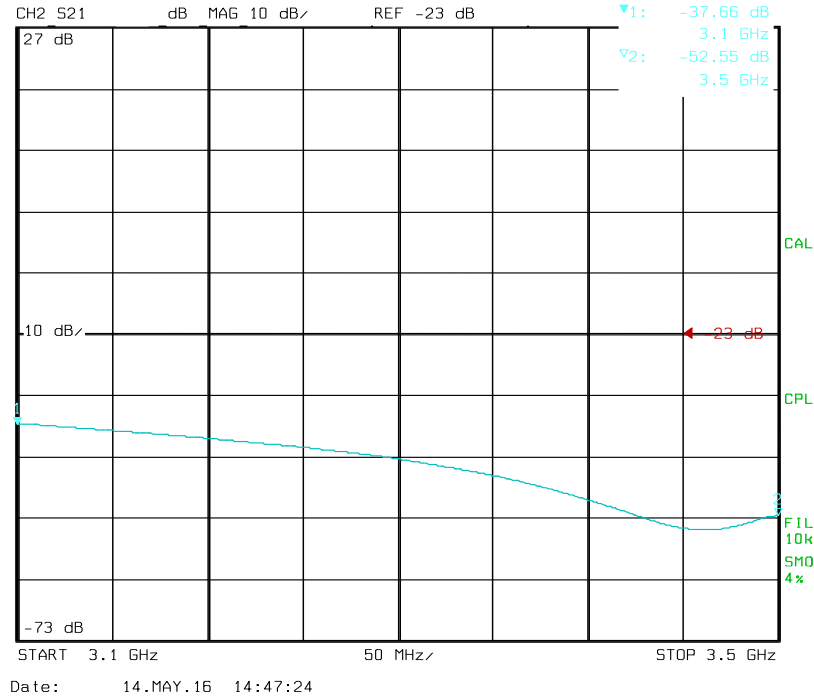
J2- J7 Isolation

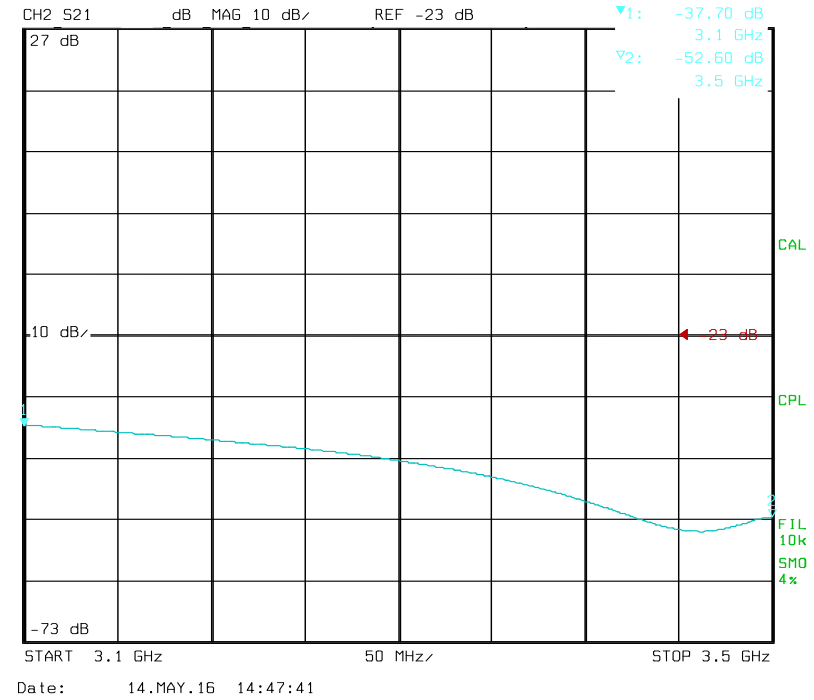
J2- J8 Isolation

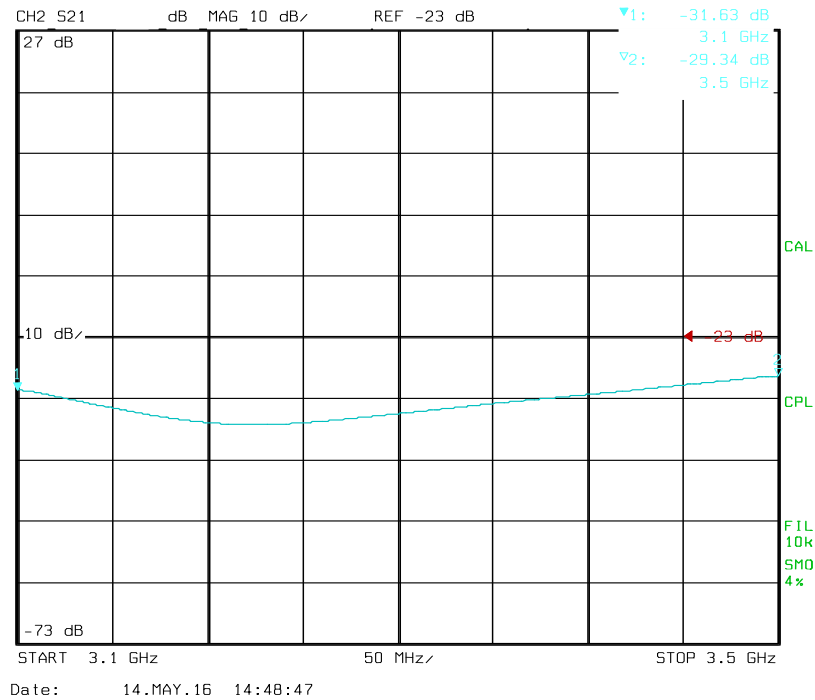
J3- J4 Isolation

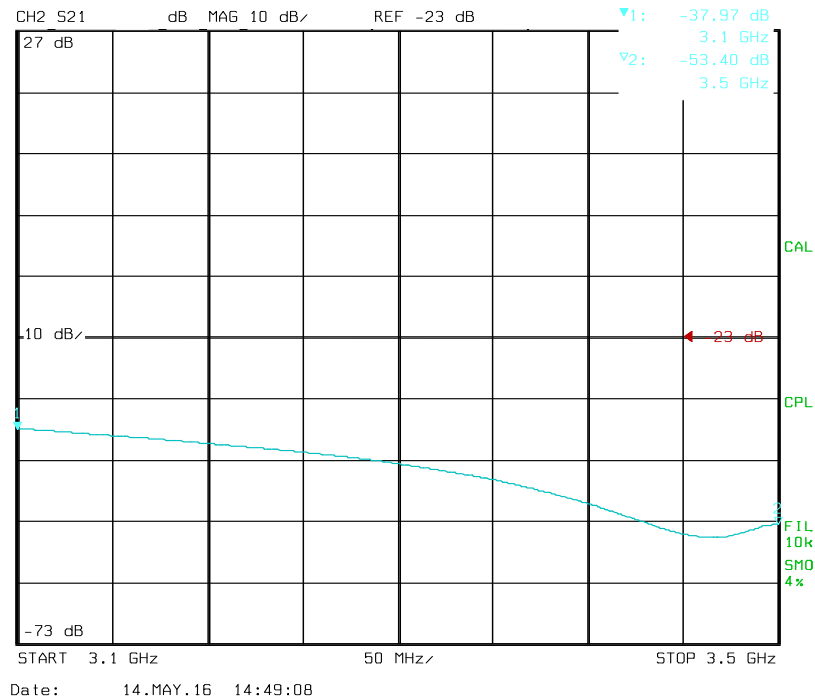
J3- J5 Isolation

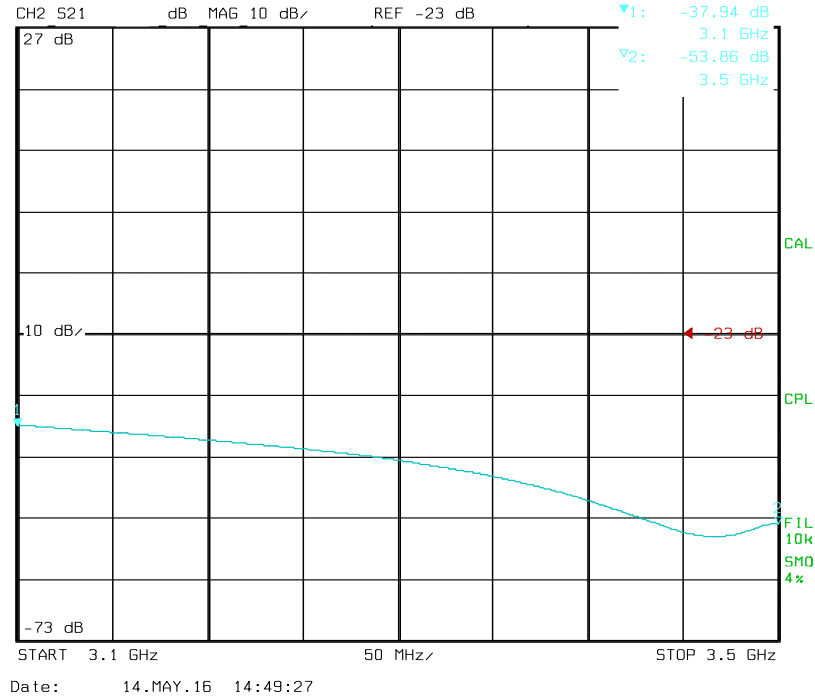
J3- J6 Isolation

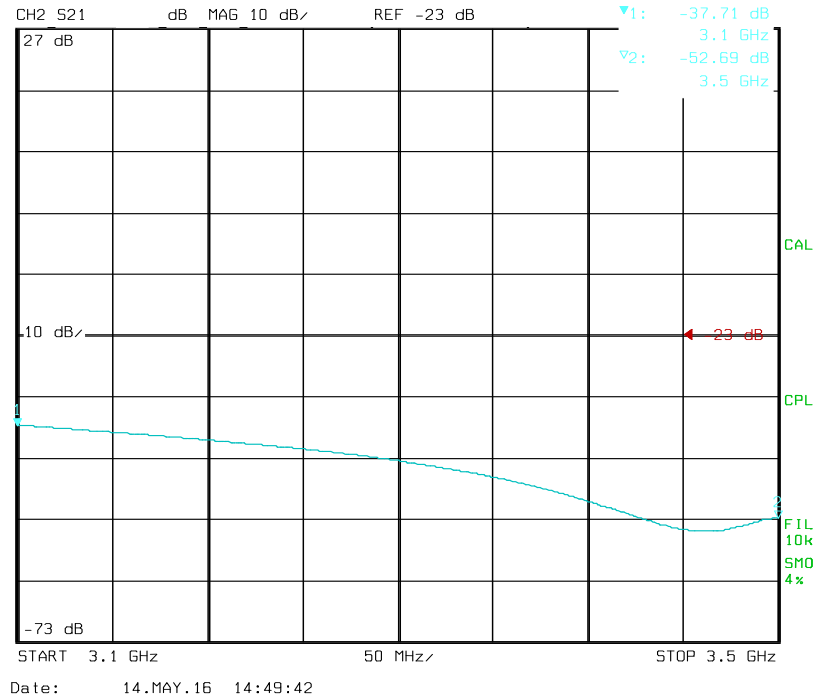
J3- J7 Isolation

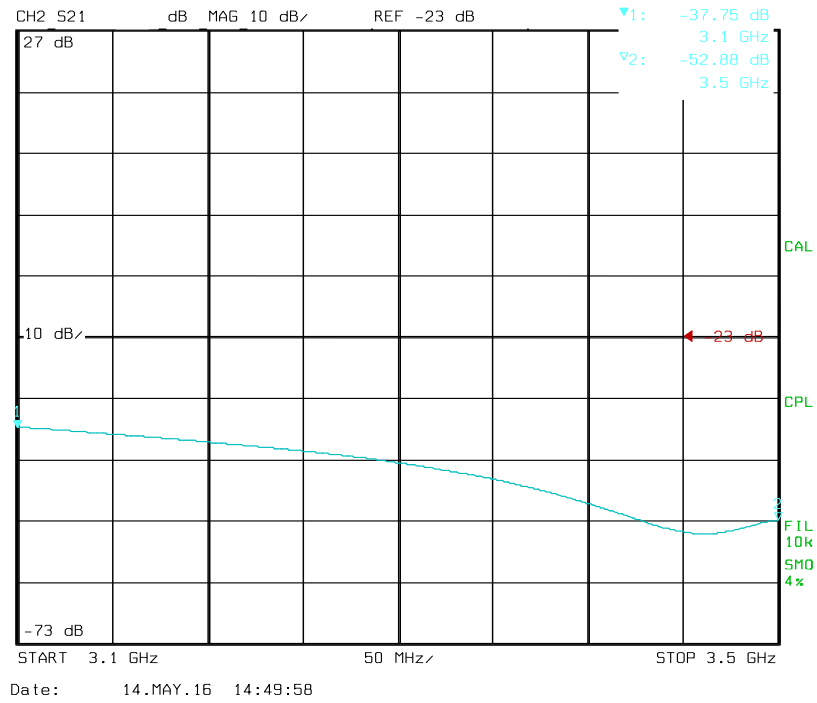
J3- J8 Isolation

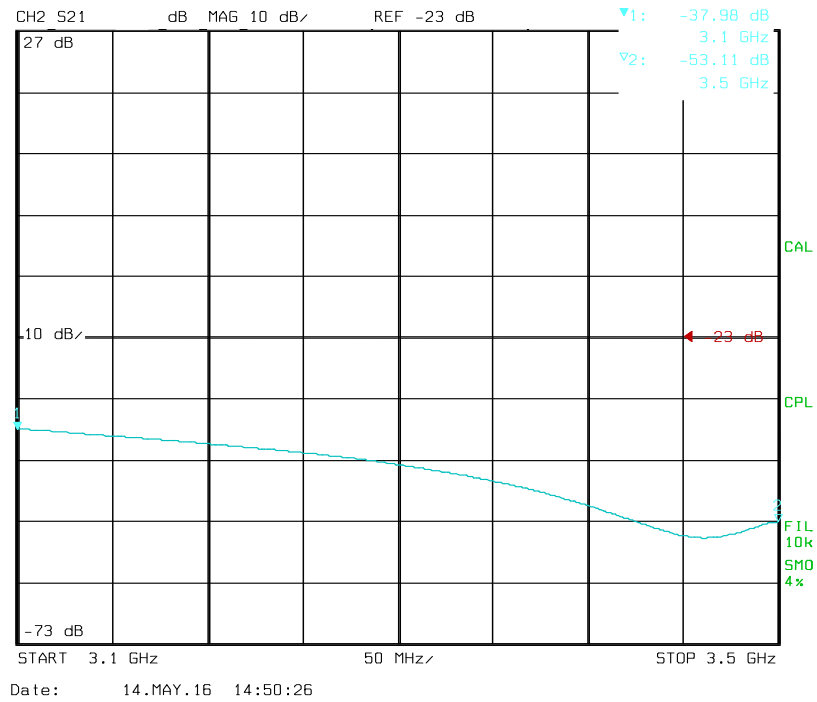
J4- J5 Isolation

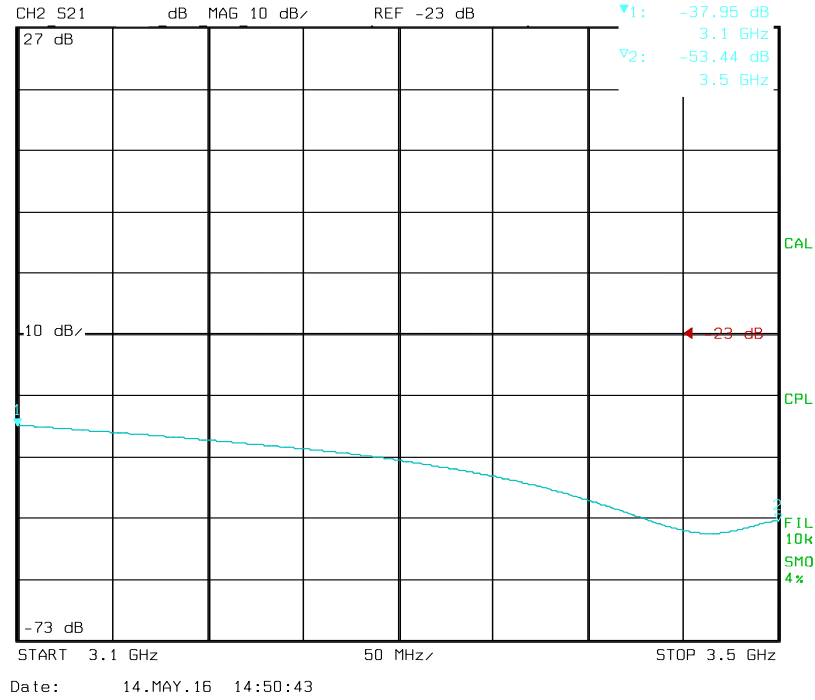
J4- J6 Isolation

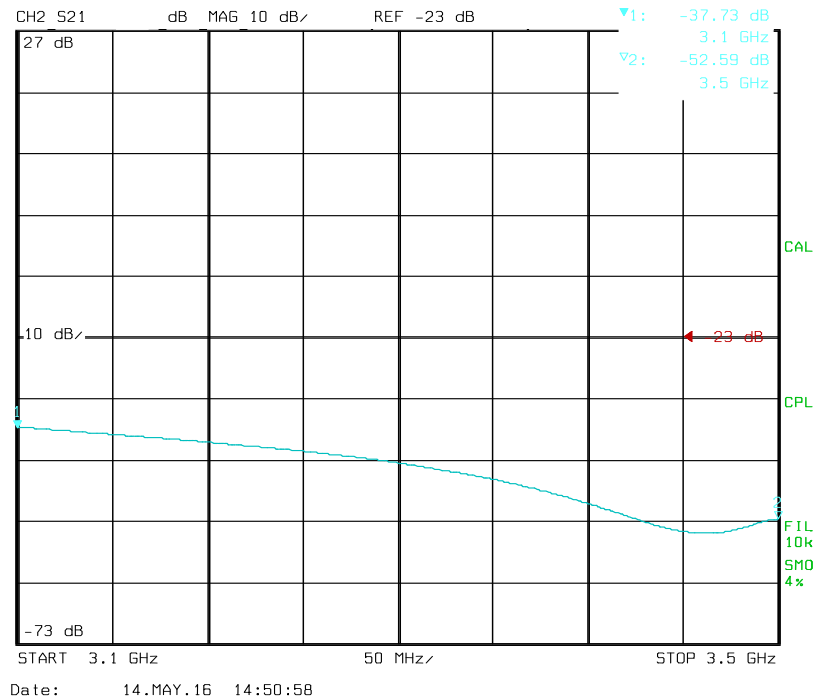
J4- J7 Isolation

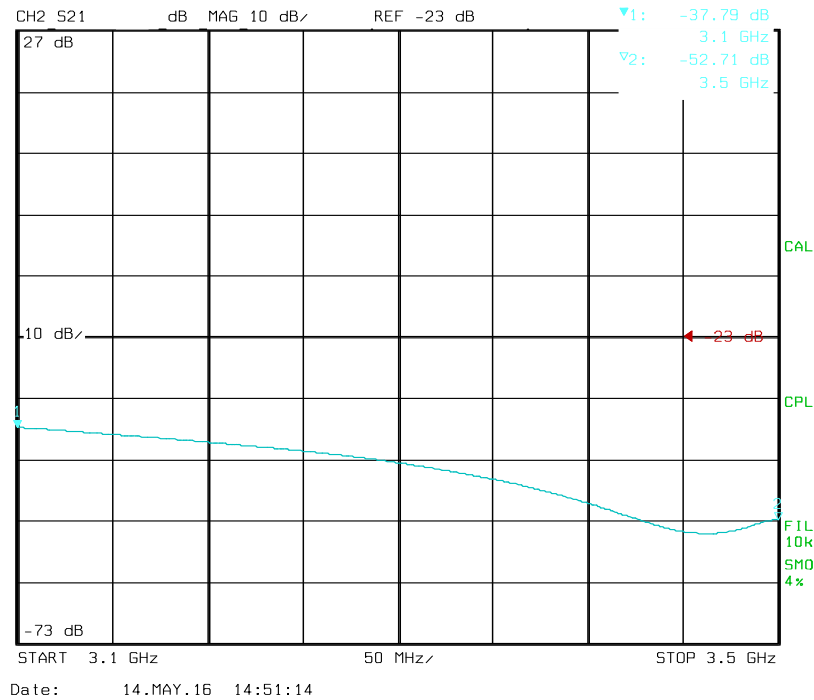
J4- J8 Isolation

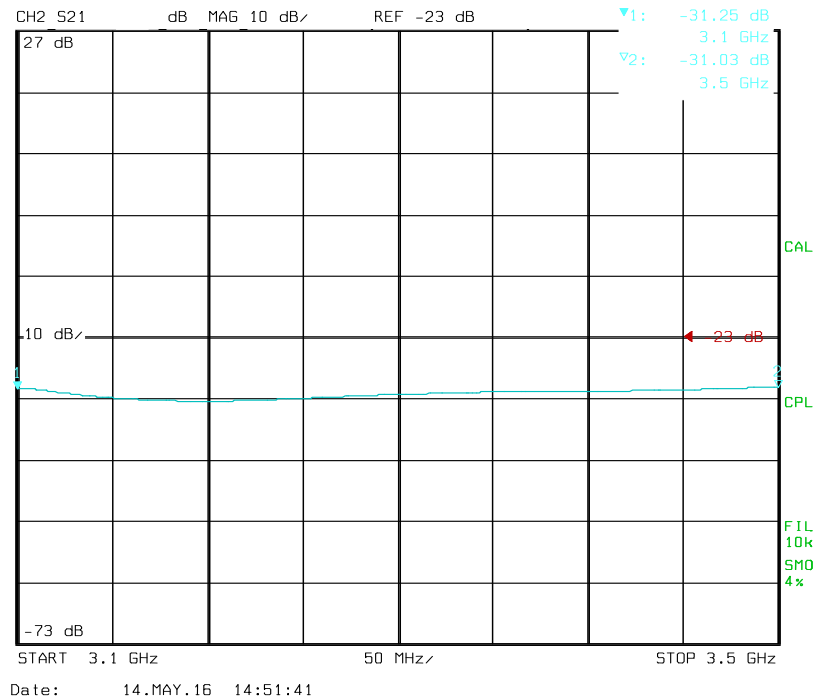
J5- J6 Isolation

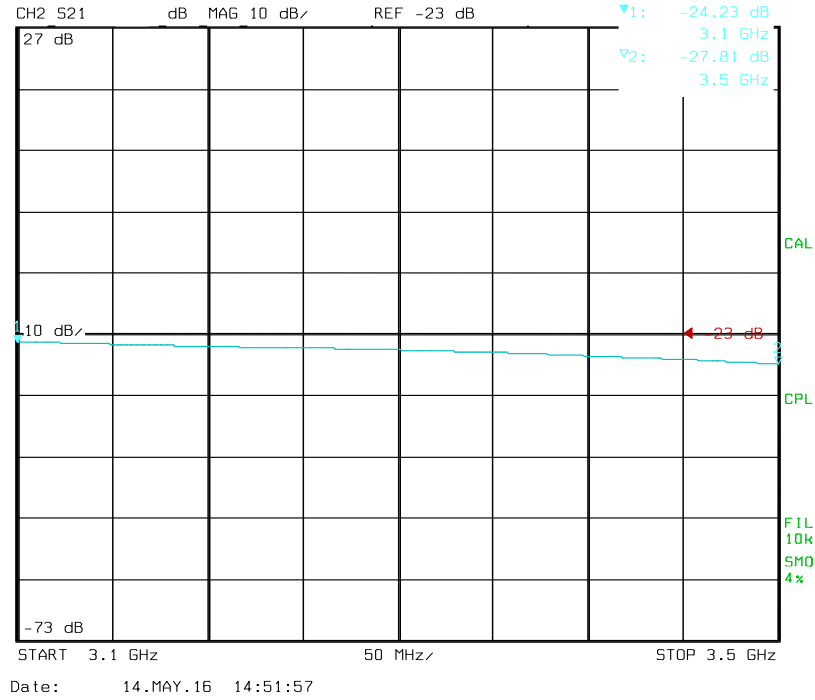
J5- J7 Isolation

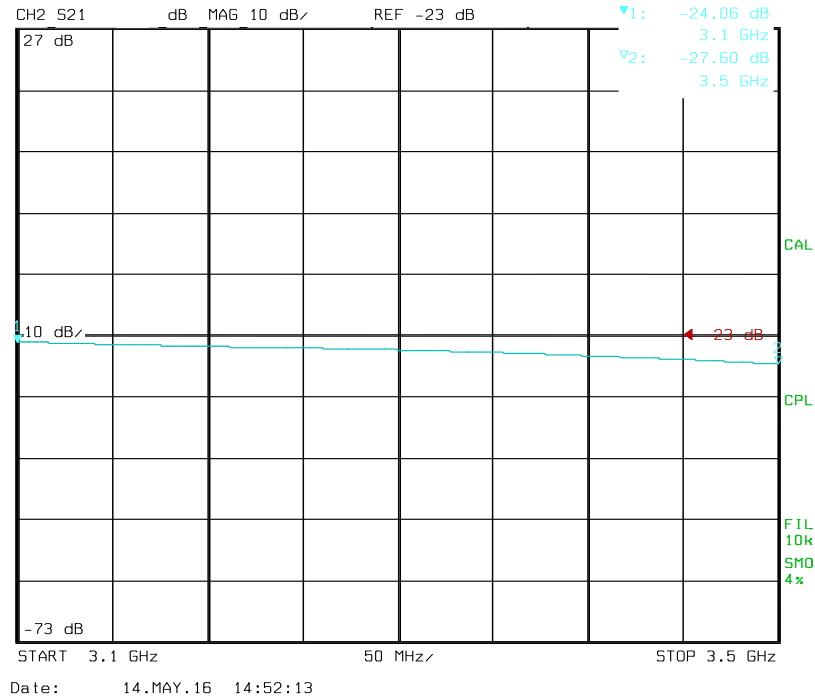
J5- J8 Isolation

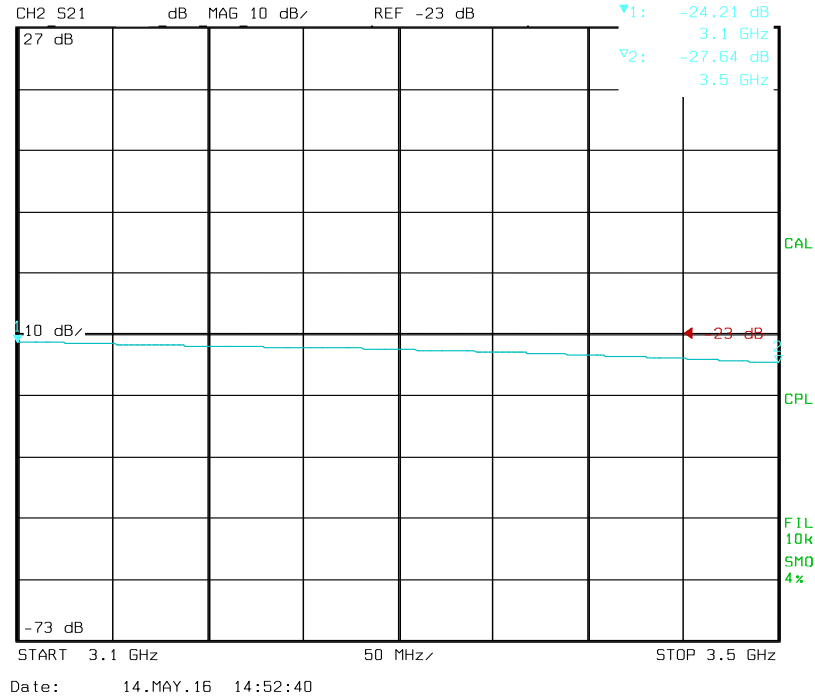
J6- J7 Isolation

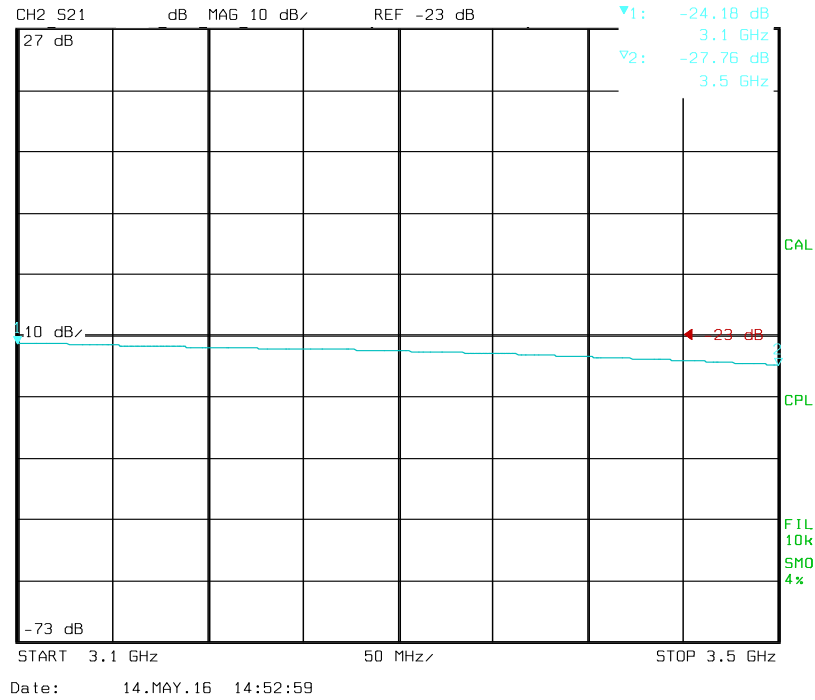
J6- J8 Isolation

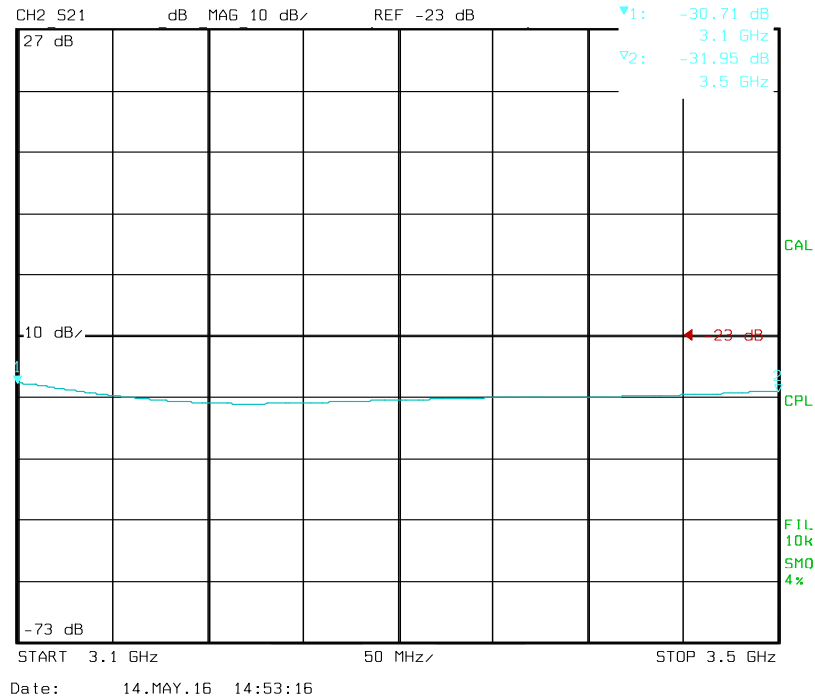
J7-J8 Isolation
