**SUMMARY TEST DATA
ON
APD-8-3D13D5-40W-SFF**

PL19242/1623

Customer: _____ Tested By: Jerry N.
 SO No: _____ Temperature: +25°C
 Model No: APD-8-3D13D5-40W-SFF Date: 05/23/2016
 Serial No: PL19242/1623 Drawing No: 27626081 Rev: A1

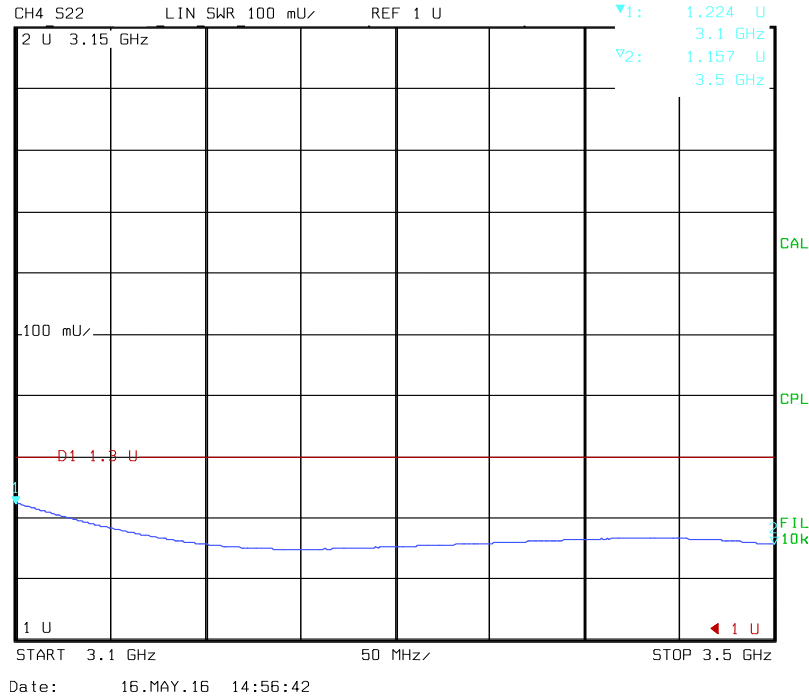
J0 Input VSWR

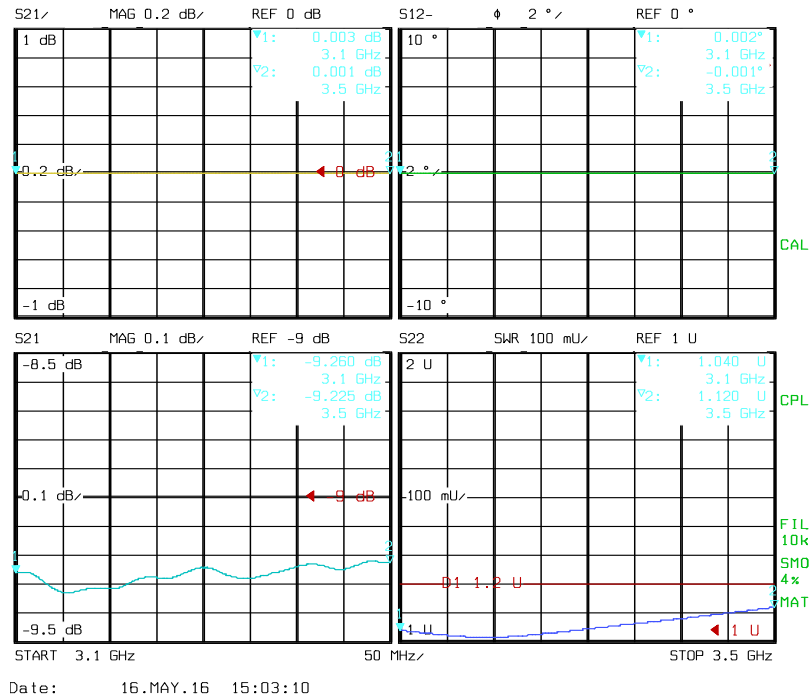
J0 to J1 Amplitude Balance, Insertion Loss, Phase balance, J1 VSWR

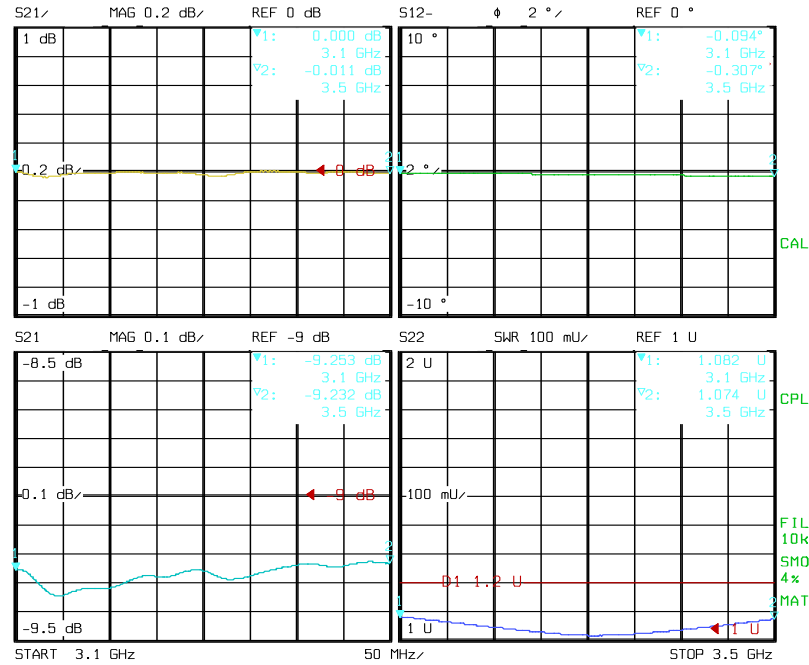
J0 to J2 Amplitude Balance, Insertion Loss, Phase balance, J2 VSWR

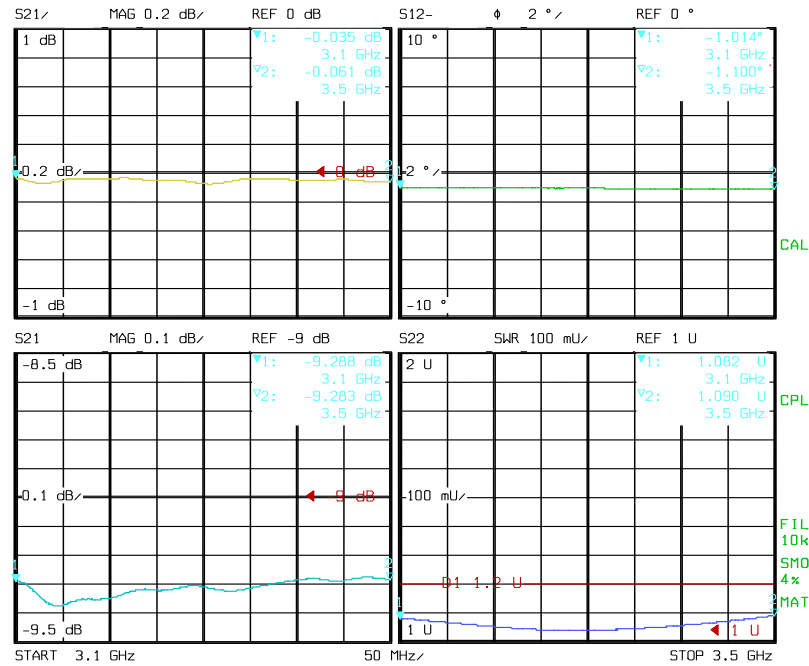
J0 to J3 Amplitude Balance, Insertion Loss, Phase balance, J3 VSWR

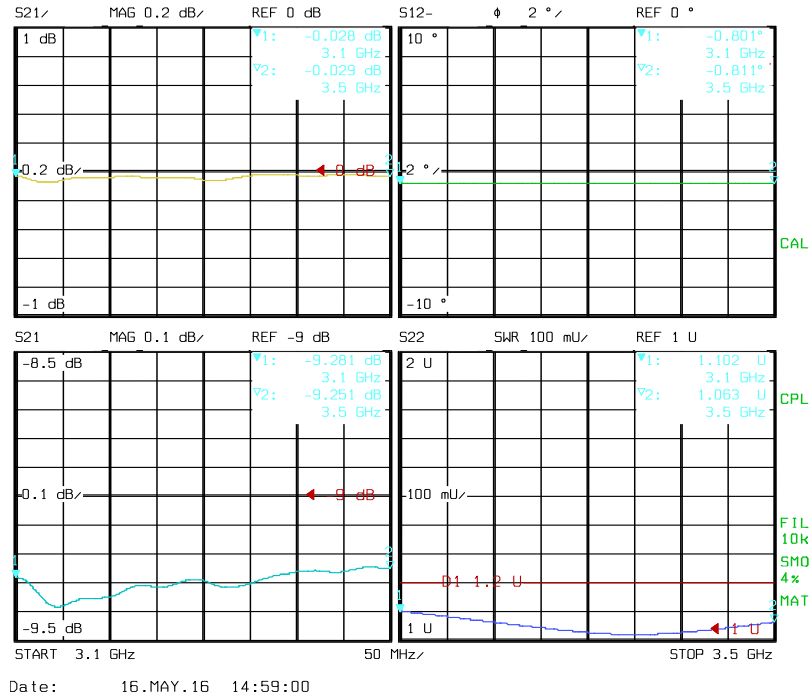
J0 to J4 Amplitude Balance, Insertion Loss, Phase balance, J4 VSWR

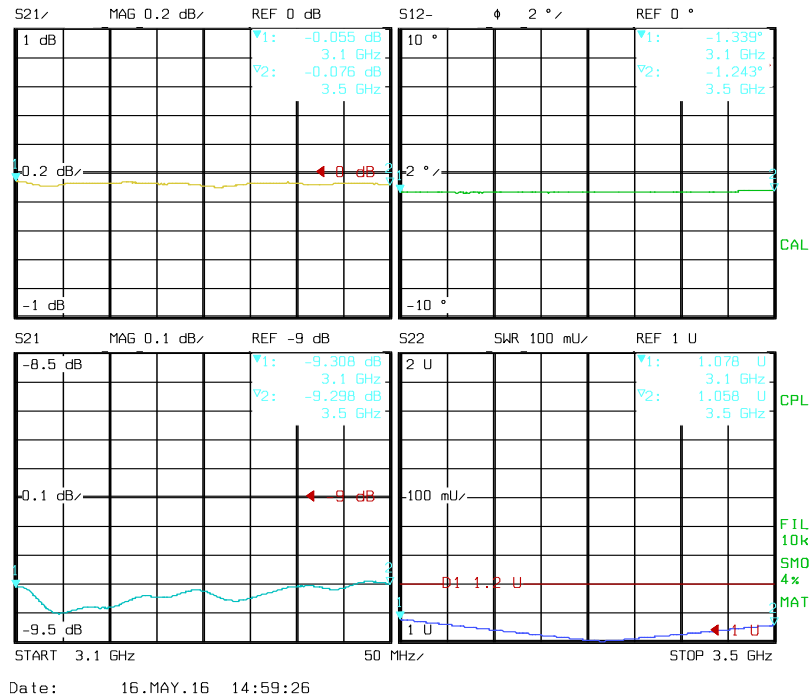
J0 to J5 Amplitude Balance, Insertion Loss, Phase balance, J5 VSWR

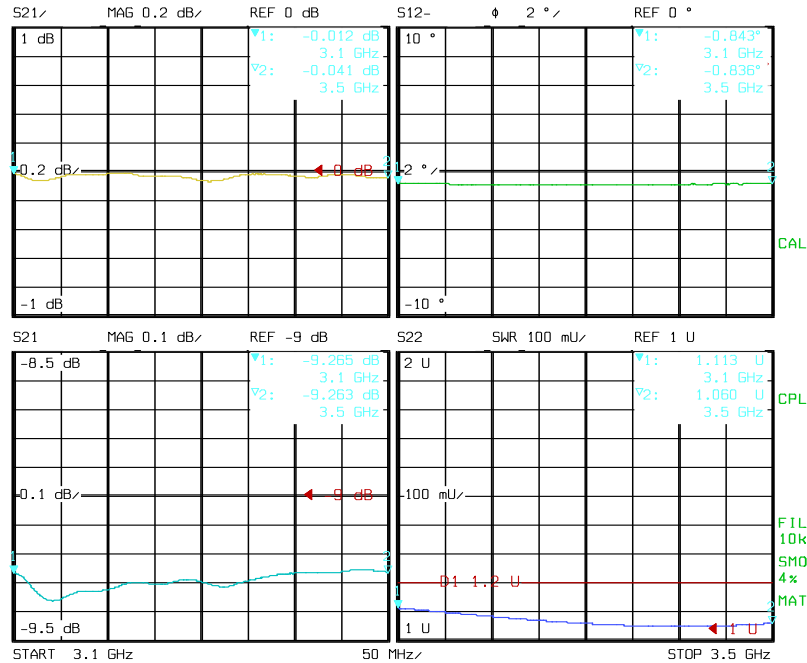
J0 to J6 Amplitude Balance, Insertion Loss, Phase balance, J6 VSWR

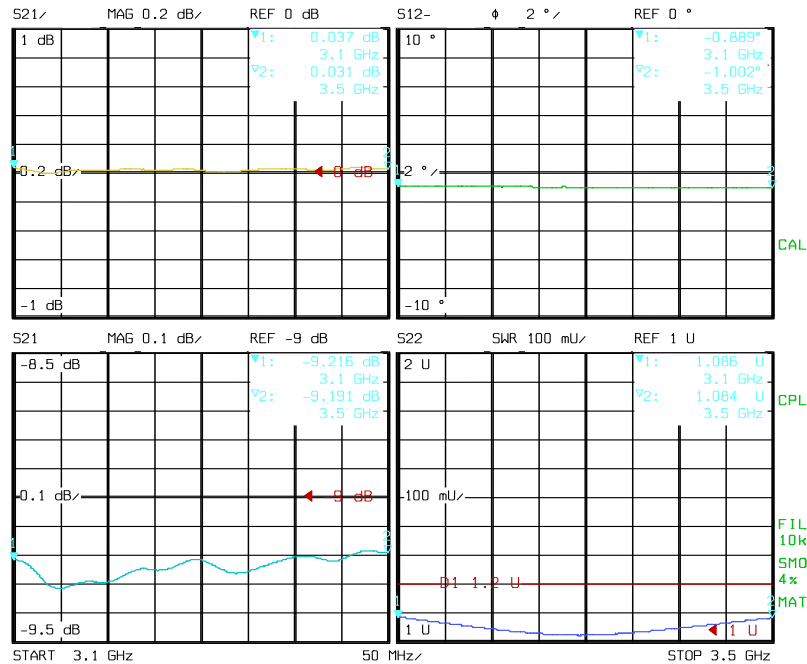
J0 to J7 Amplitude Balance, Insertion Loss, Phase balance, J7 VSWR

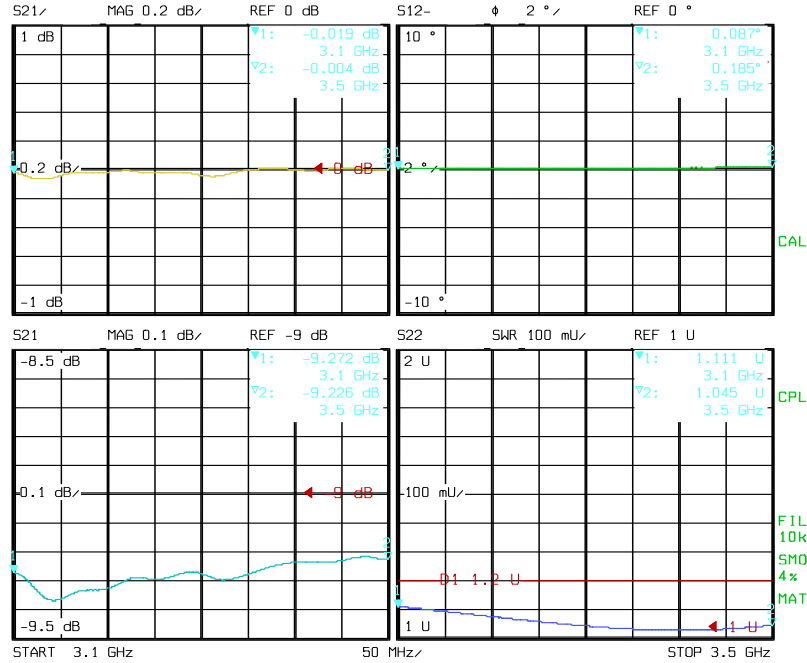
J0 to J8 Amplitude Balance, Insertion Loss, Phase balance, J8 VSWR

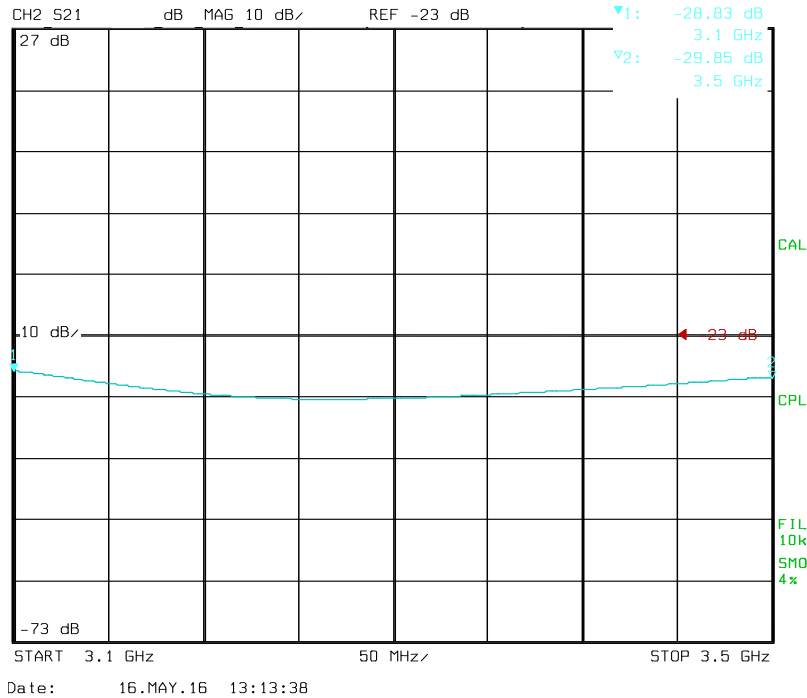
J1- J2 Isolation

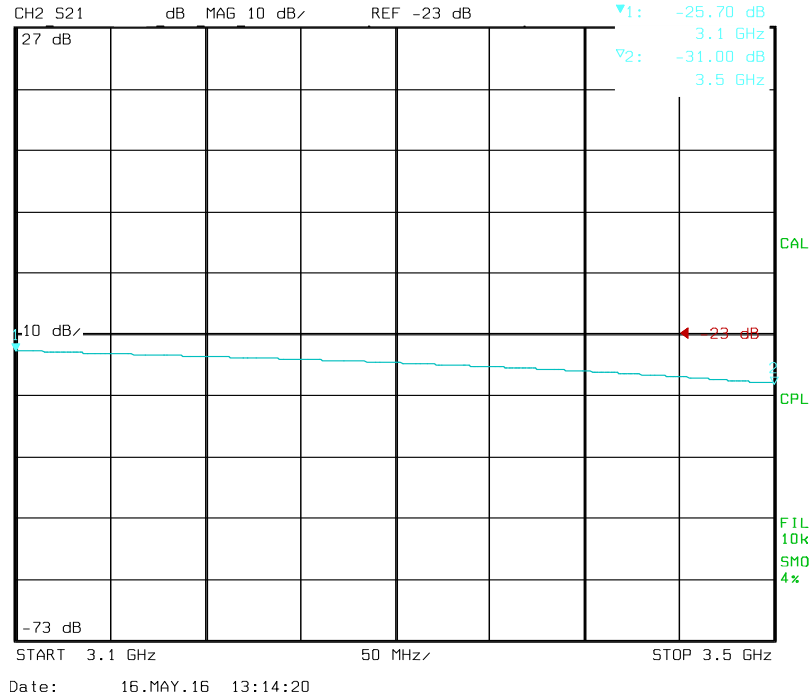
J1- J3 Isolation

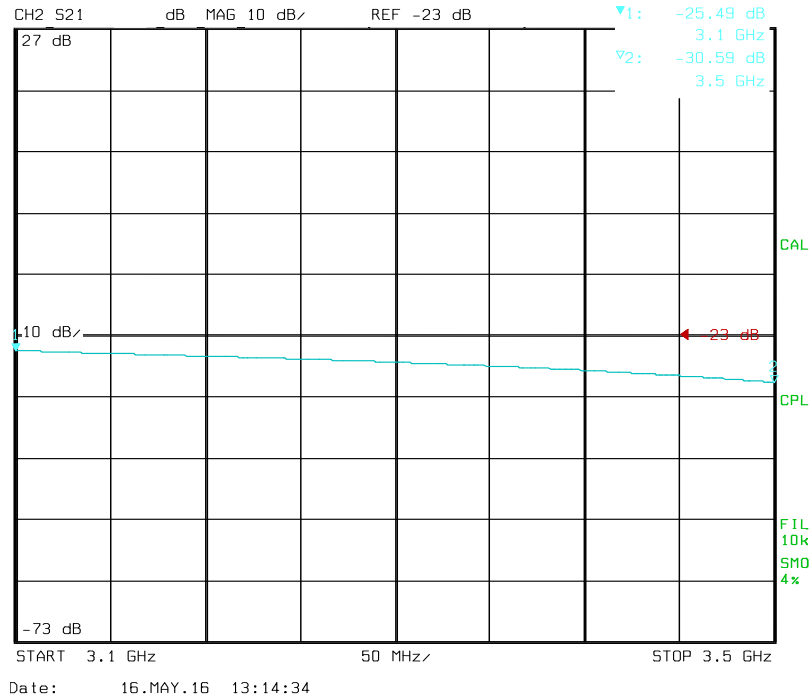
J1- J4 Isolation

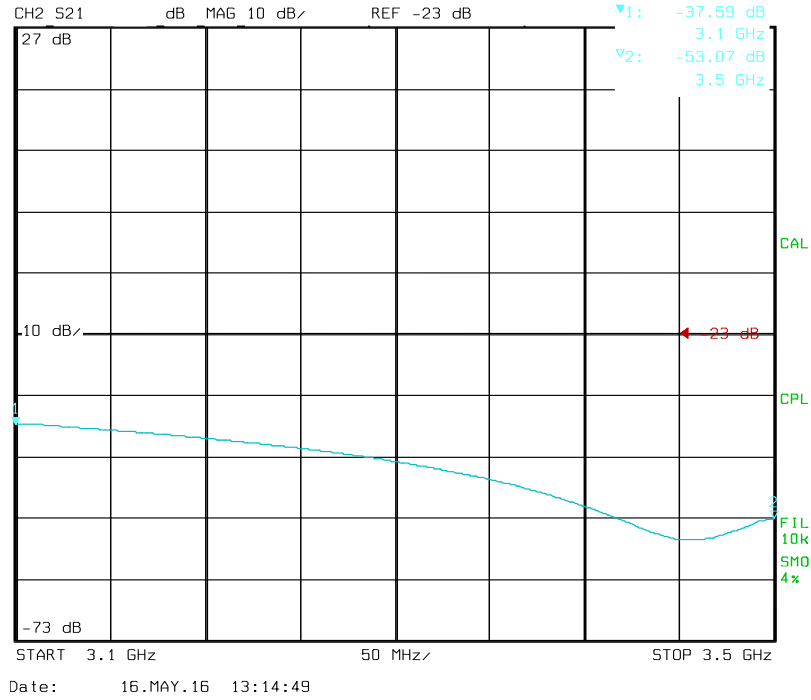
J1- J5 Isolation

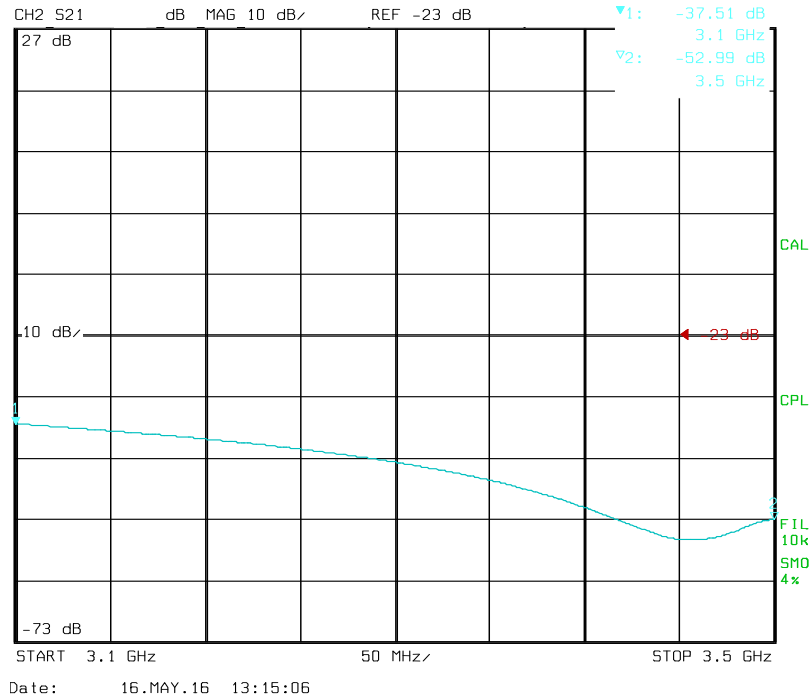
J1- J6 Isolation

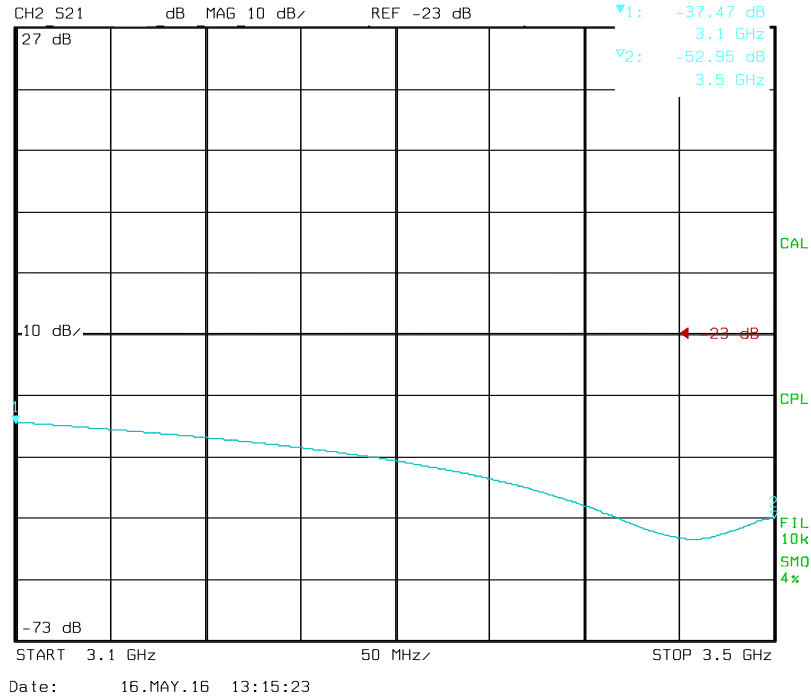
J1- J7 Isolation

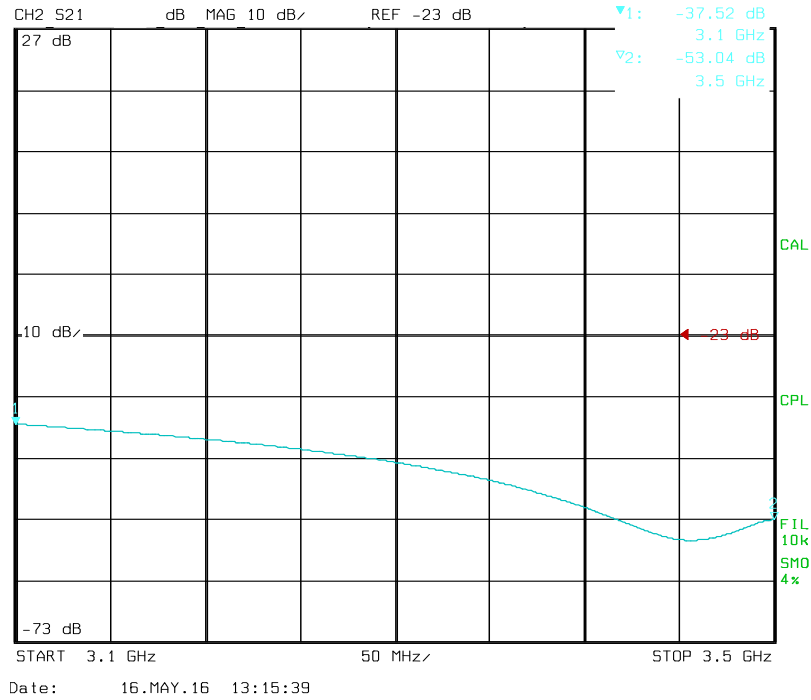
J1- J8 Isolation

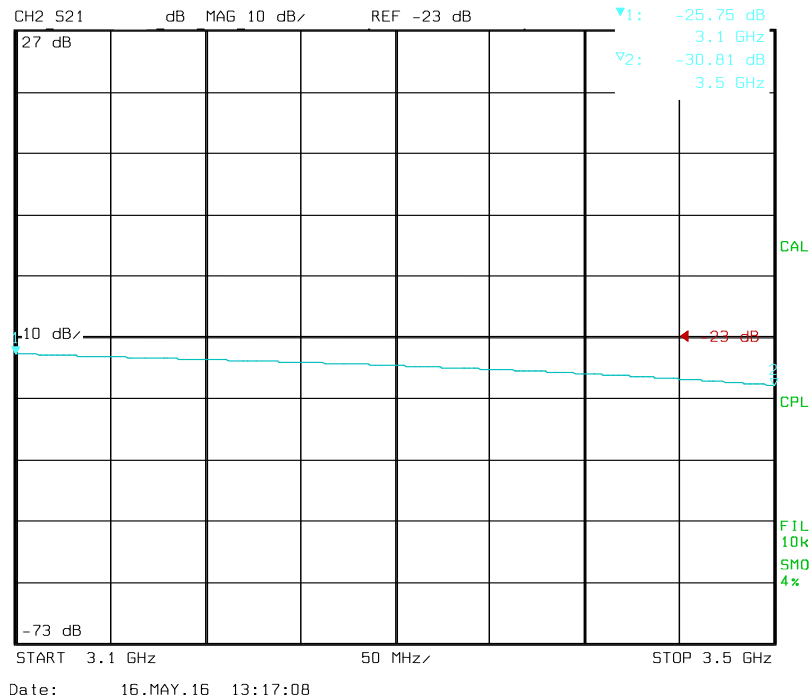
J2- J3 Isolation

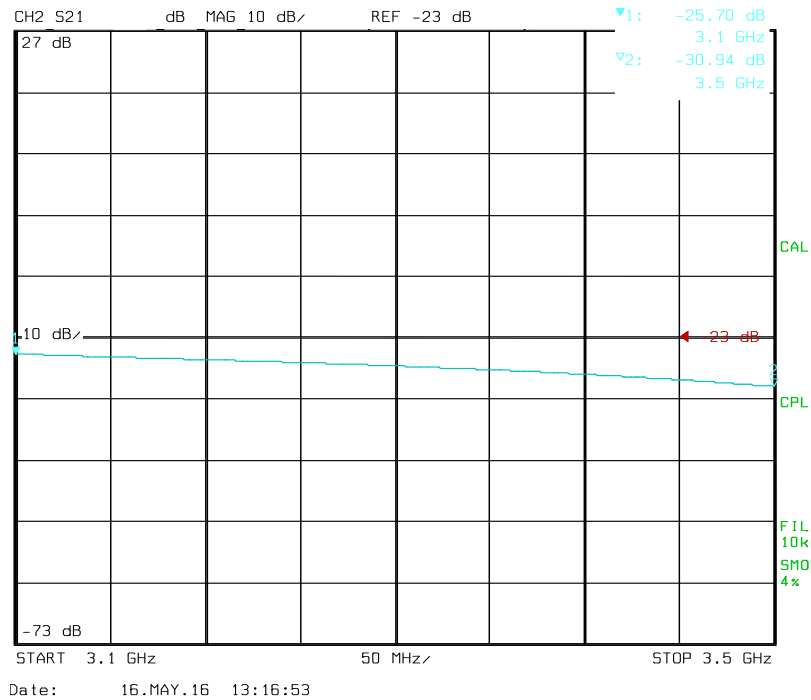
J2- J4 Isolation

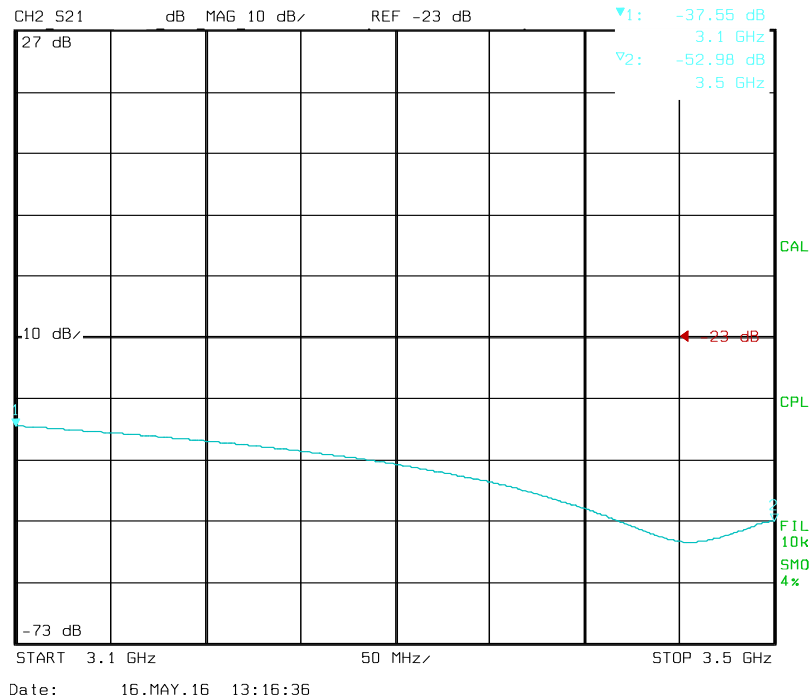
J2- J5 Isolation

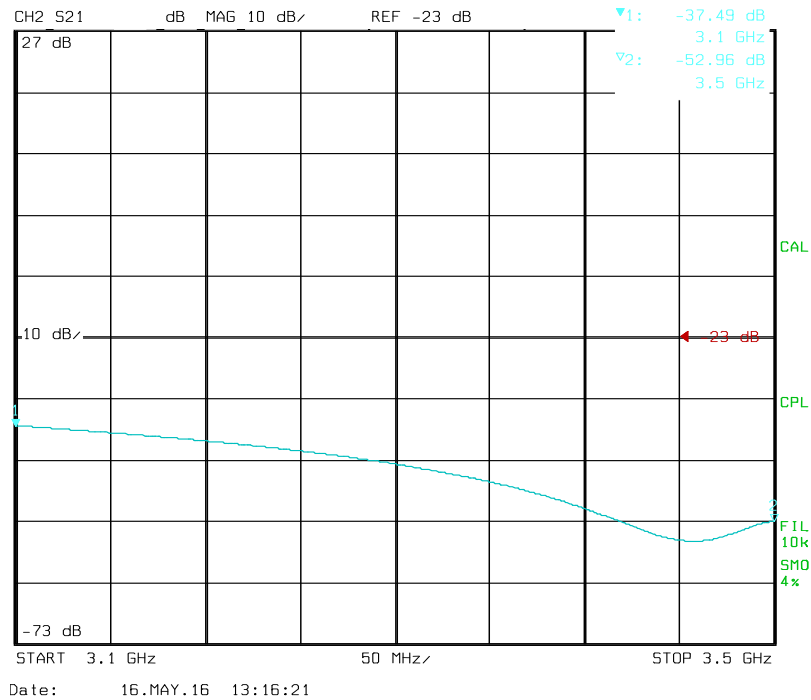
J2- J6 Isolation

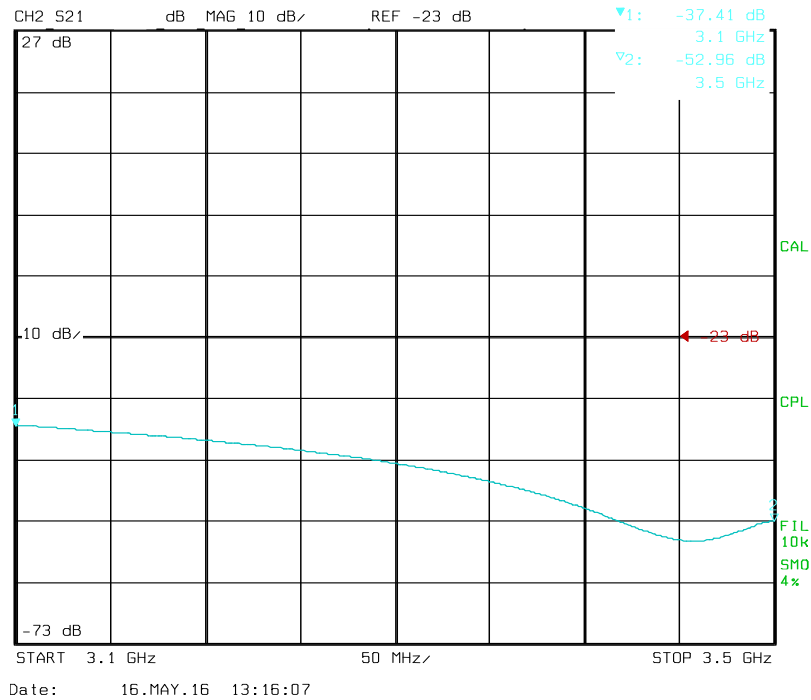
J2- J7 Isolation

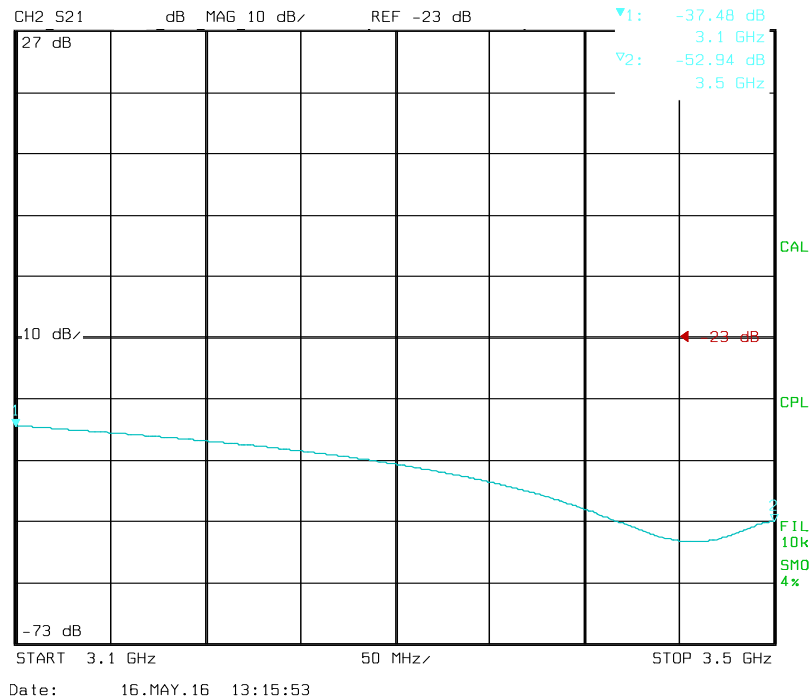
J2- J8 Isolation

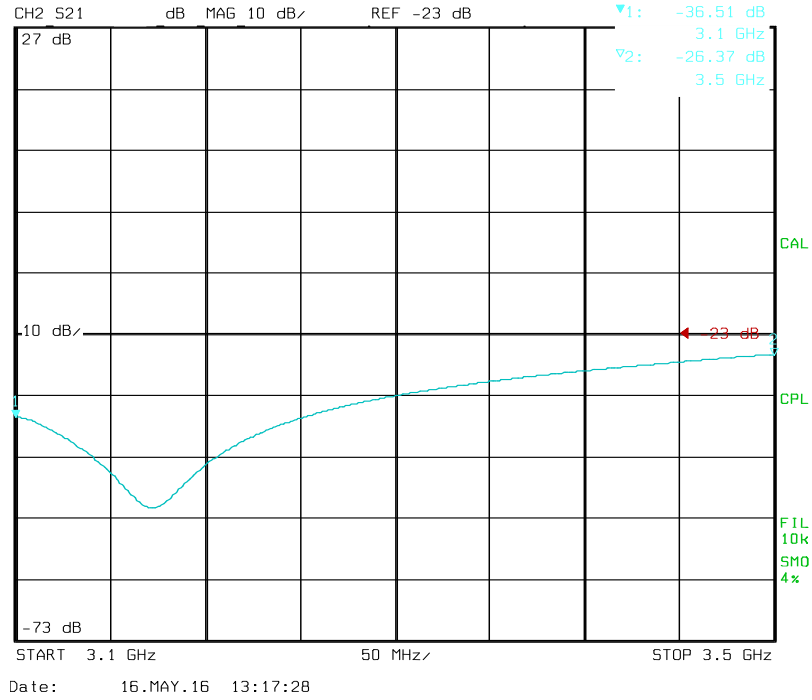
J3- J4 Isolation

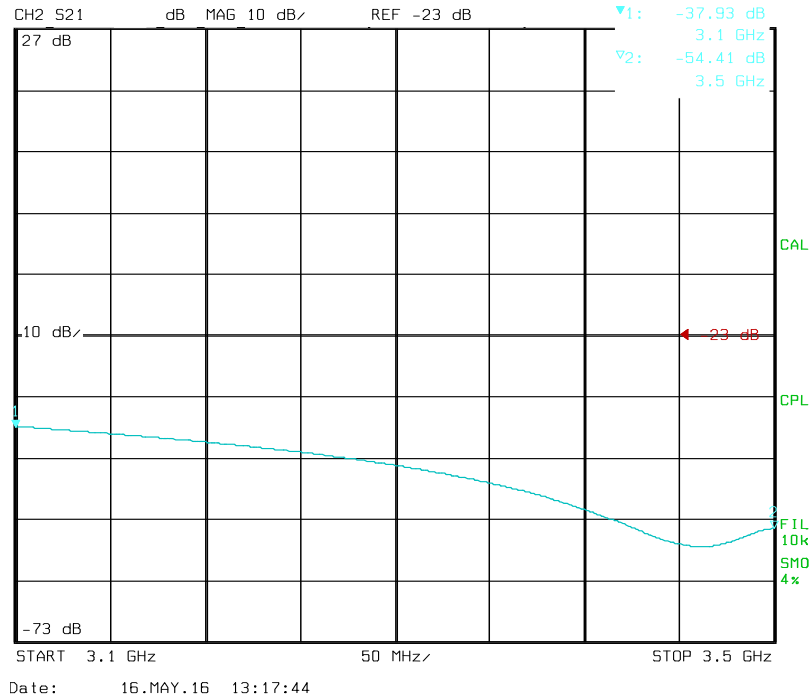
J3- J5 Isolation

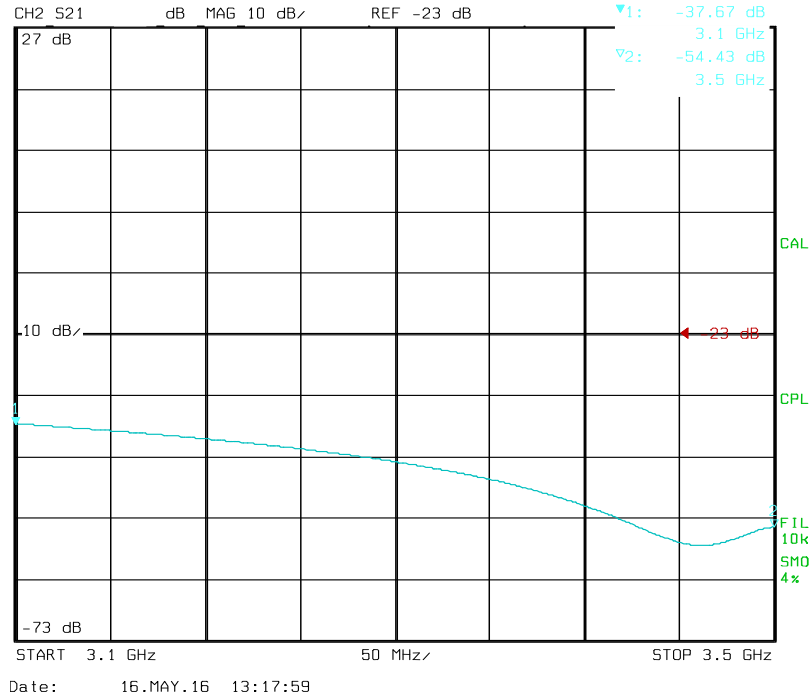
J3- J6 Isolation

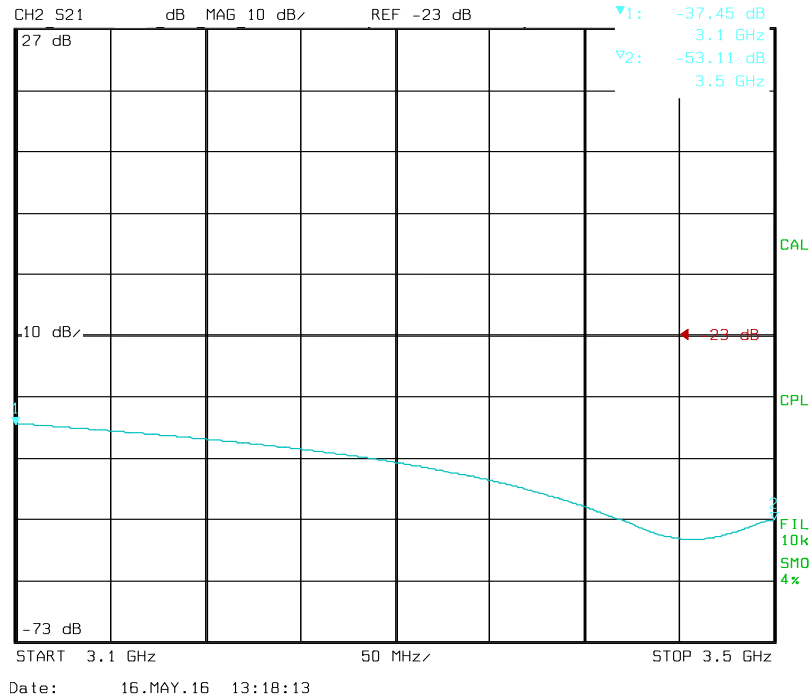
J3- J7 Isolation

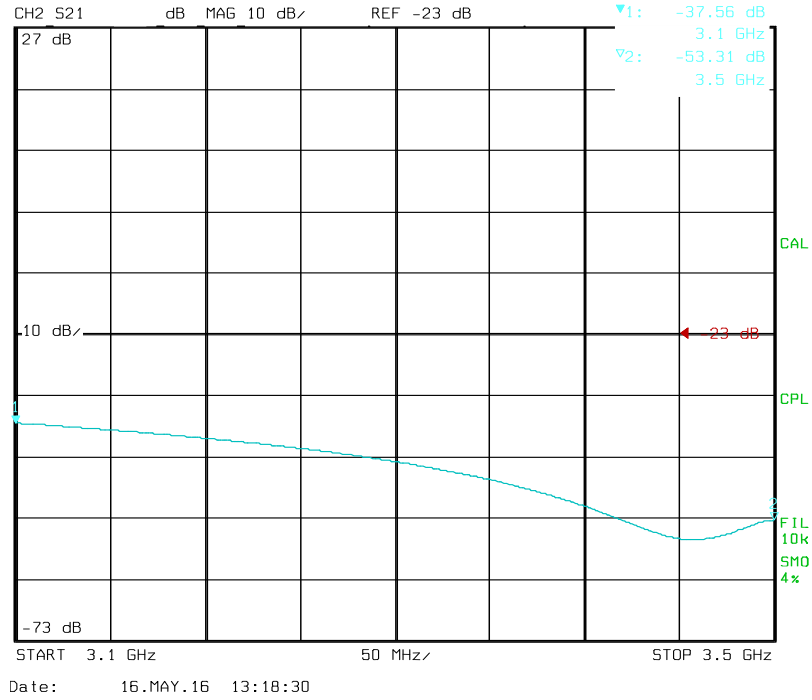
J3- J8 Isolation

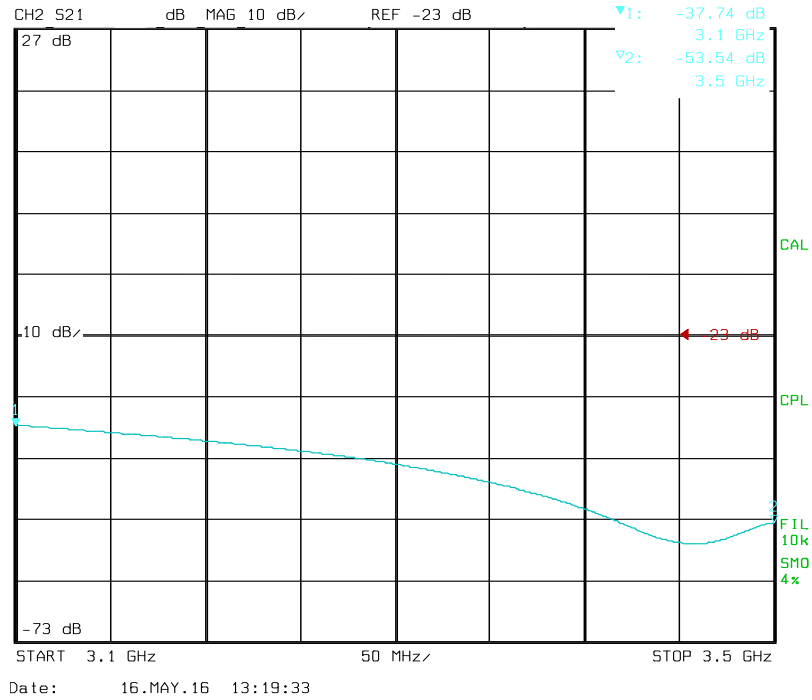
J4- J5 Isolation

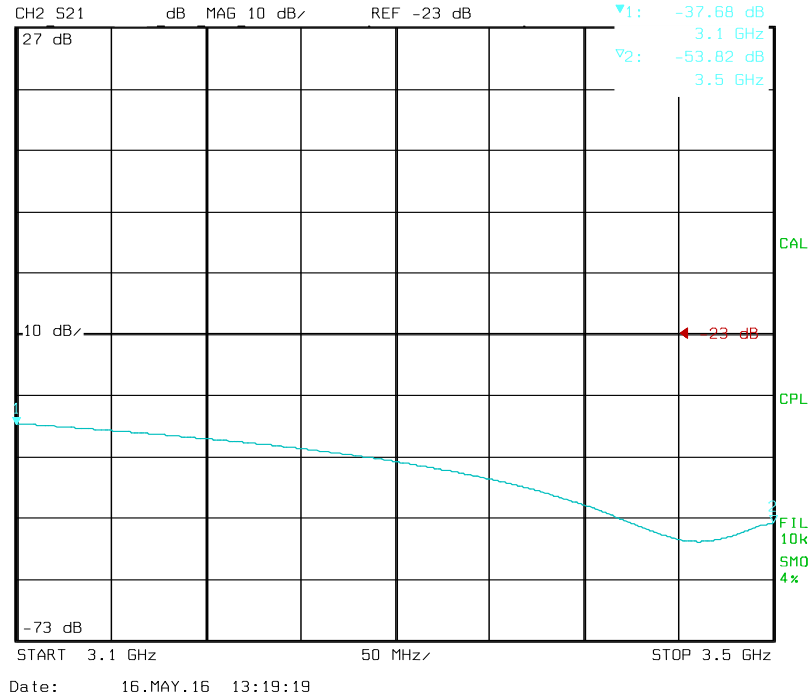
J4- J6 Isolation

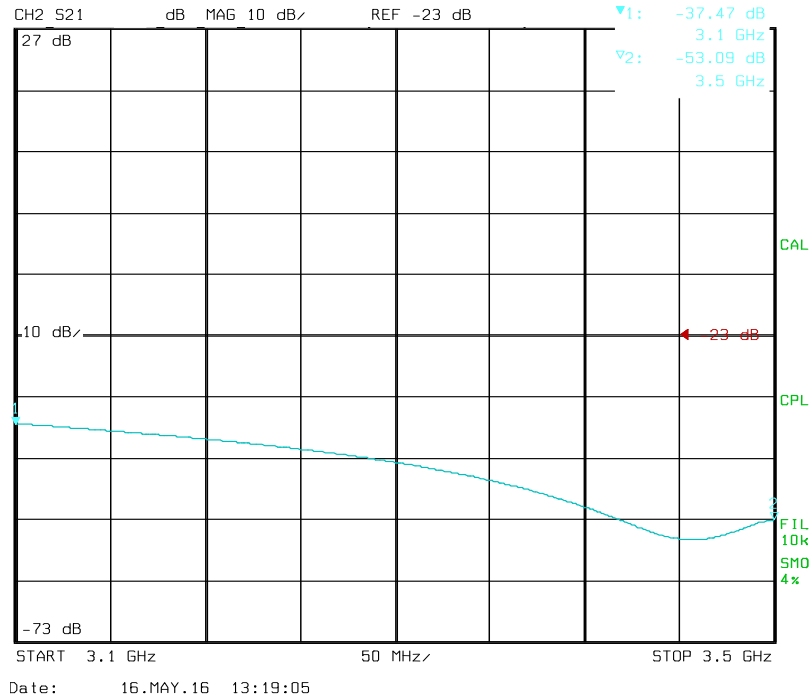
J4- J7 Isolation

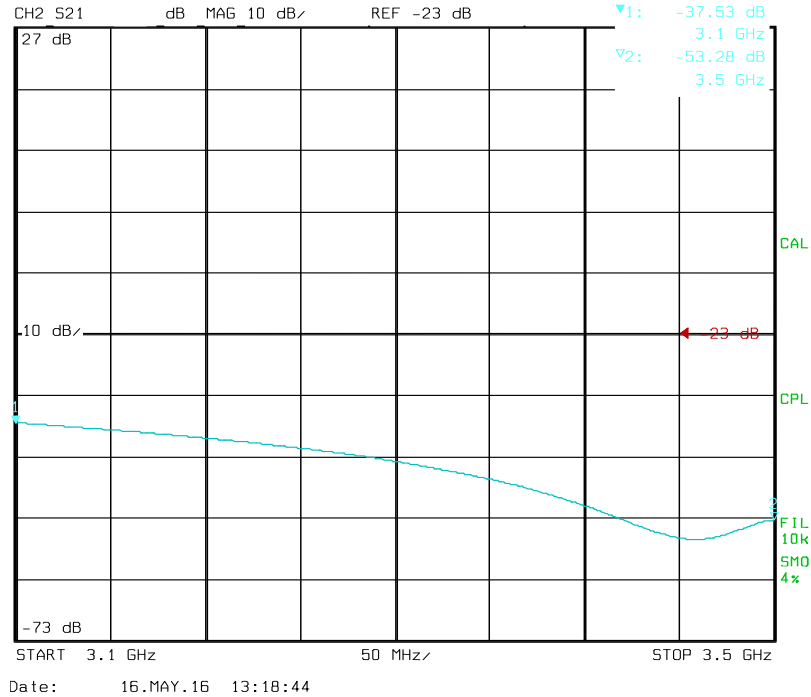
J4- J8 Isolation

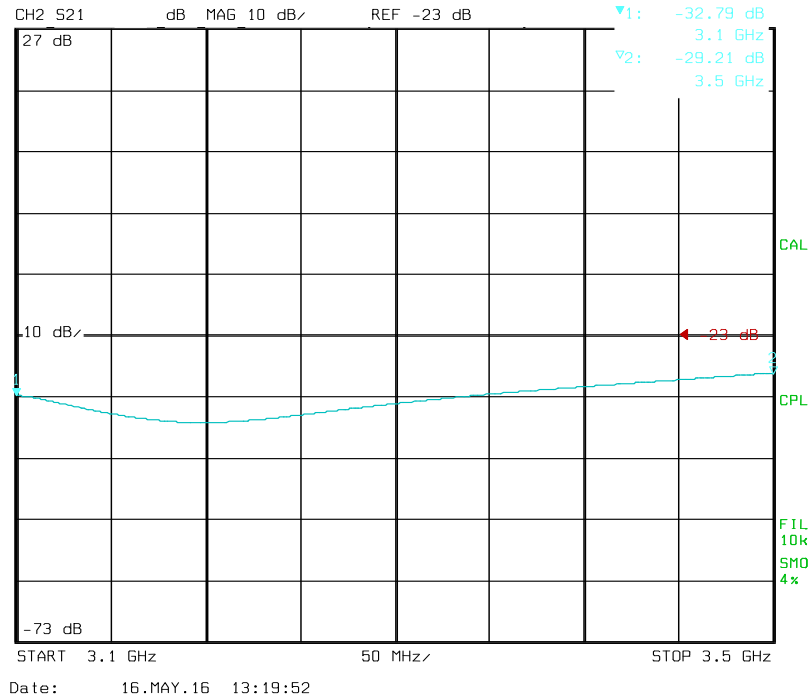
J5- J6 Isolation

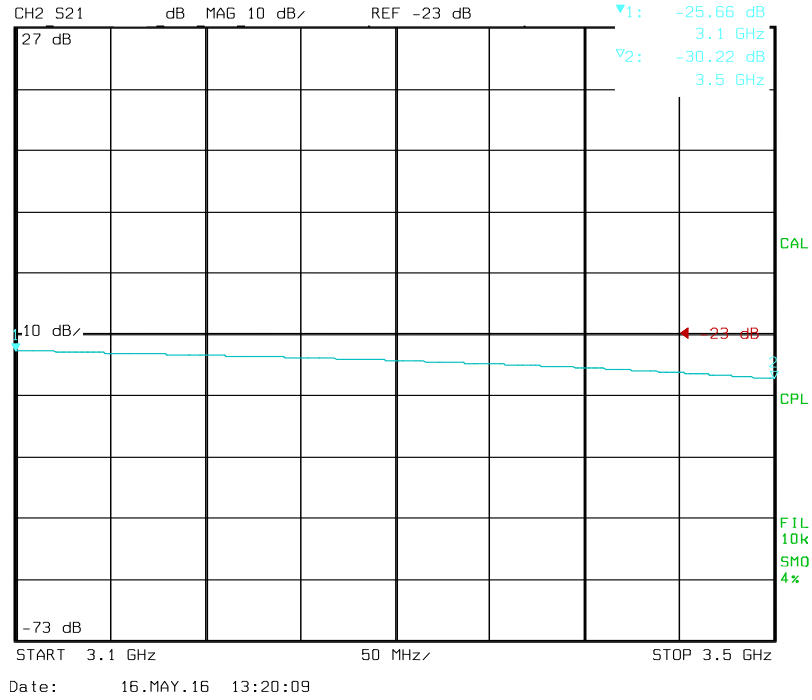
J5- J7 Isolation

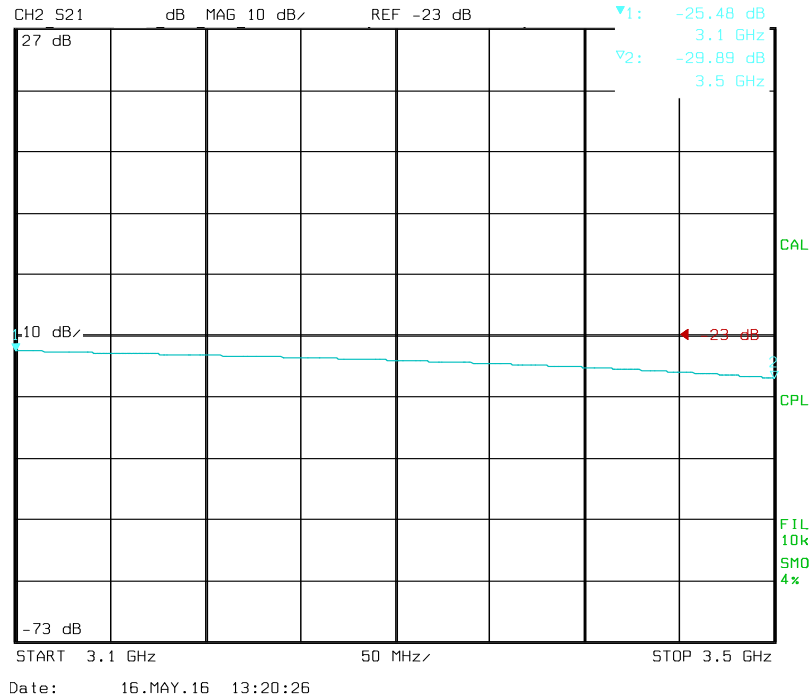
J5- J8 Isolation

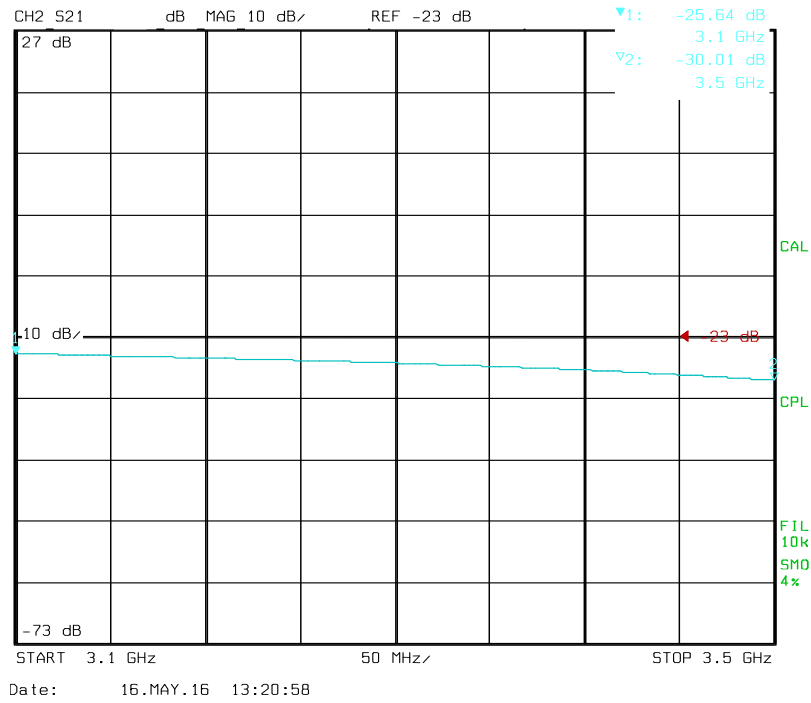
J6- J7 Isolation

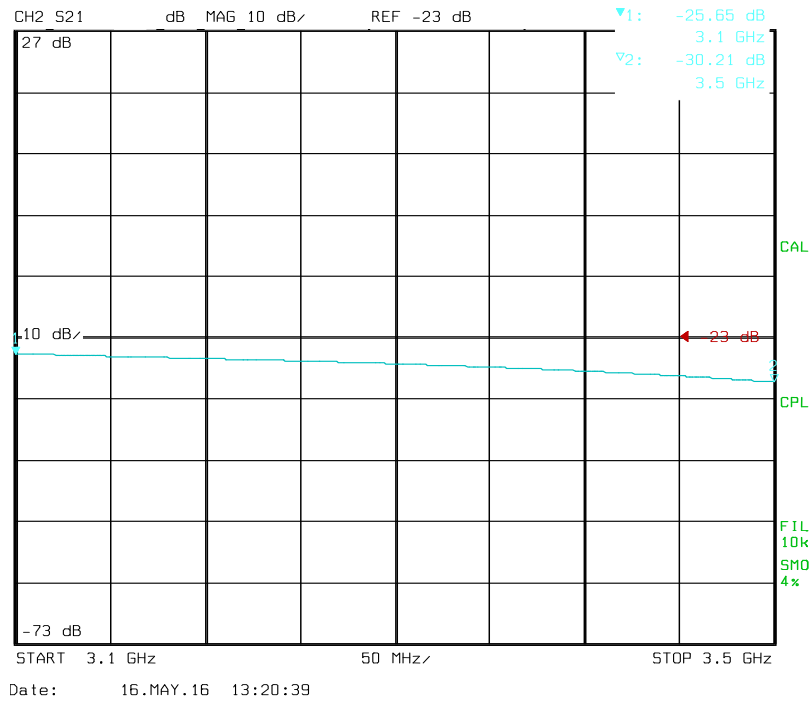
J6- J8 Isolation

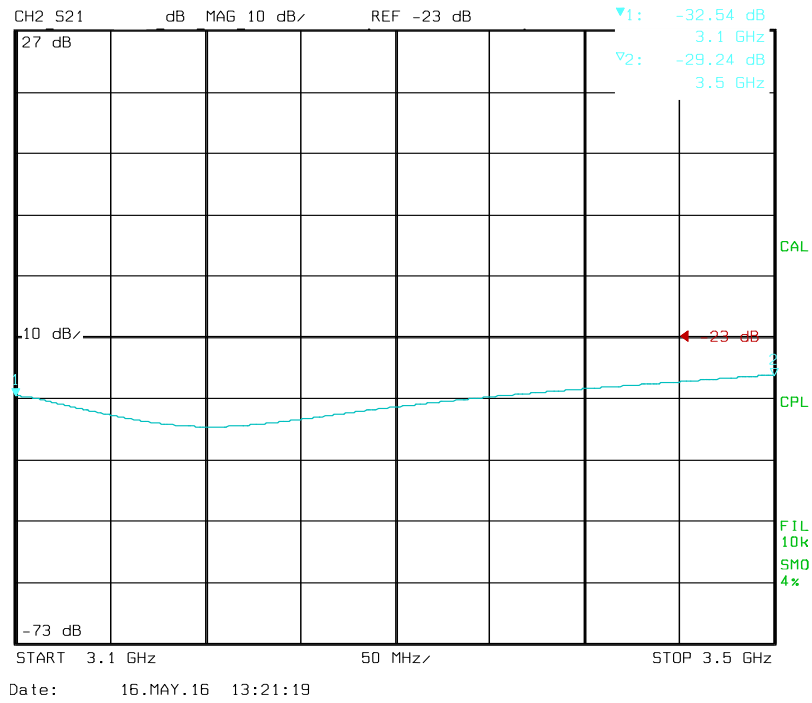
J7- J8 Isolation
