**SUMMARY TEST DATA
ON
APD-8-3D13D5-40W-SFF**

PL19245/1623

Customer: _____ Tested By: Jerry N.
SO No: _____ Temperature: +25°C
Model No: APD-8-3D13D5-40W-SFF Date: 05/23/2016
Serial No: PL19245/1623 Drawing No: 27626081 Rev: A1

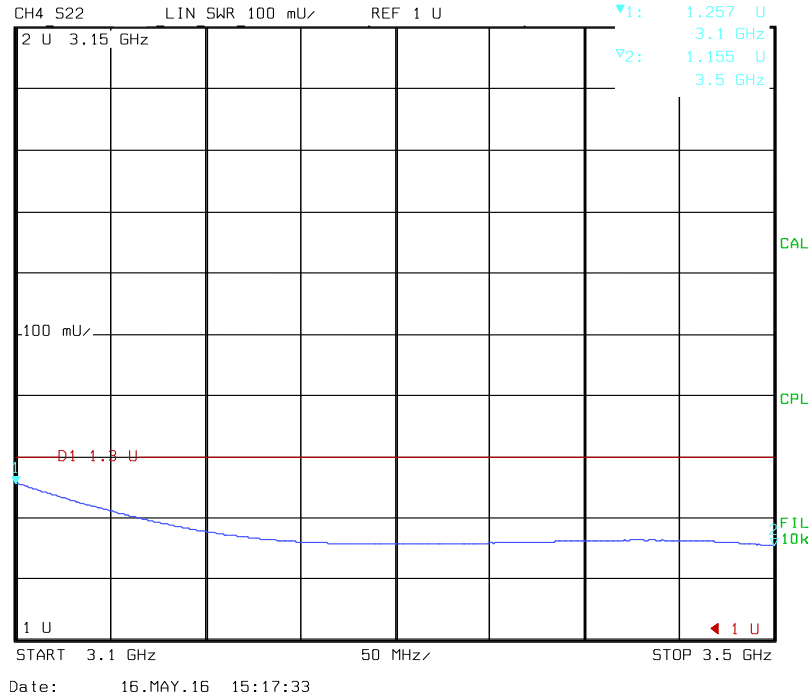
J0 Input VSWR

TEST. ITEM NO	PARAMETERS	SPECIFIED VALUE	TEST RESULTS	QA QC
1	Frequency Range	3.1 TO 3.5 GHz	3.1 TO 3.5 GHz	
2	Insertion Loss	≤0.6 dB	0.49dB (See Plot)	
3	Isolation	≥23 dB	24.9dB (See Plot)	
4	VSWR	INPUT ≤1.30:1 OUTPUT ≤1.20:1	INPUT 1.26 :1 OUTPUT 1.13 :1 (See Plot)	
5	Amplitude Balance	≤ ±0.2 dB	±0.09dB (See Plot)	
6	Phase Balance	≤ ±2°	1.0° (See Plot)	
7	Power Handling	Forward ≤40 W Reverse ≤1 W	40W 1W	
8	Impedance	50 Ω	50 Ω

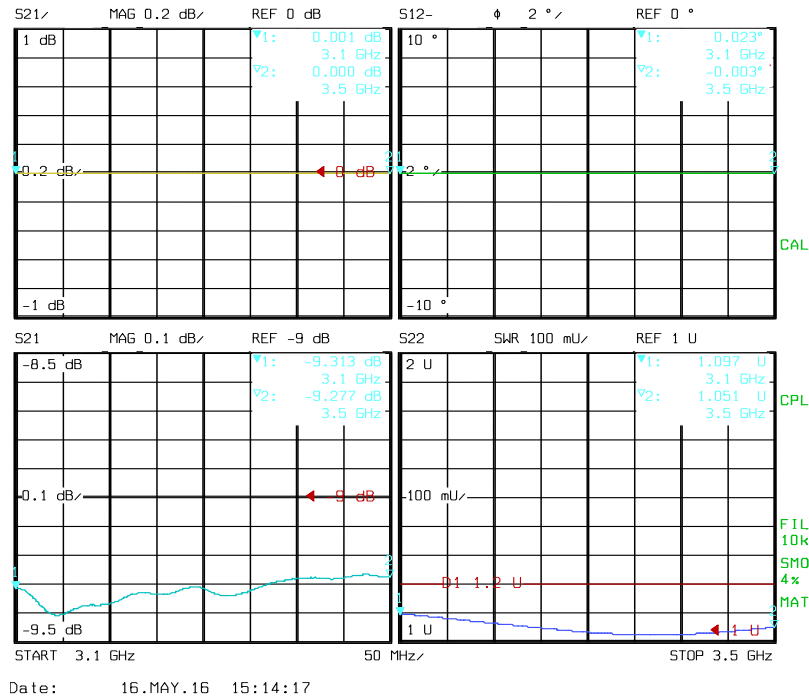
J0 to J1 Amplitude Balance, Insertion Loss, Phase balance, J1 VSWR

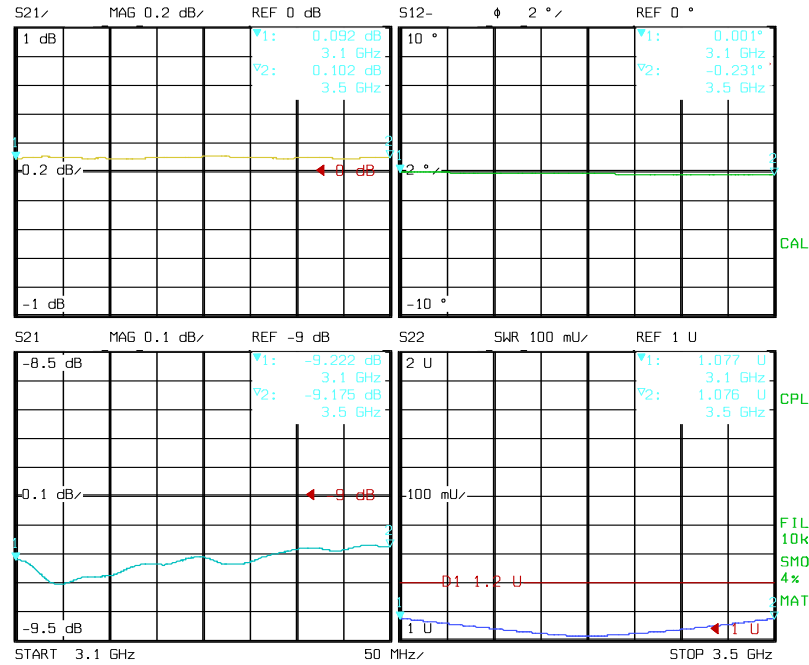
J0 to J2 Amplitude Balance, Insertion Loss, Phase balance, J2 VSWR

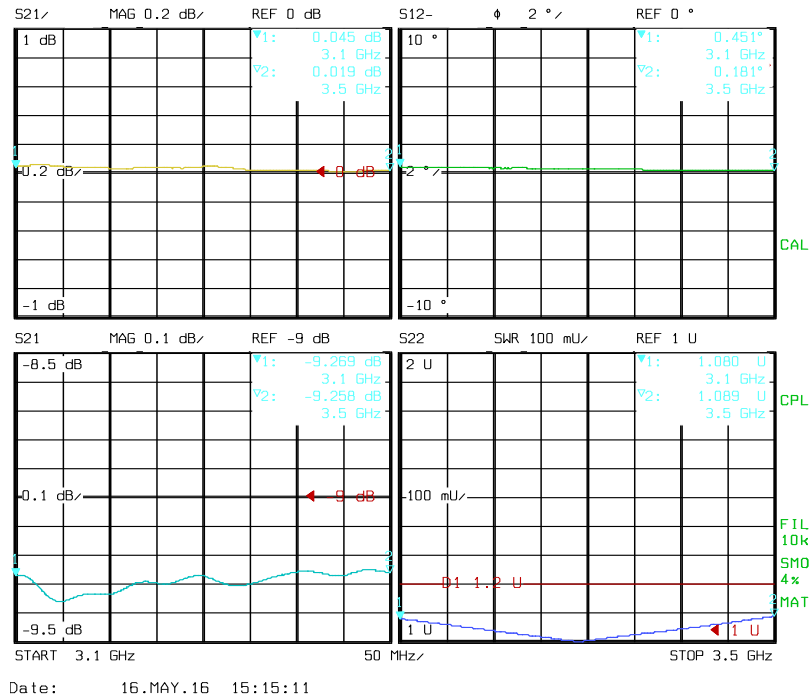
J0 to J3 Amplitude Balance, Insertion Loss, Phase balance, J3 VSWR

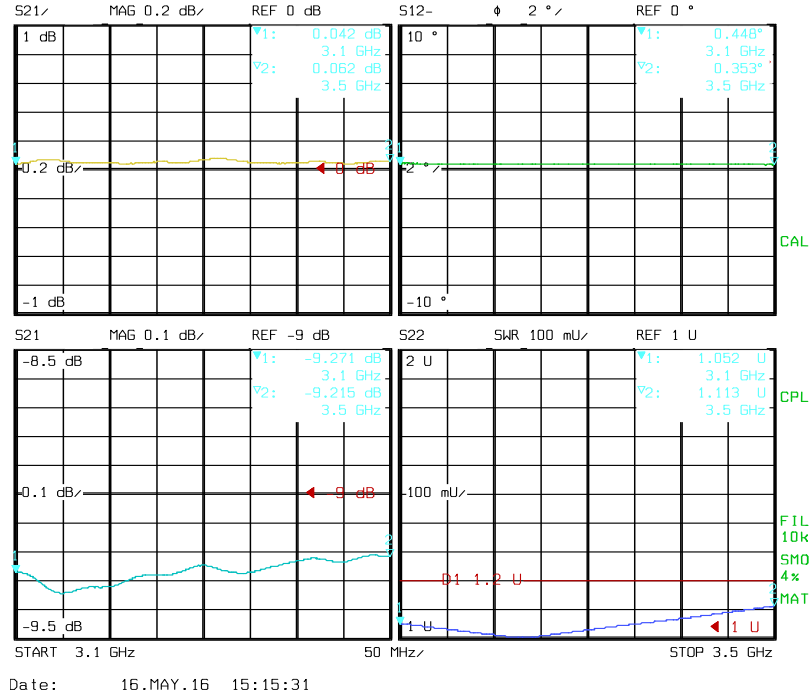
J0 to J4 Amplitude Balance, Insertion Loss, Phase balance, J4 VSWR

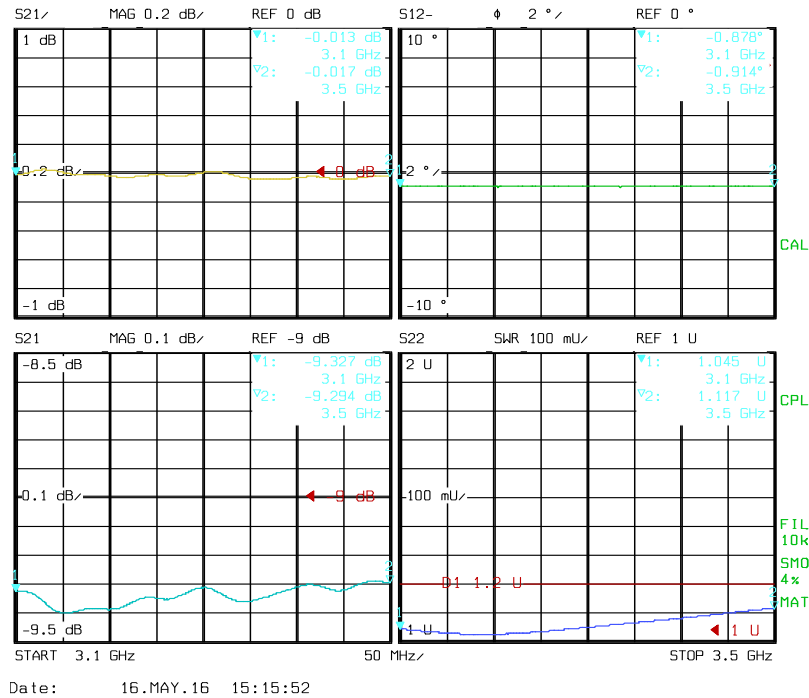
J0 to J5 Amplitude Balance, Insertion Loss, Phase balance, J5 VSWR

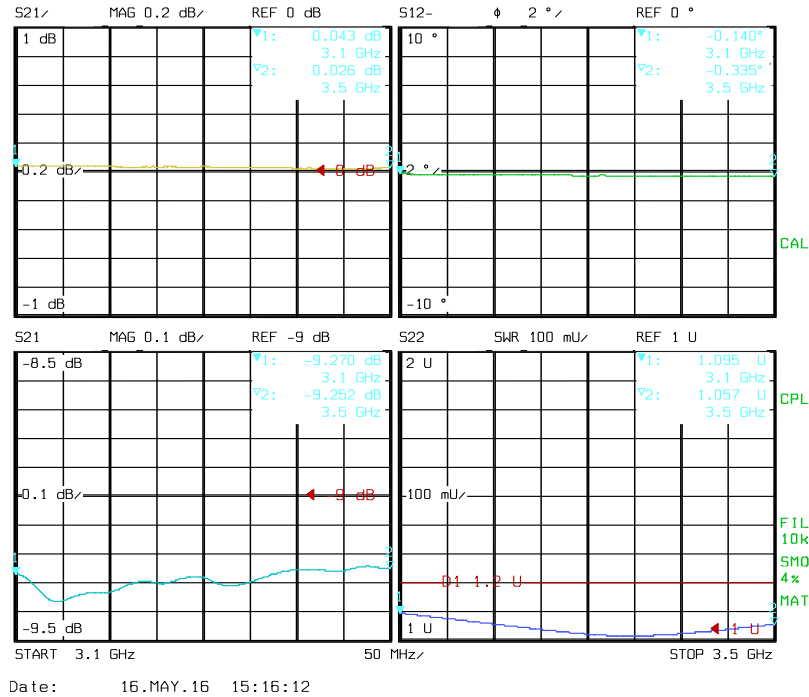
J0 to J6 Amplitude Balance, Insertion Loss, Phase balance, J6 VSWR

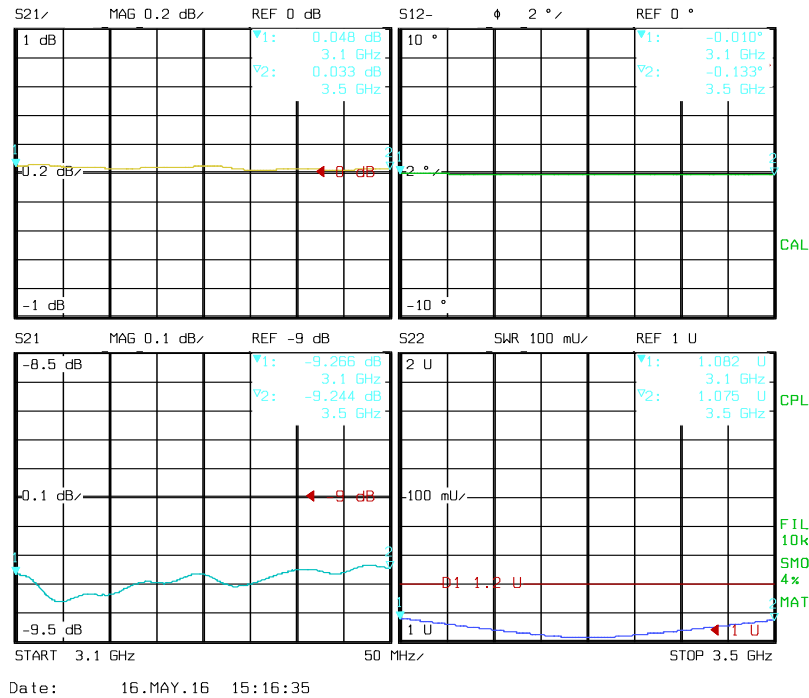
J0 to J7 Amplitude Balance, Insertion Loss, Phase balance, J7 VSWR

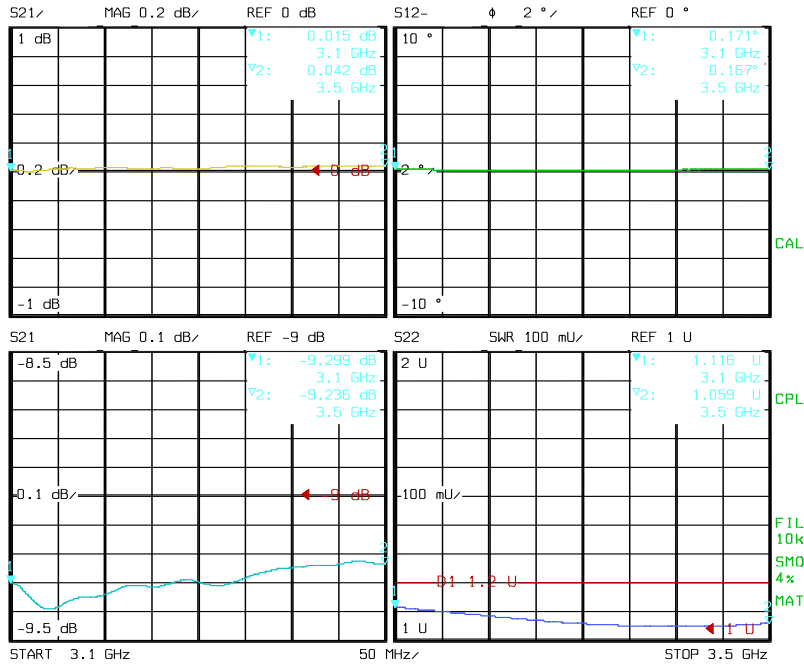
J0 to J8 Amplitude Balance, Insertion Loss, Phase balance, J8 VSWR

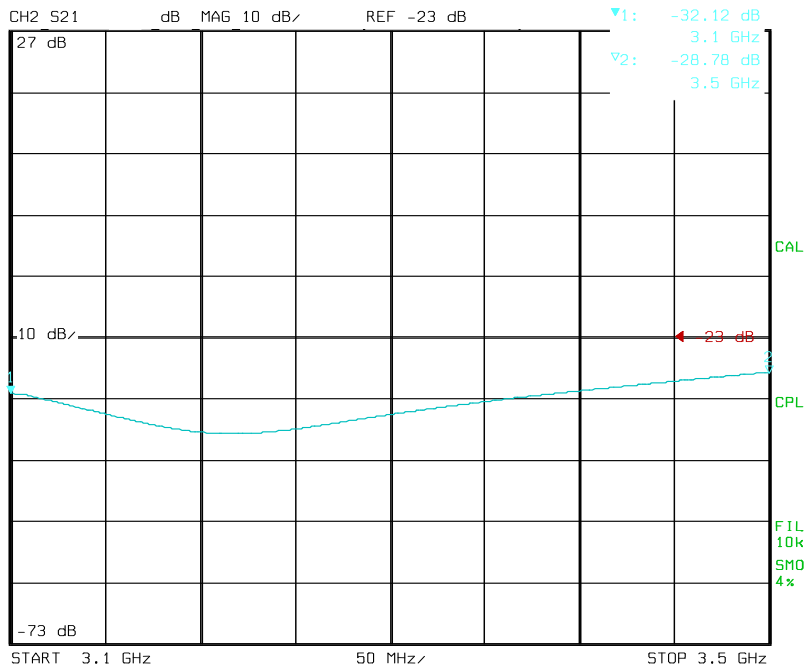
J1- J2 Isolation

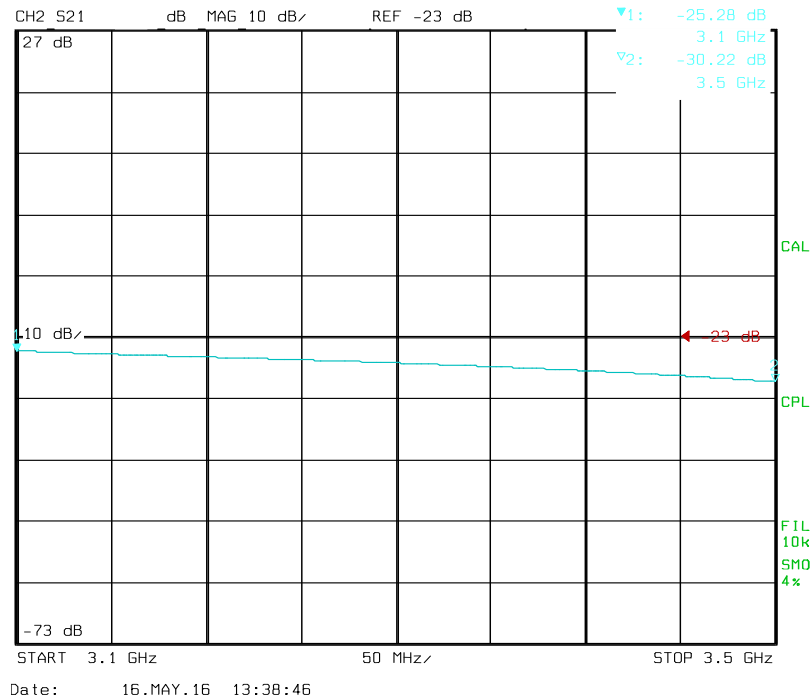
J1- J3 Isolation

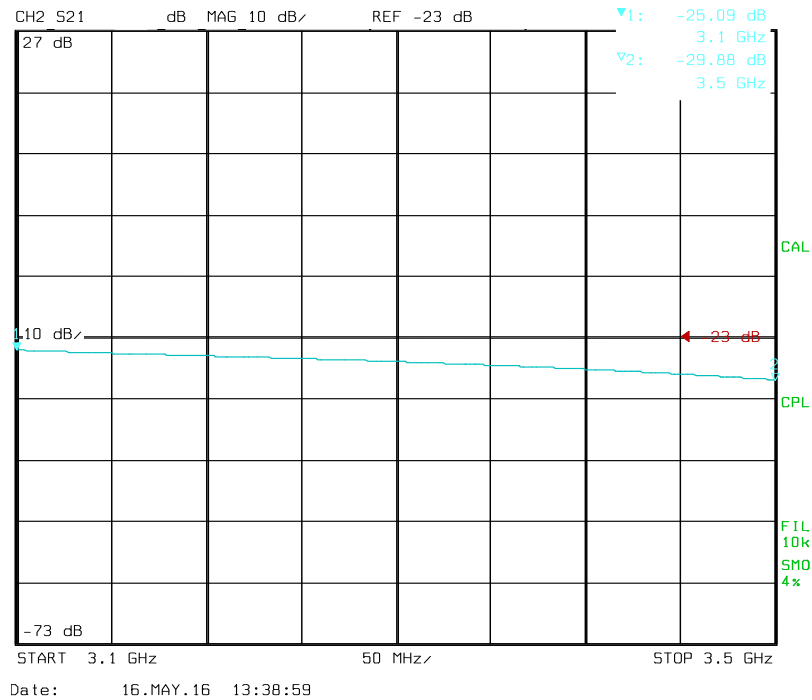
J1- J4 Isolation

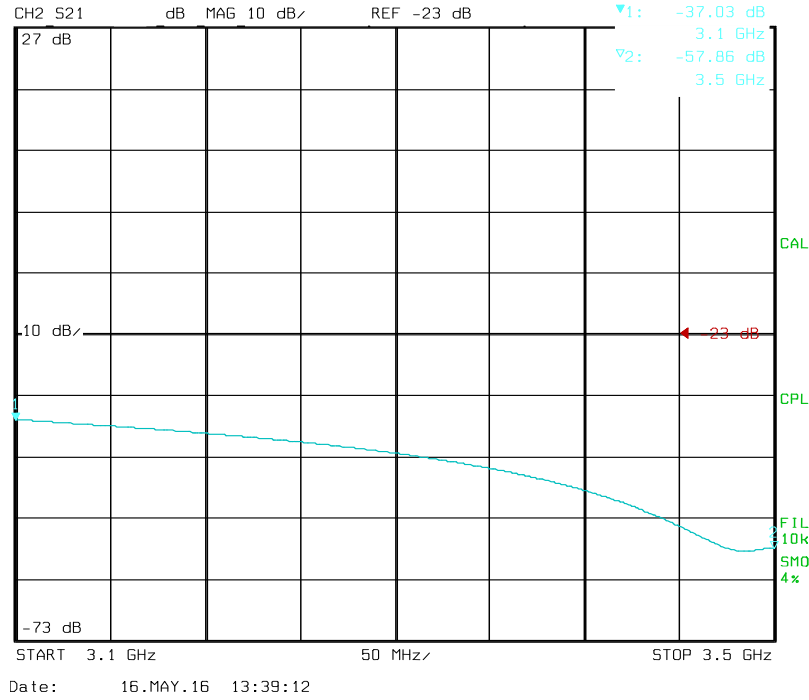
J1- J5 Isolation

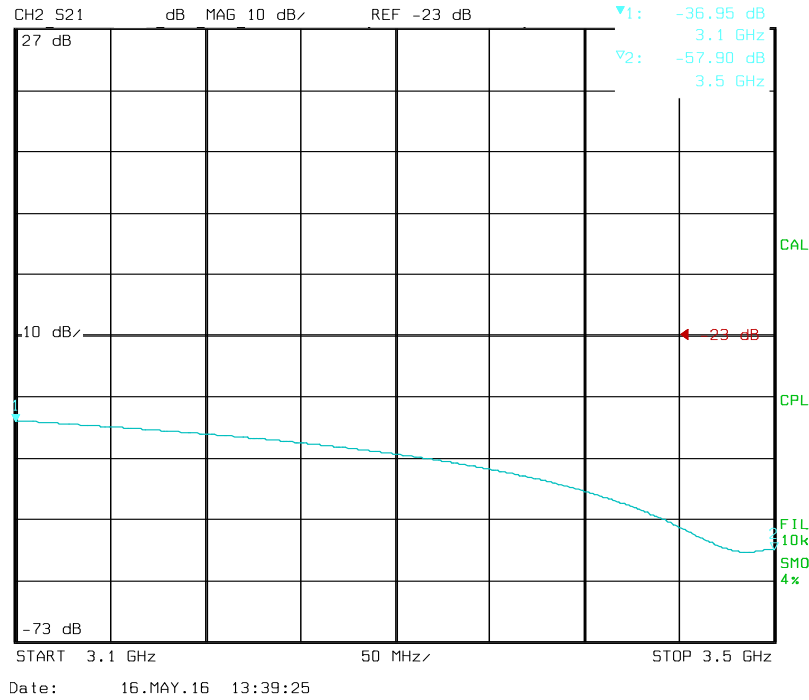
J1- J6 Isolation

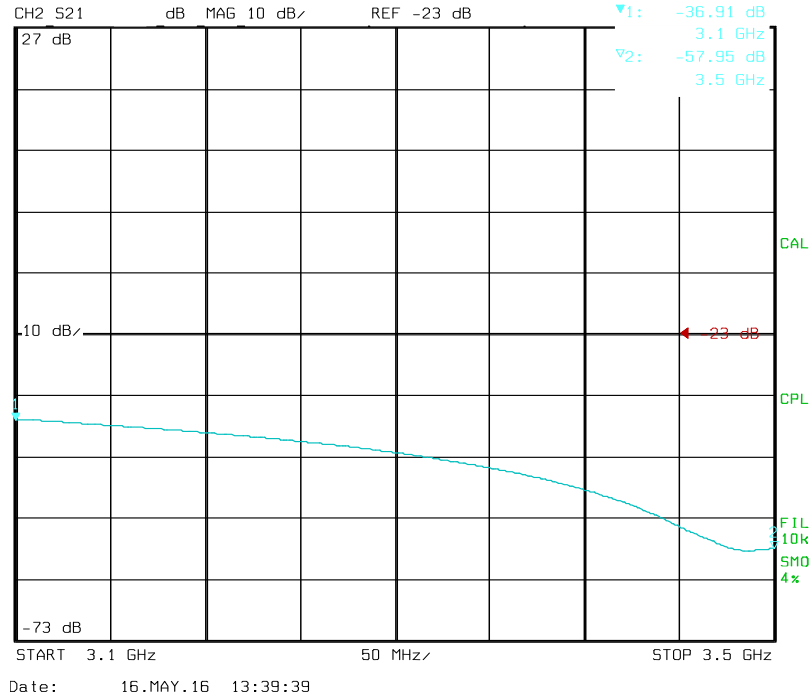
J1- J7 Isolation

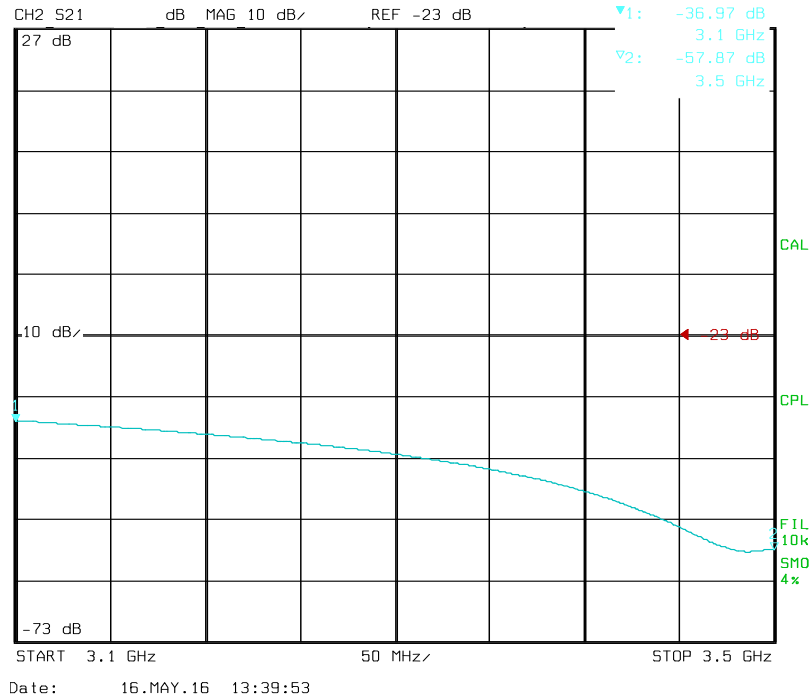
J1- J8 Isolation

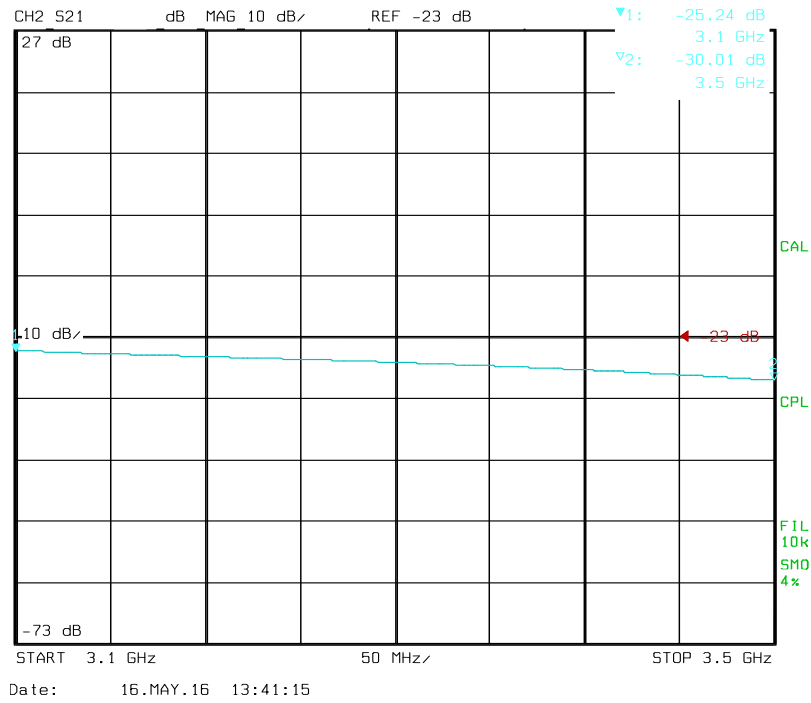
J2- J3 Isolation

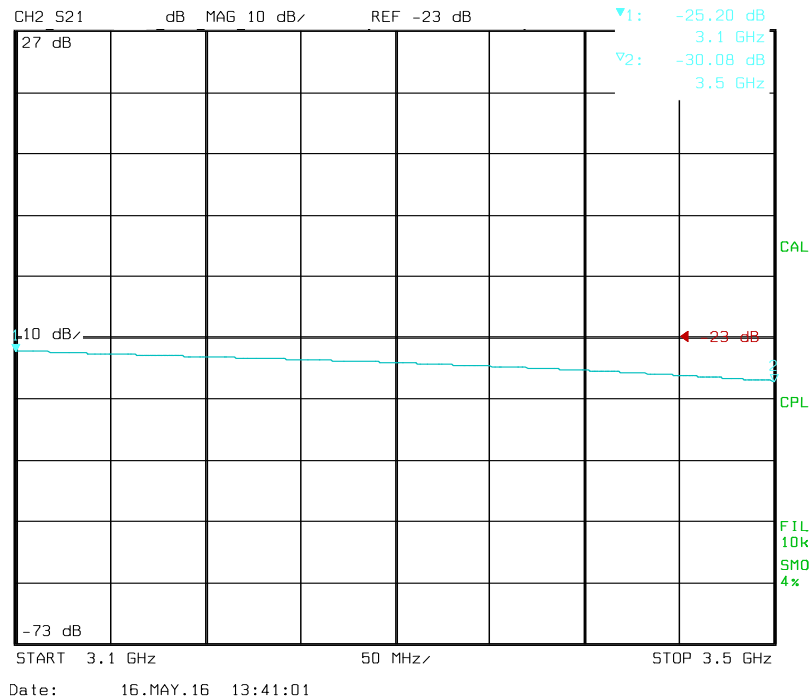
J2- J4 Isolation

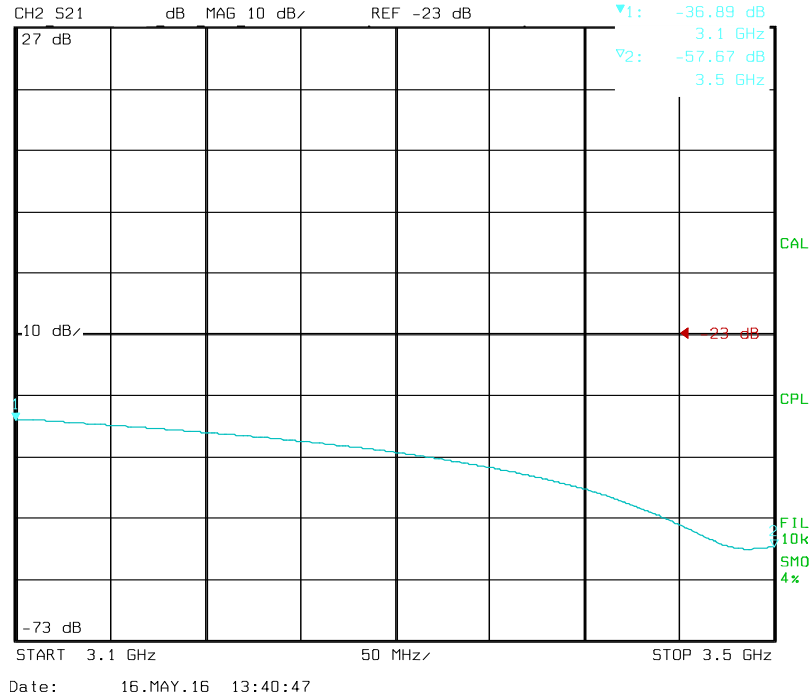
J2- J5 Isolation

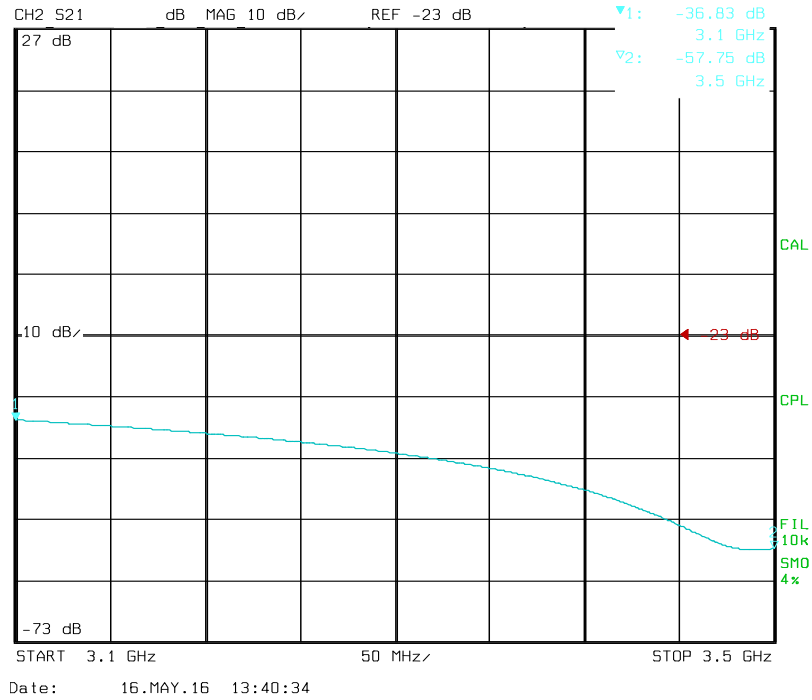
J2- J6 Isolation

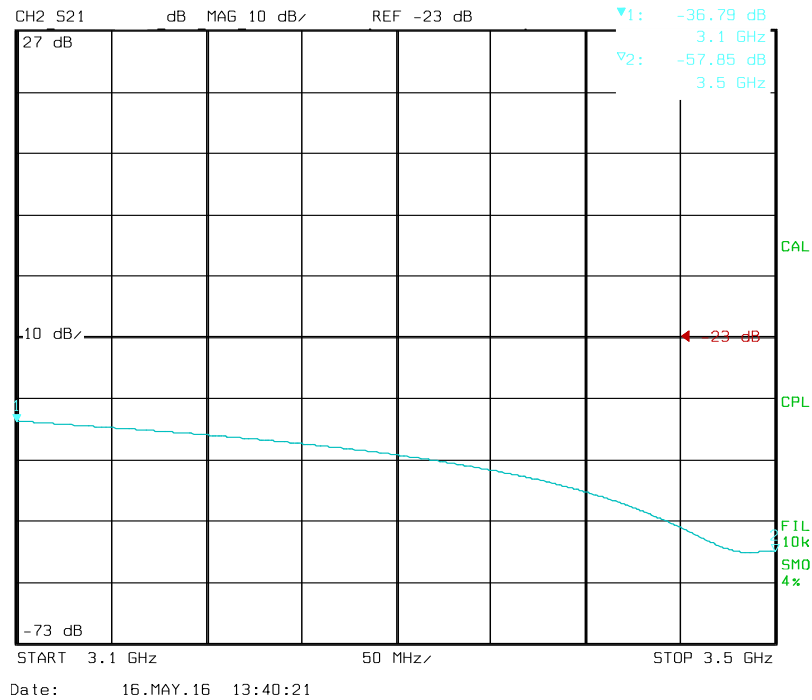
J2- J7 Isolation

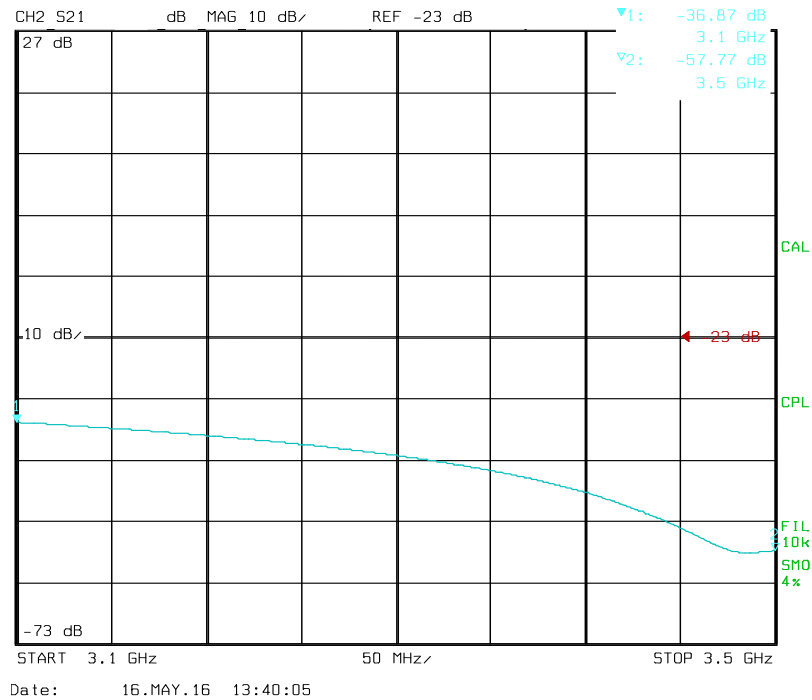
J2- J8 Isolation

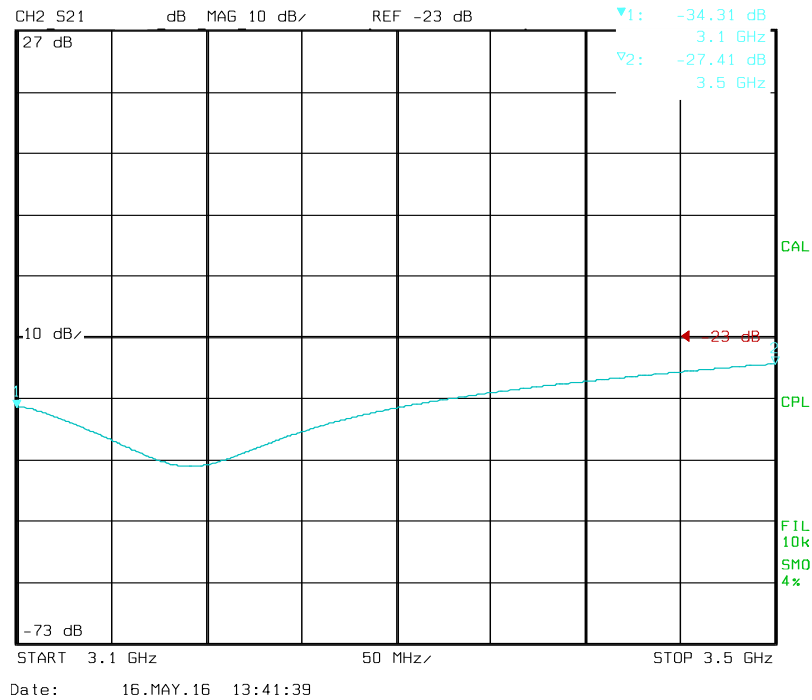
J3- J4 Isolation

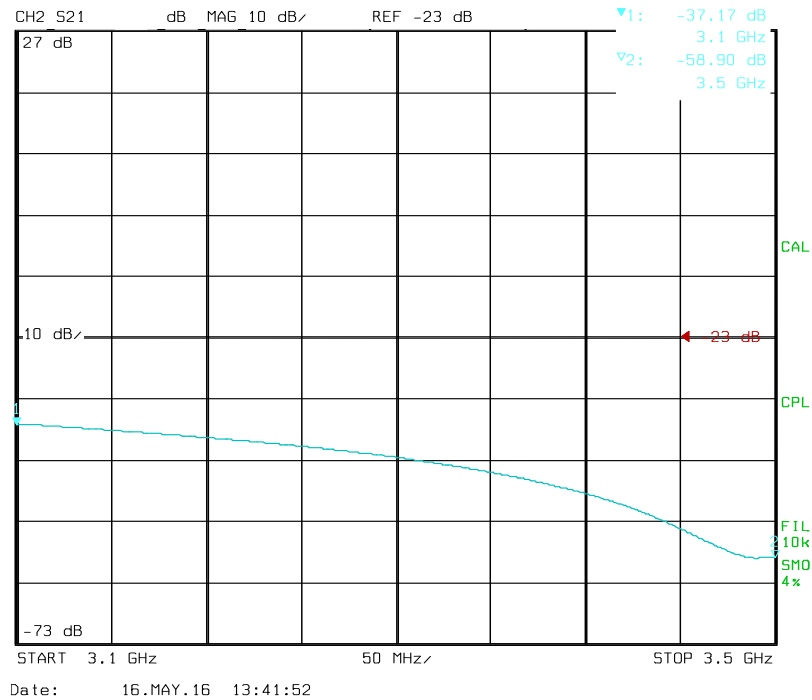
J3- J5 Isolation

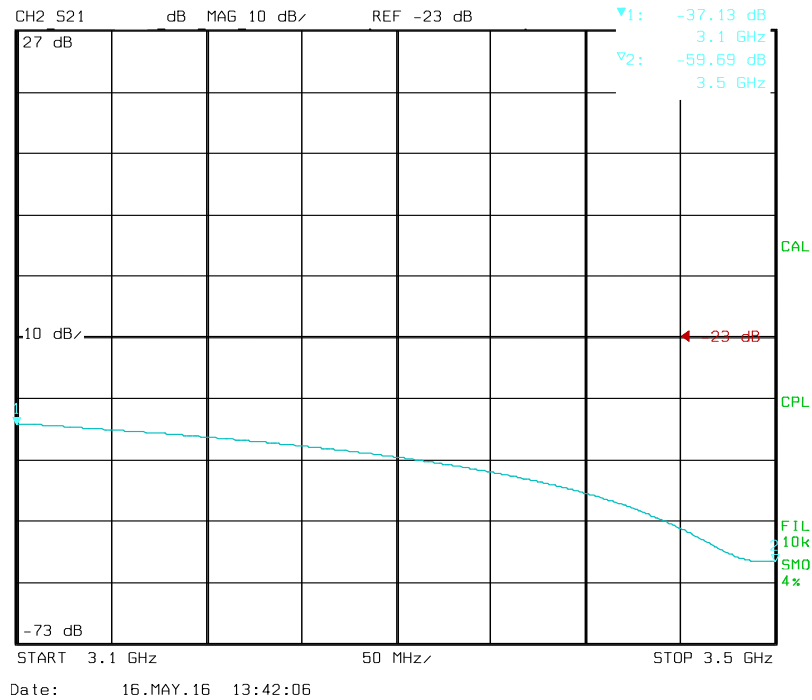
J3- J6 Isolation

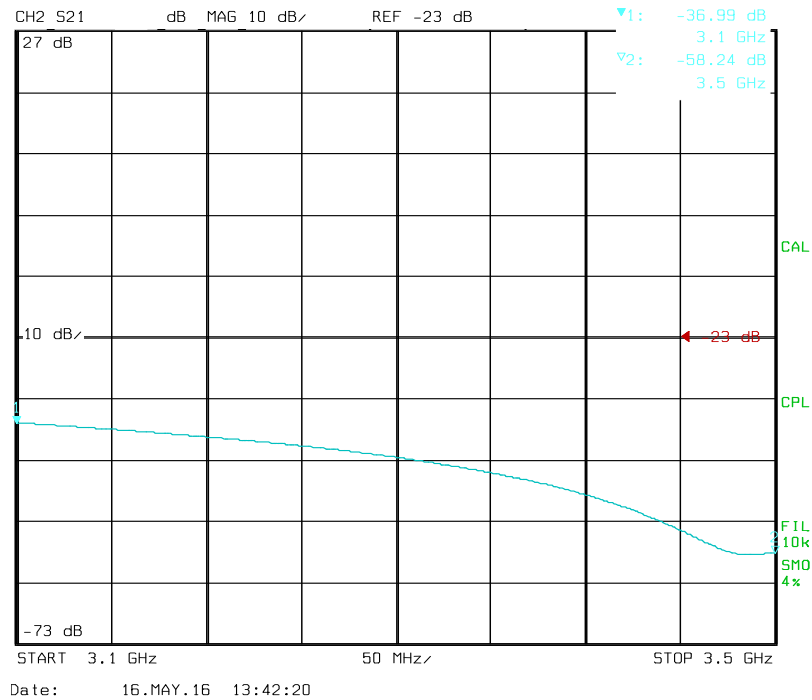
J3- J7 Isolation

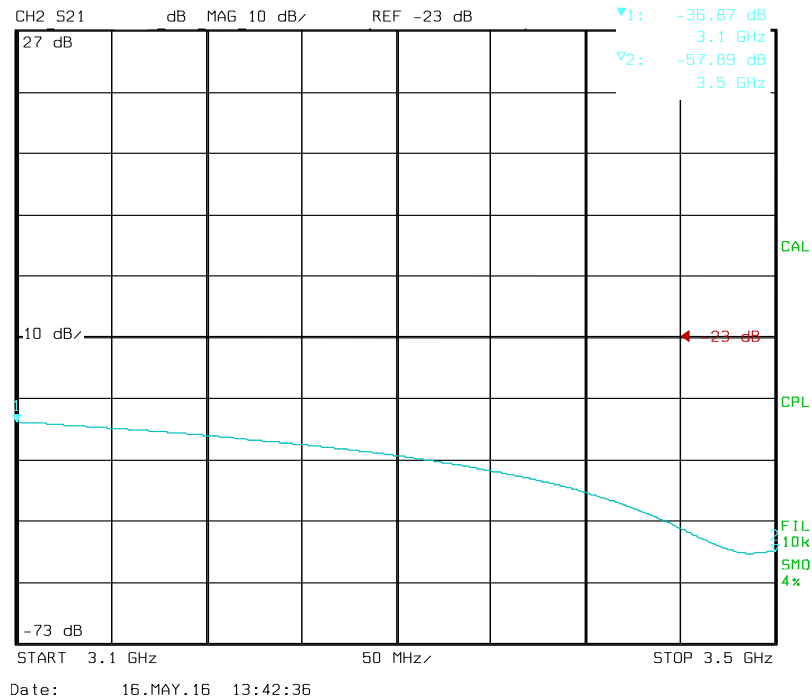
J3- J8 Isolation

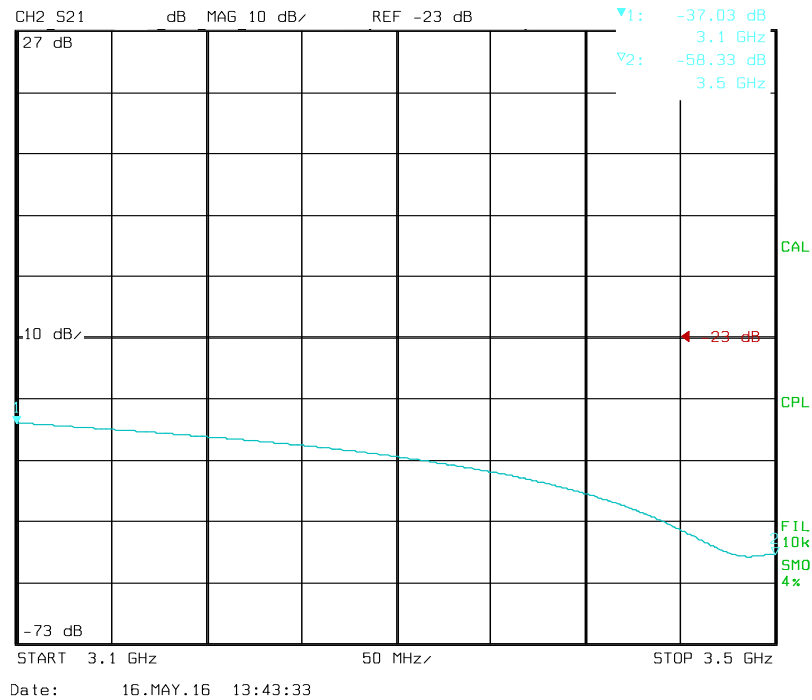
J4- J5 Isolation

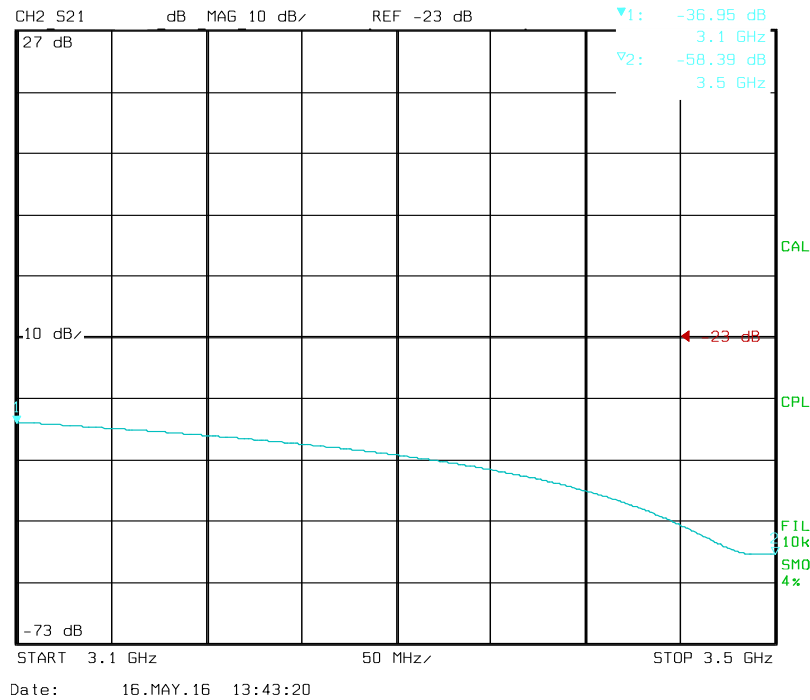
J4- J6 Isolation

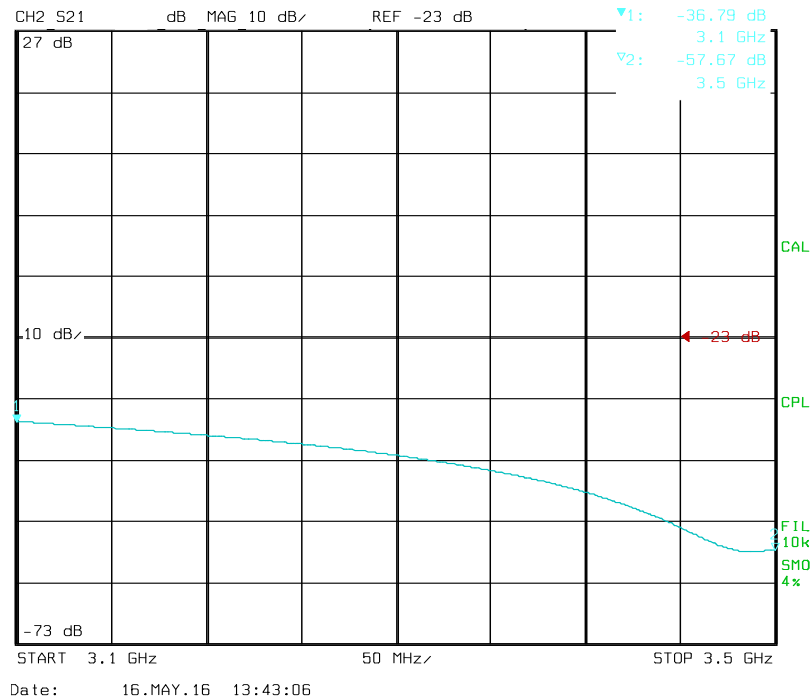
J4- J7 Isolation

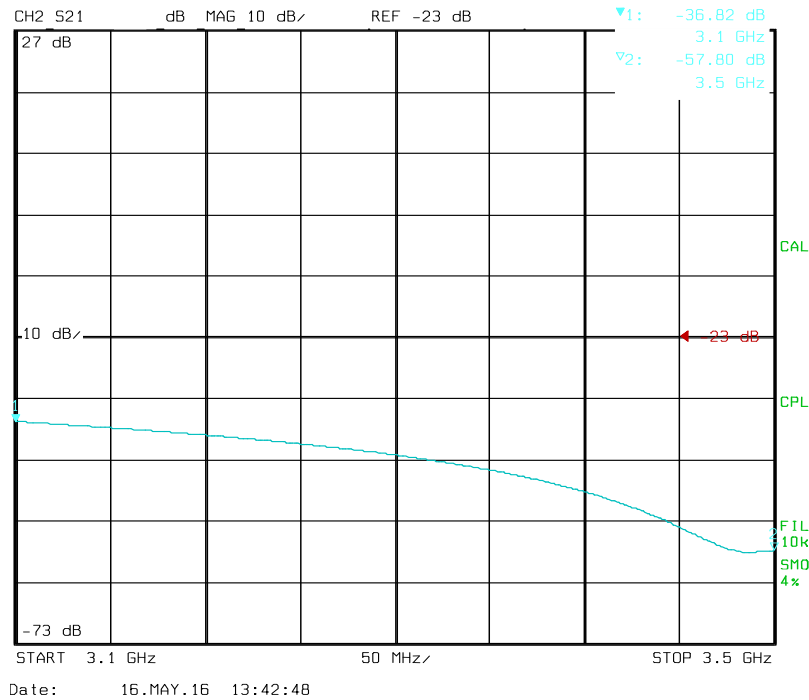
J4- J8 Isolation

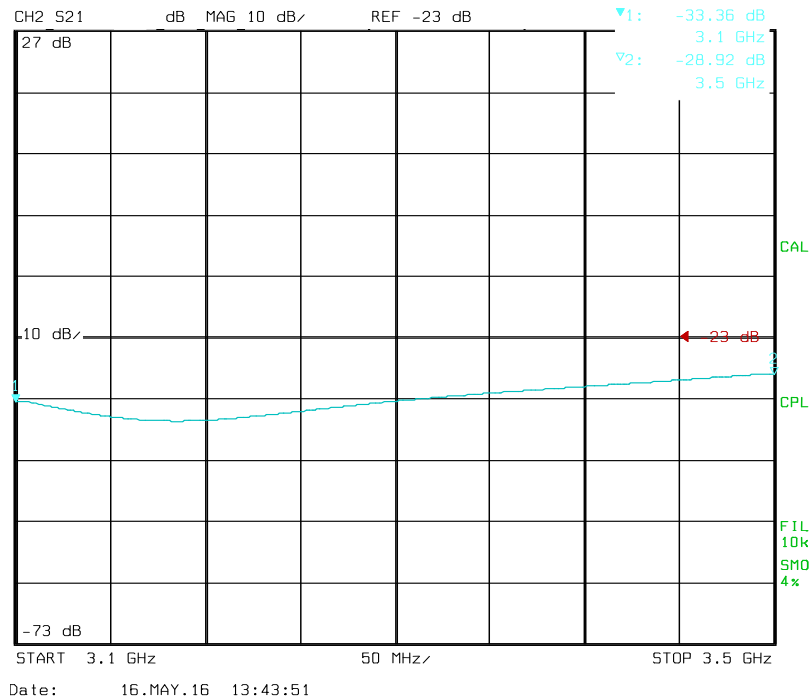
J5- J6 Isolation

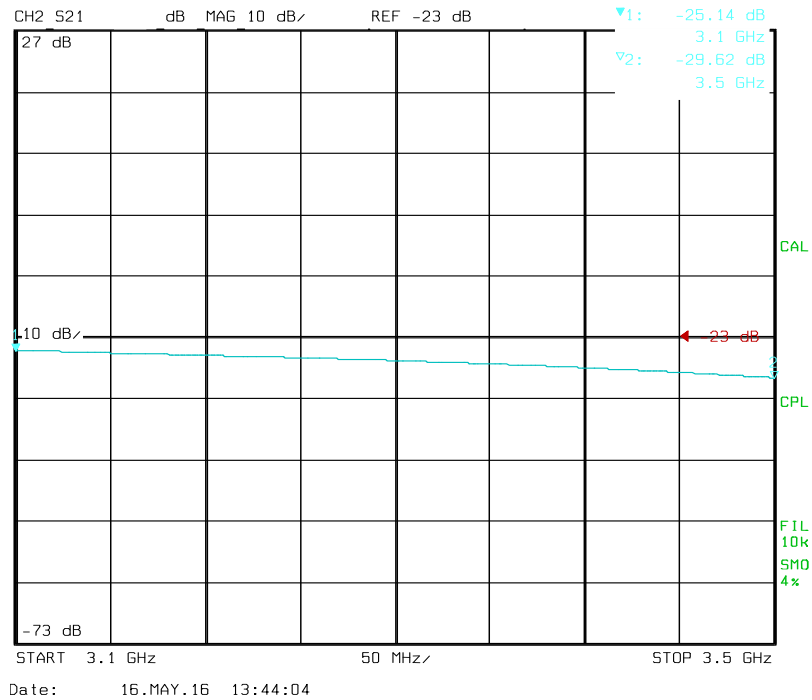
J5- J7 Isolation

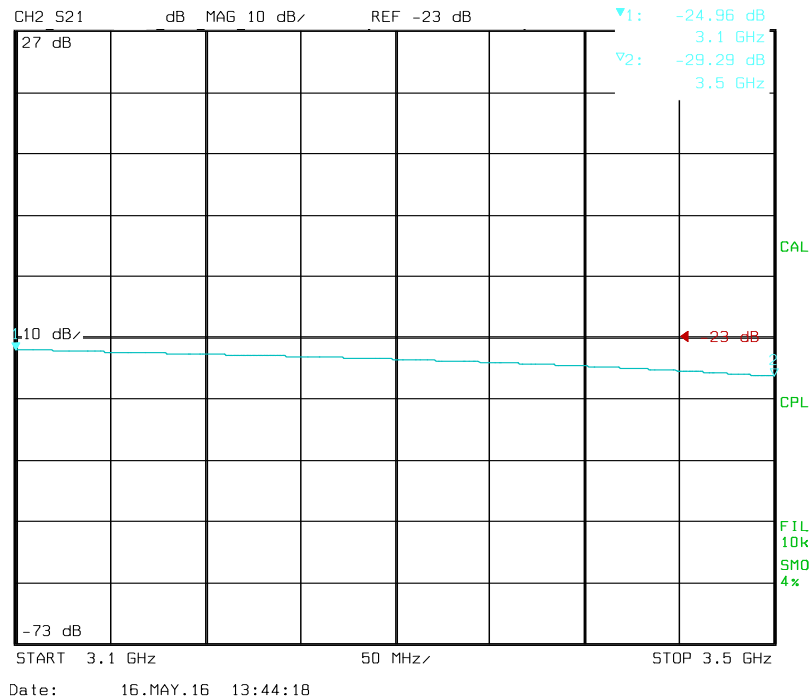
J5- J8 Isolation

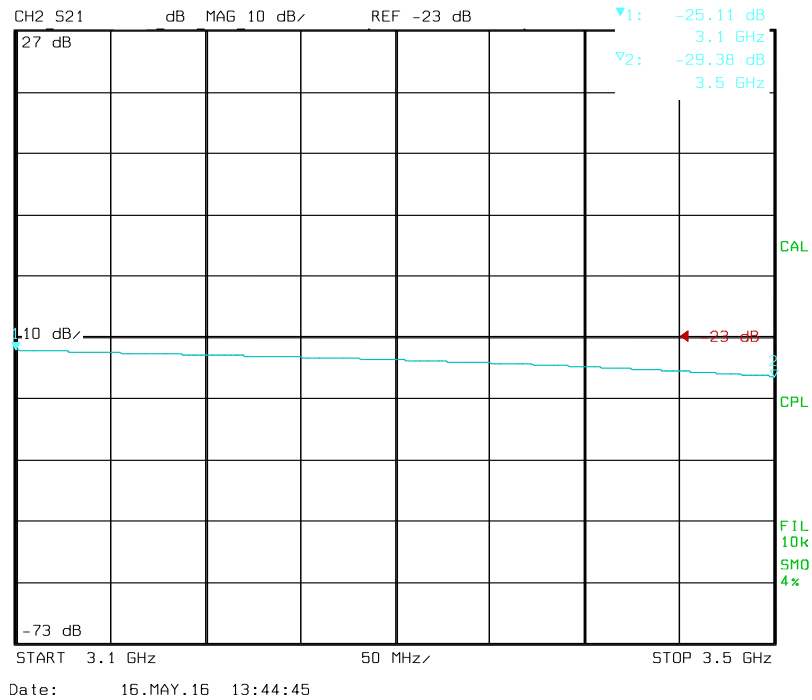
J6- J7 Isolation

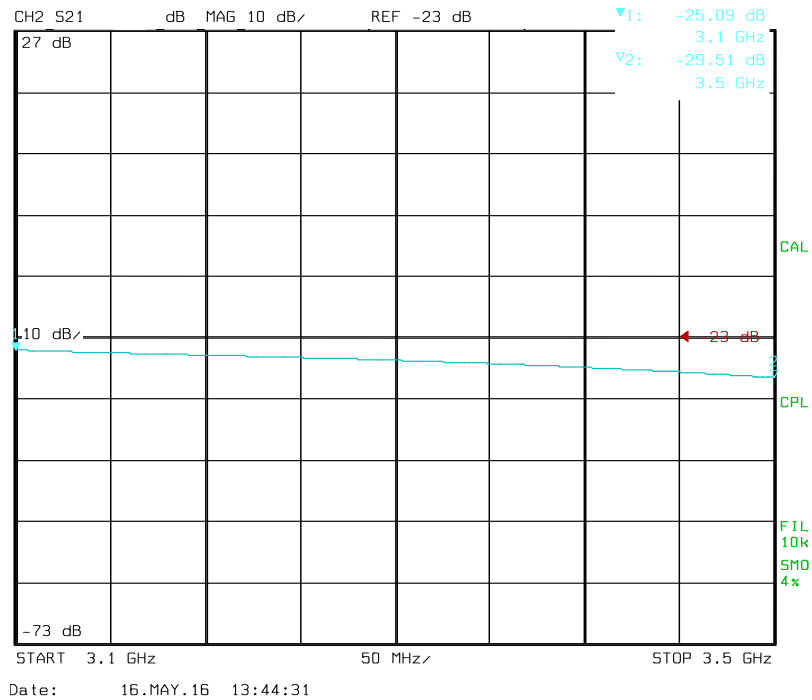
J6- J8 Isolation

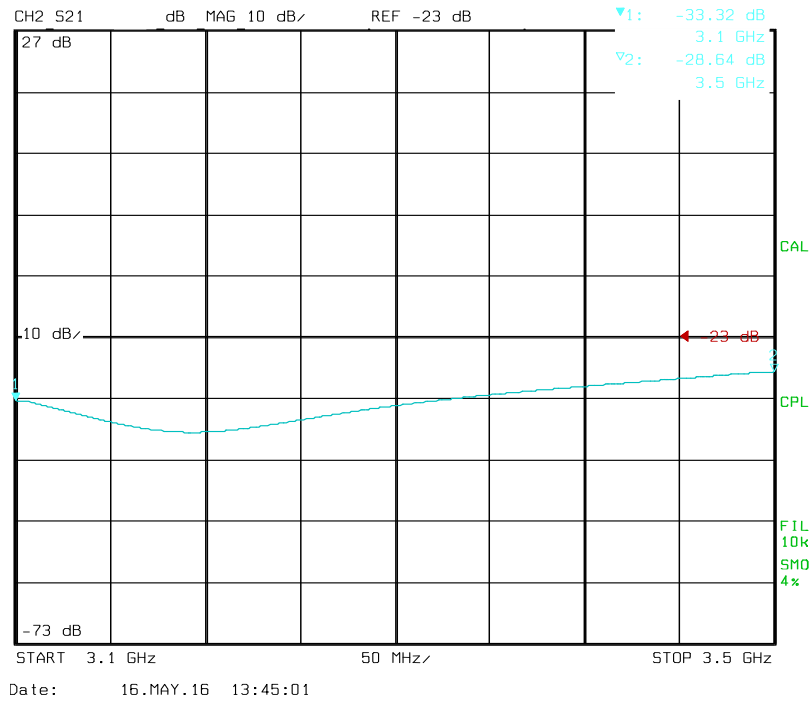
J7- J8 Isolation
